In the following photos, the orange line is the Occidental property boundary; the pink lines are other parcel boundaries.

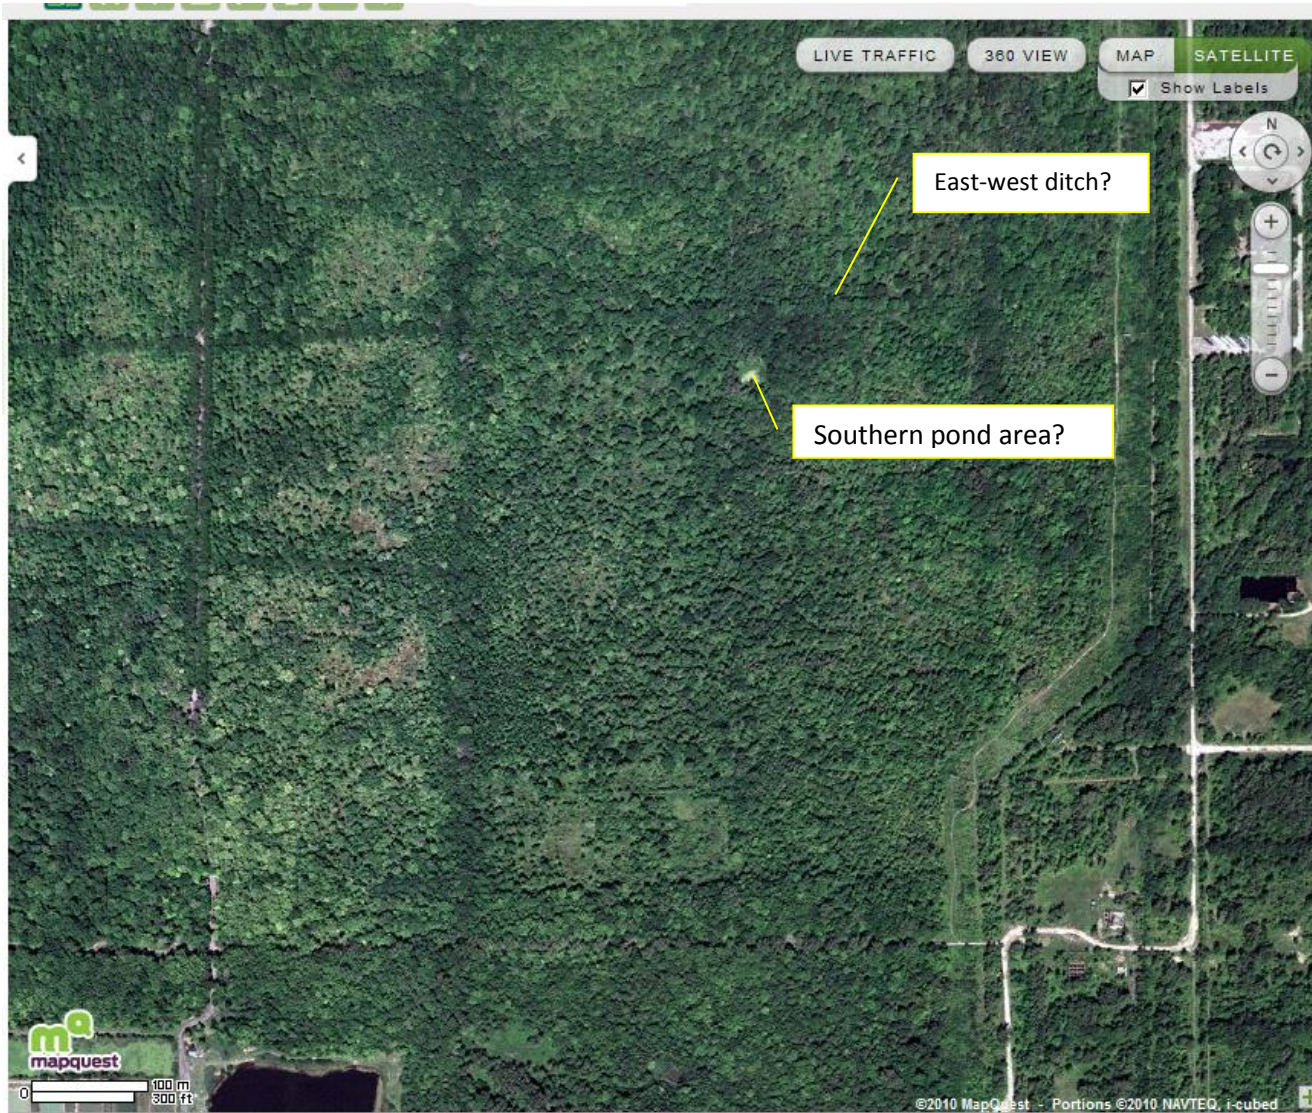
Aerial accessed from Mapquest on Nov. 17, 2010. Note the location of the hatchery and the development just east of the labels in the 2005 photo to help orient yourself with this 2010 photo.
