Appendix O

Historical Aerial Photographs

**Comparison of Historical Site Operations
Near the IWCS With Current Groundwater
Contamination (Dissolved Total U)**

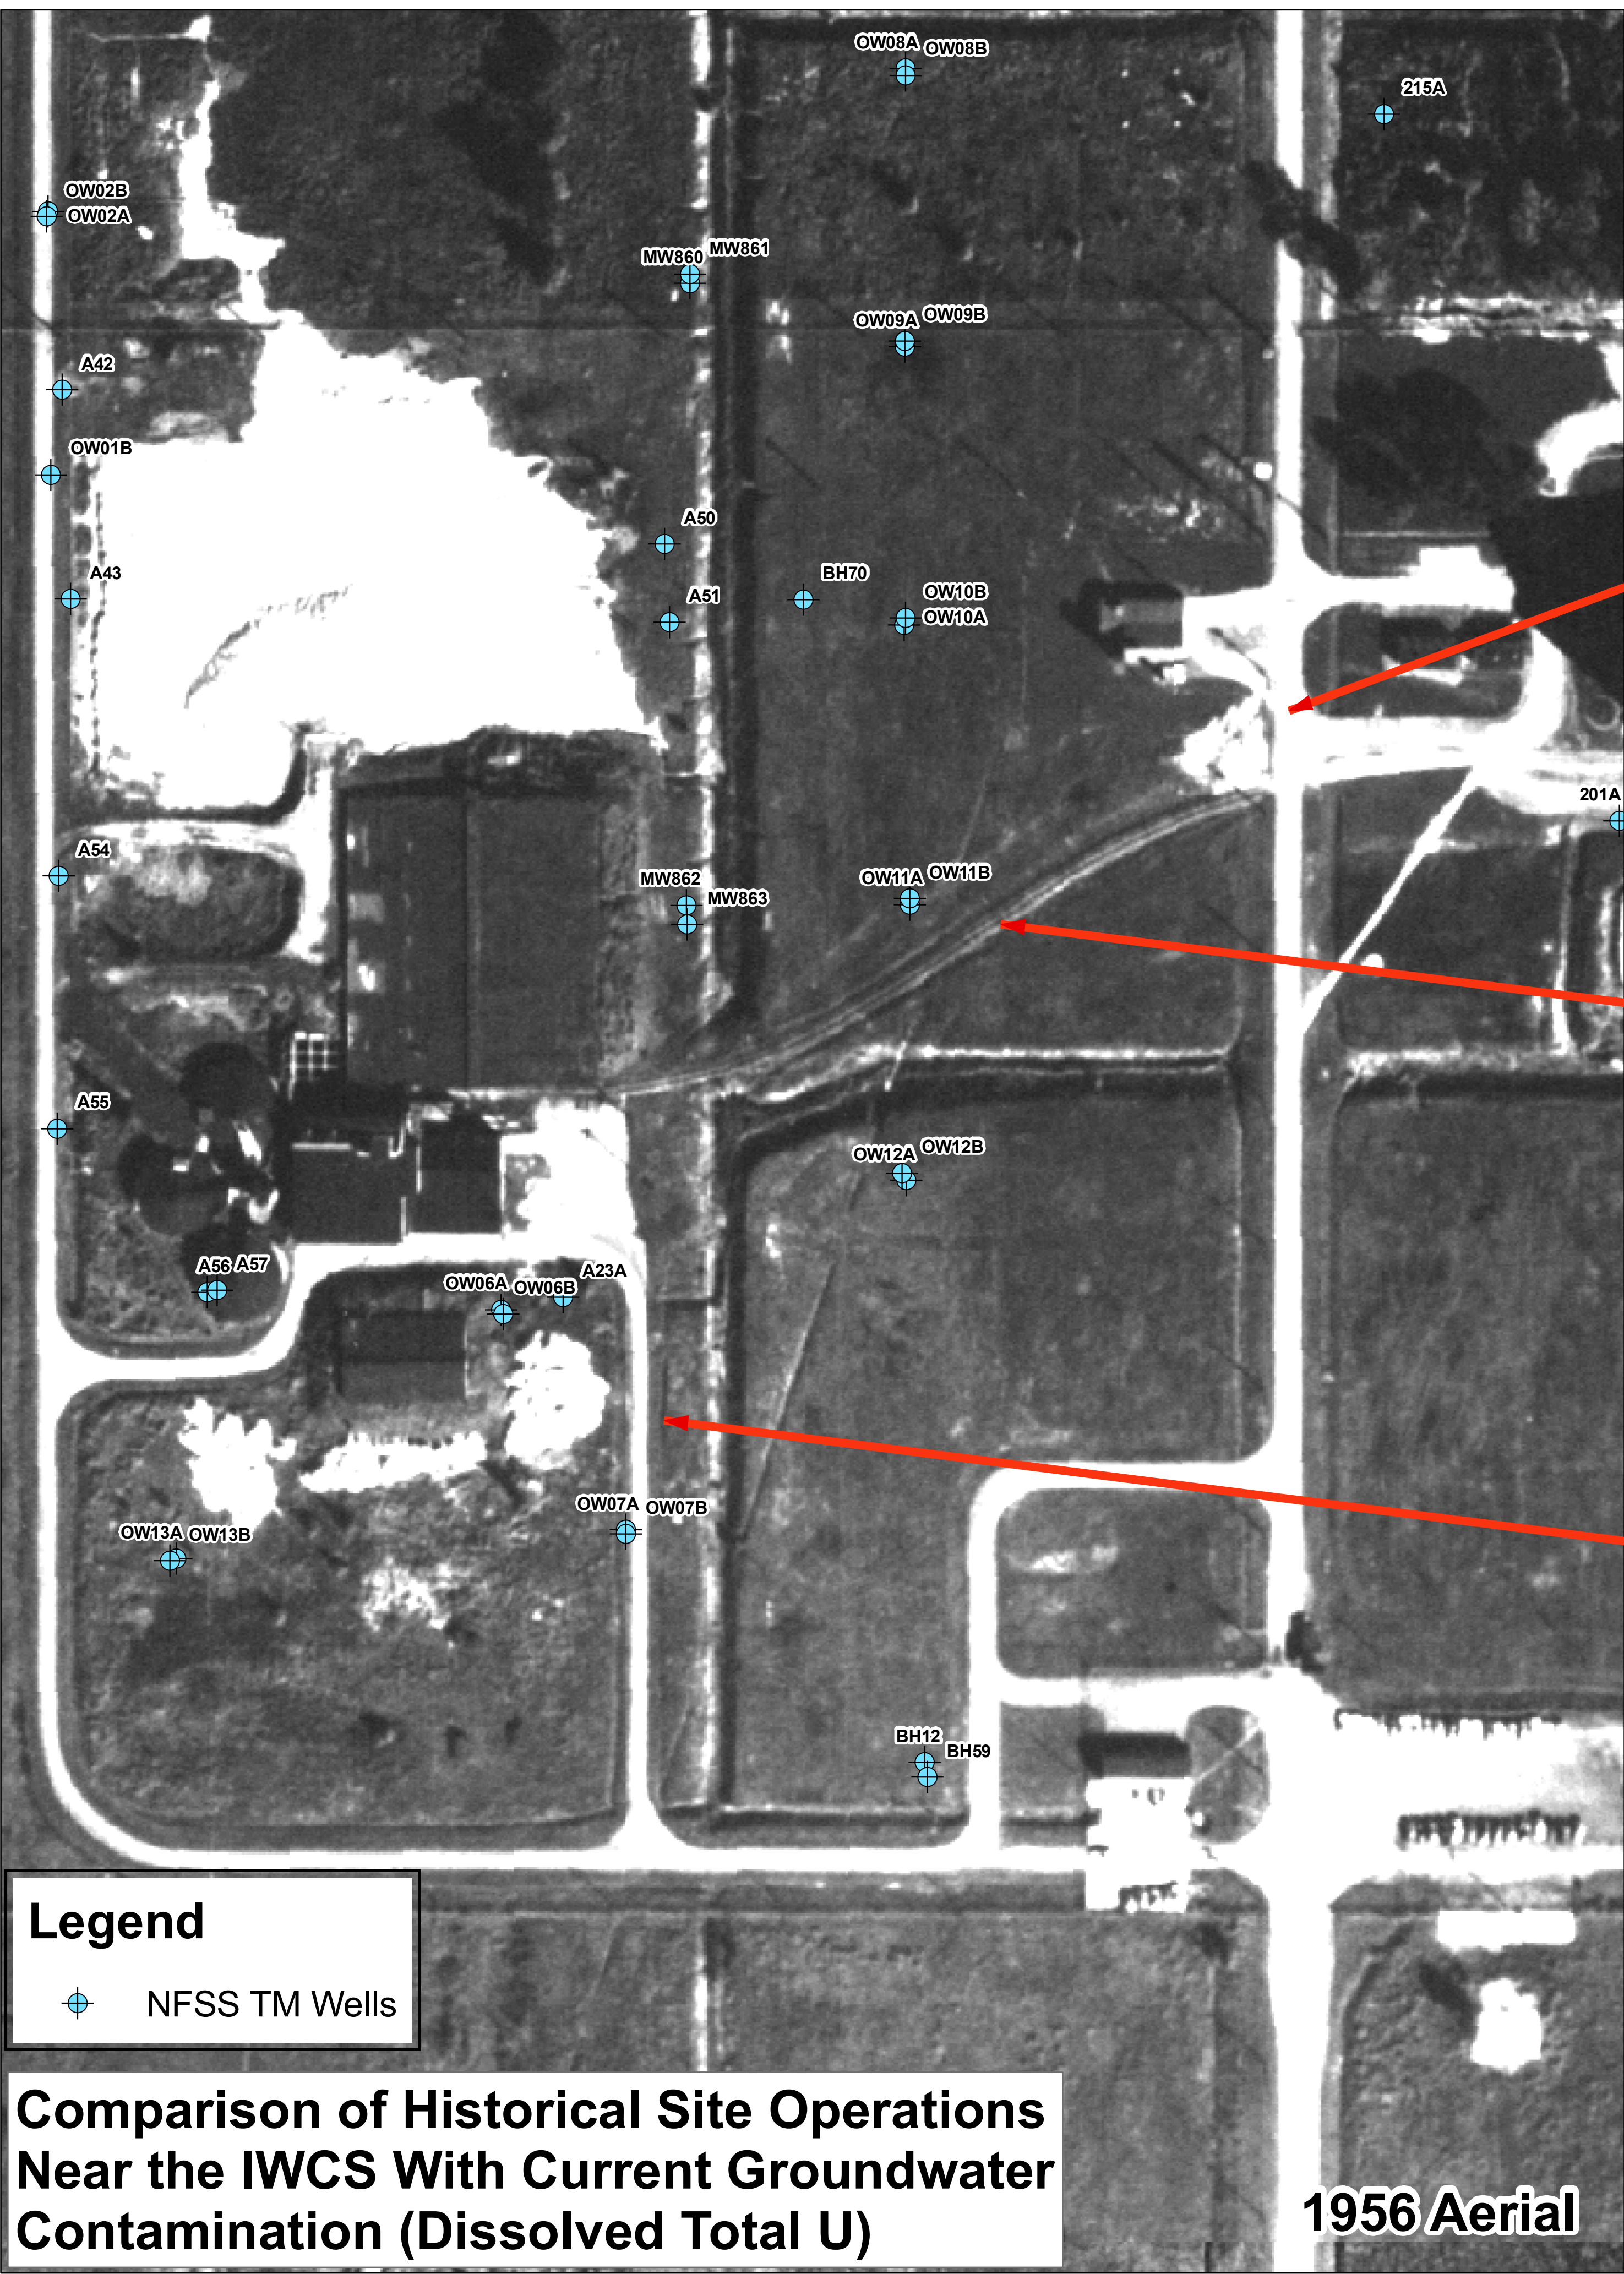
Material Storage Pile

**This area is crossed by various utilities, including
the Sanitary Sewer line that is impacted from
surface inflows from nearby operations that included
decontamination pads, ground scaring from usage,
and rail-line activities.**

**Material Storage Piles and
Operations Evident Through 1981**

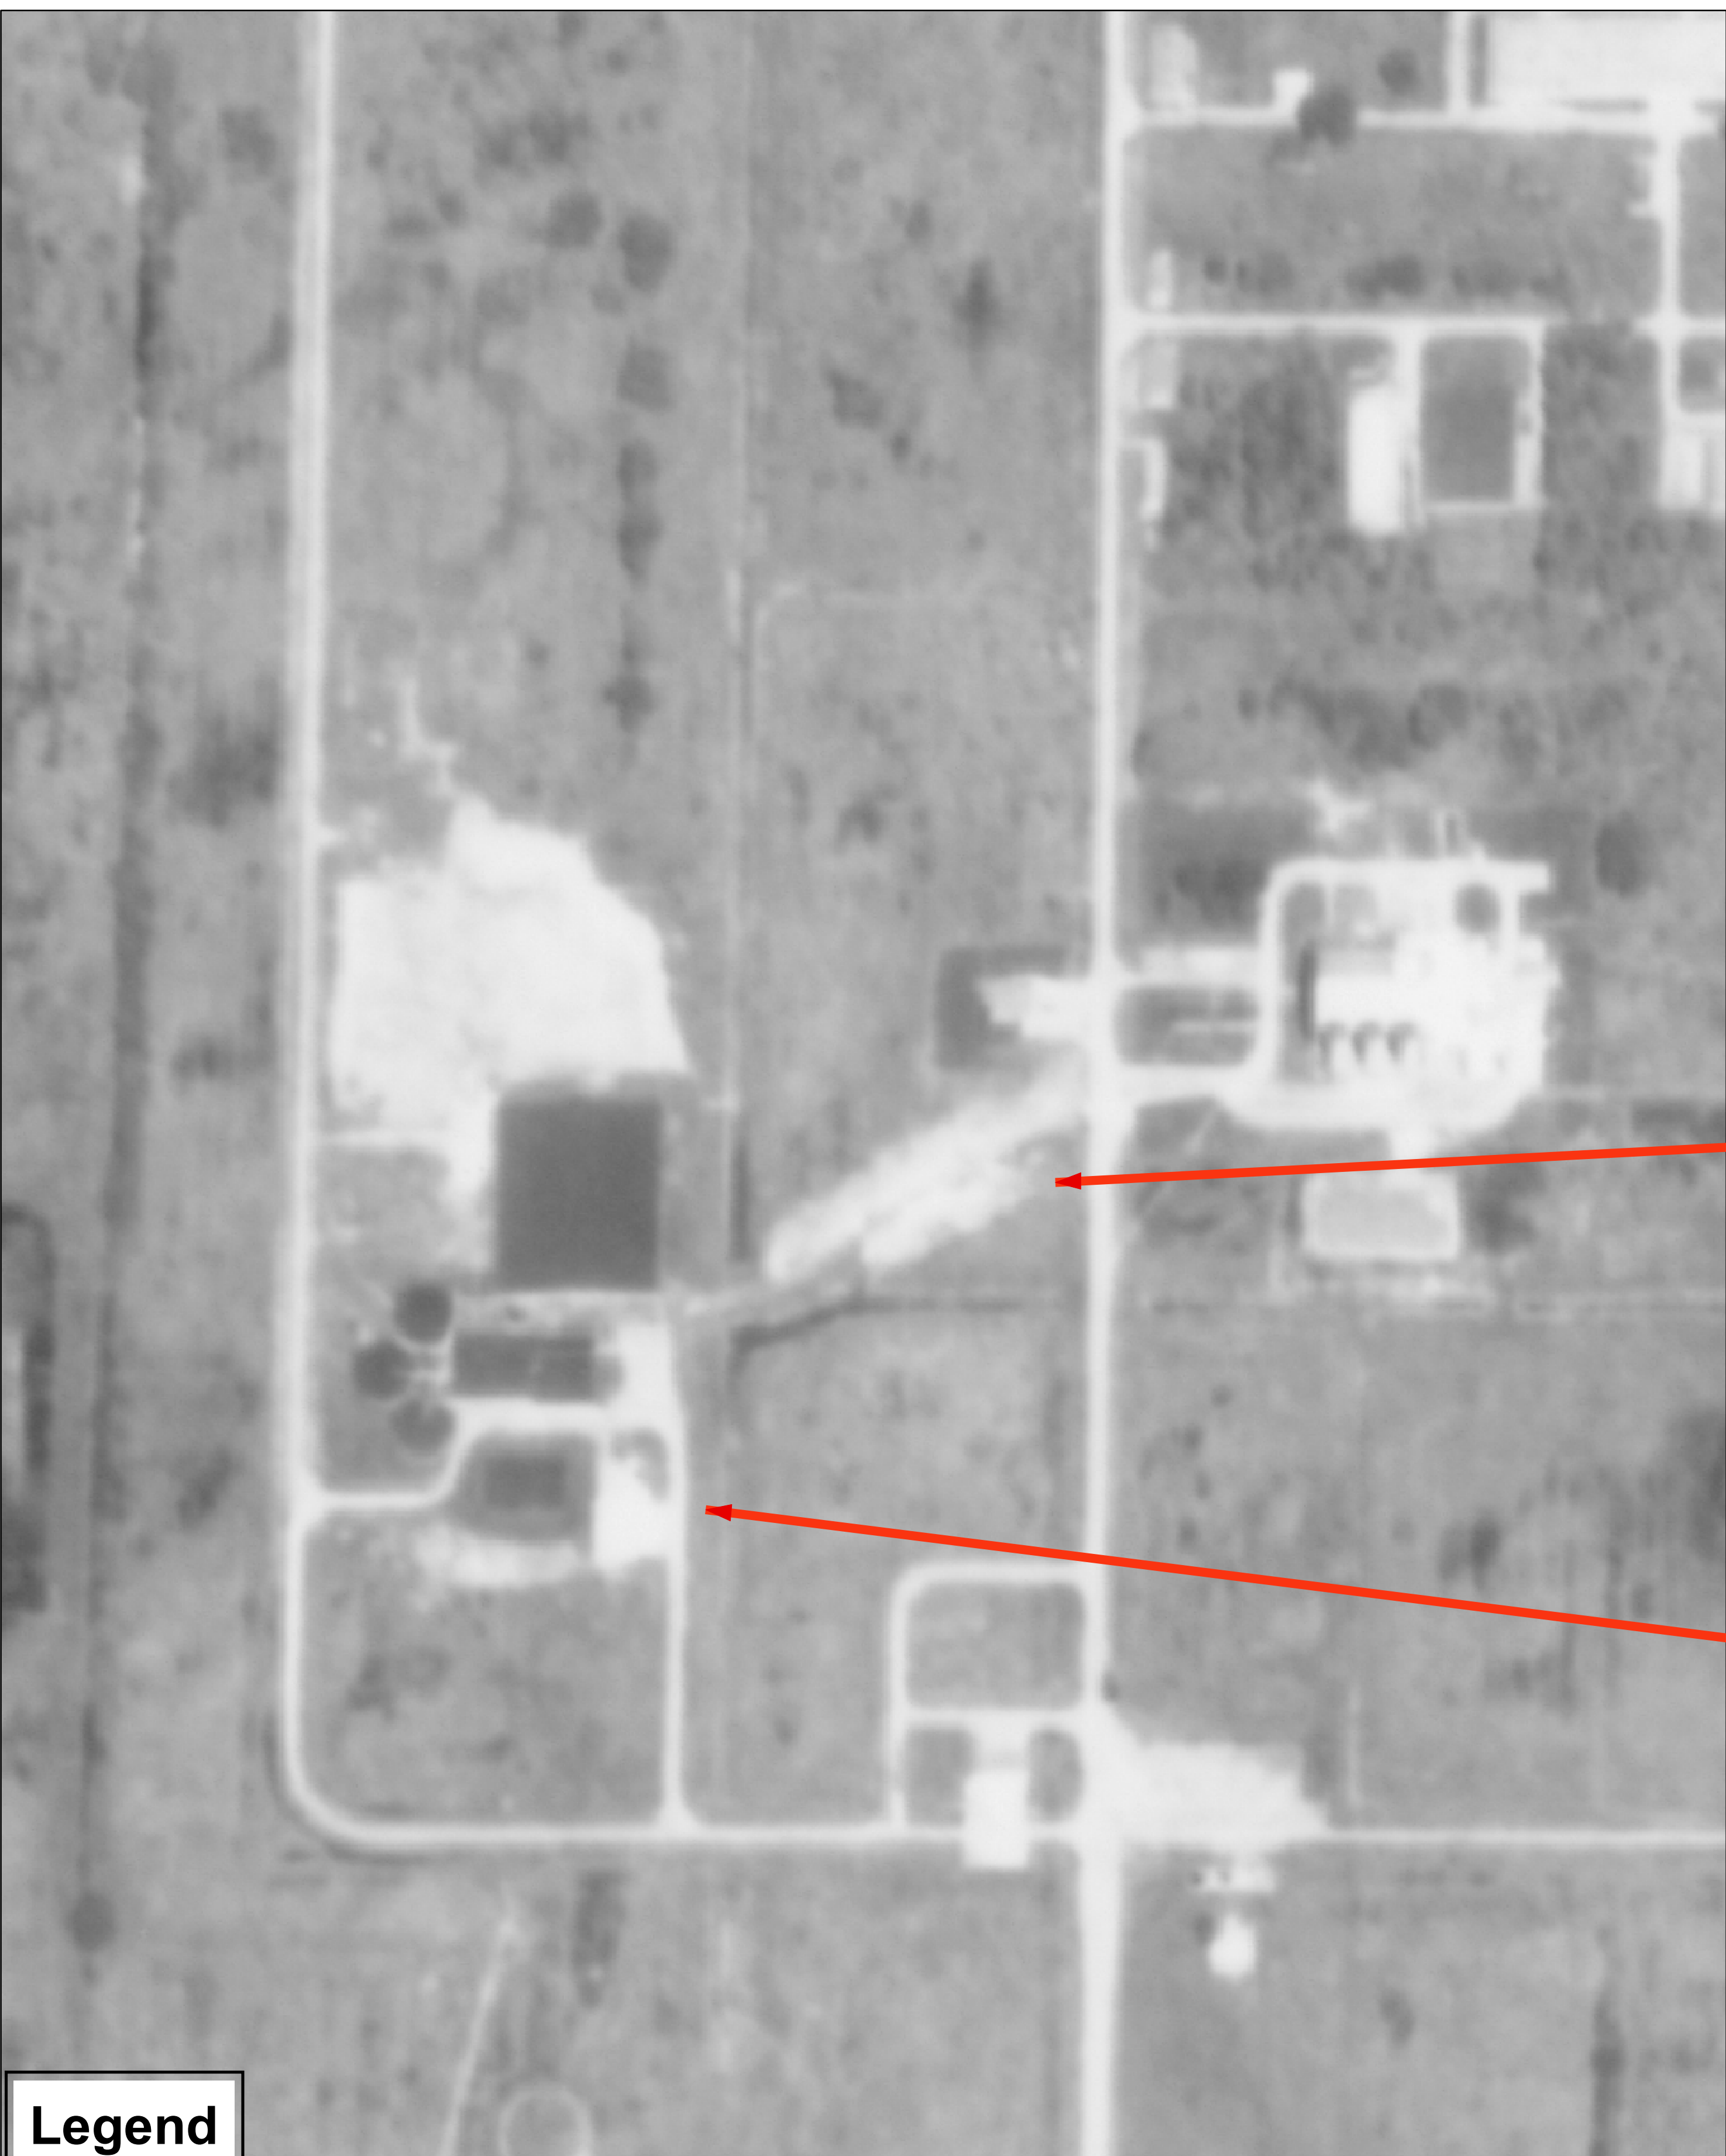
1960 Aerial

This area is crossed by various utilities, including the Sanitary Sewer line that is impacted from surface inflows from nearby operations that included decontamination pads, ground scaring from usage, and rail-line activities.

Material Storage Piles and Operations Evident Through 1981

**Comparison of Historical Site Operations
Near the IWCS With Current Groundwater
Contamination (Dissolved Total U)**

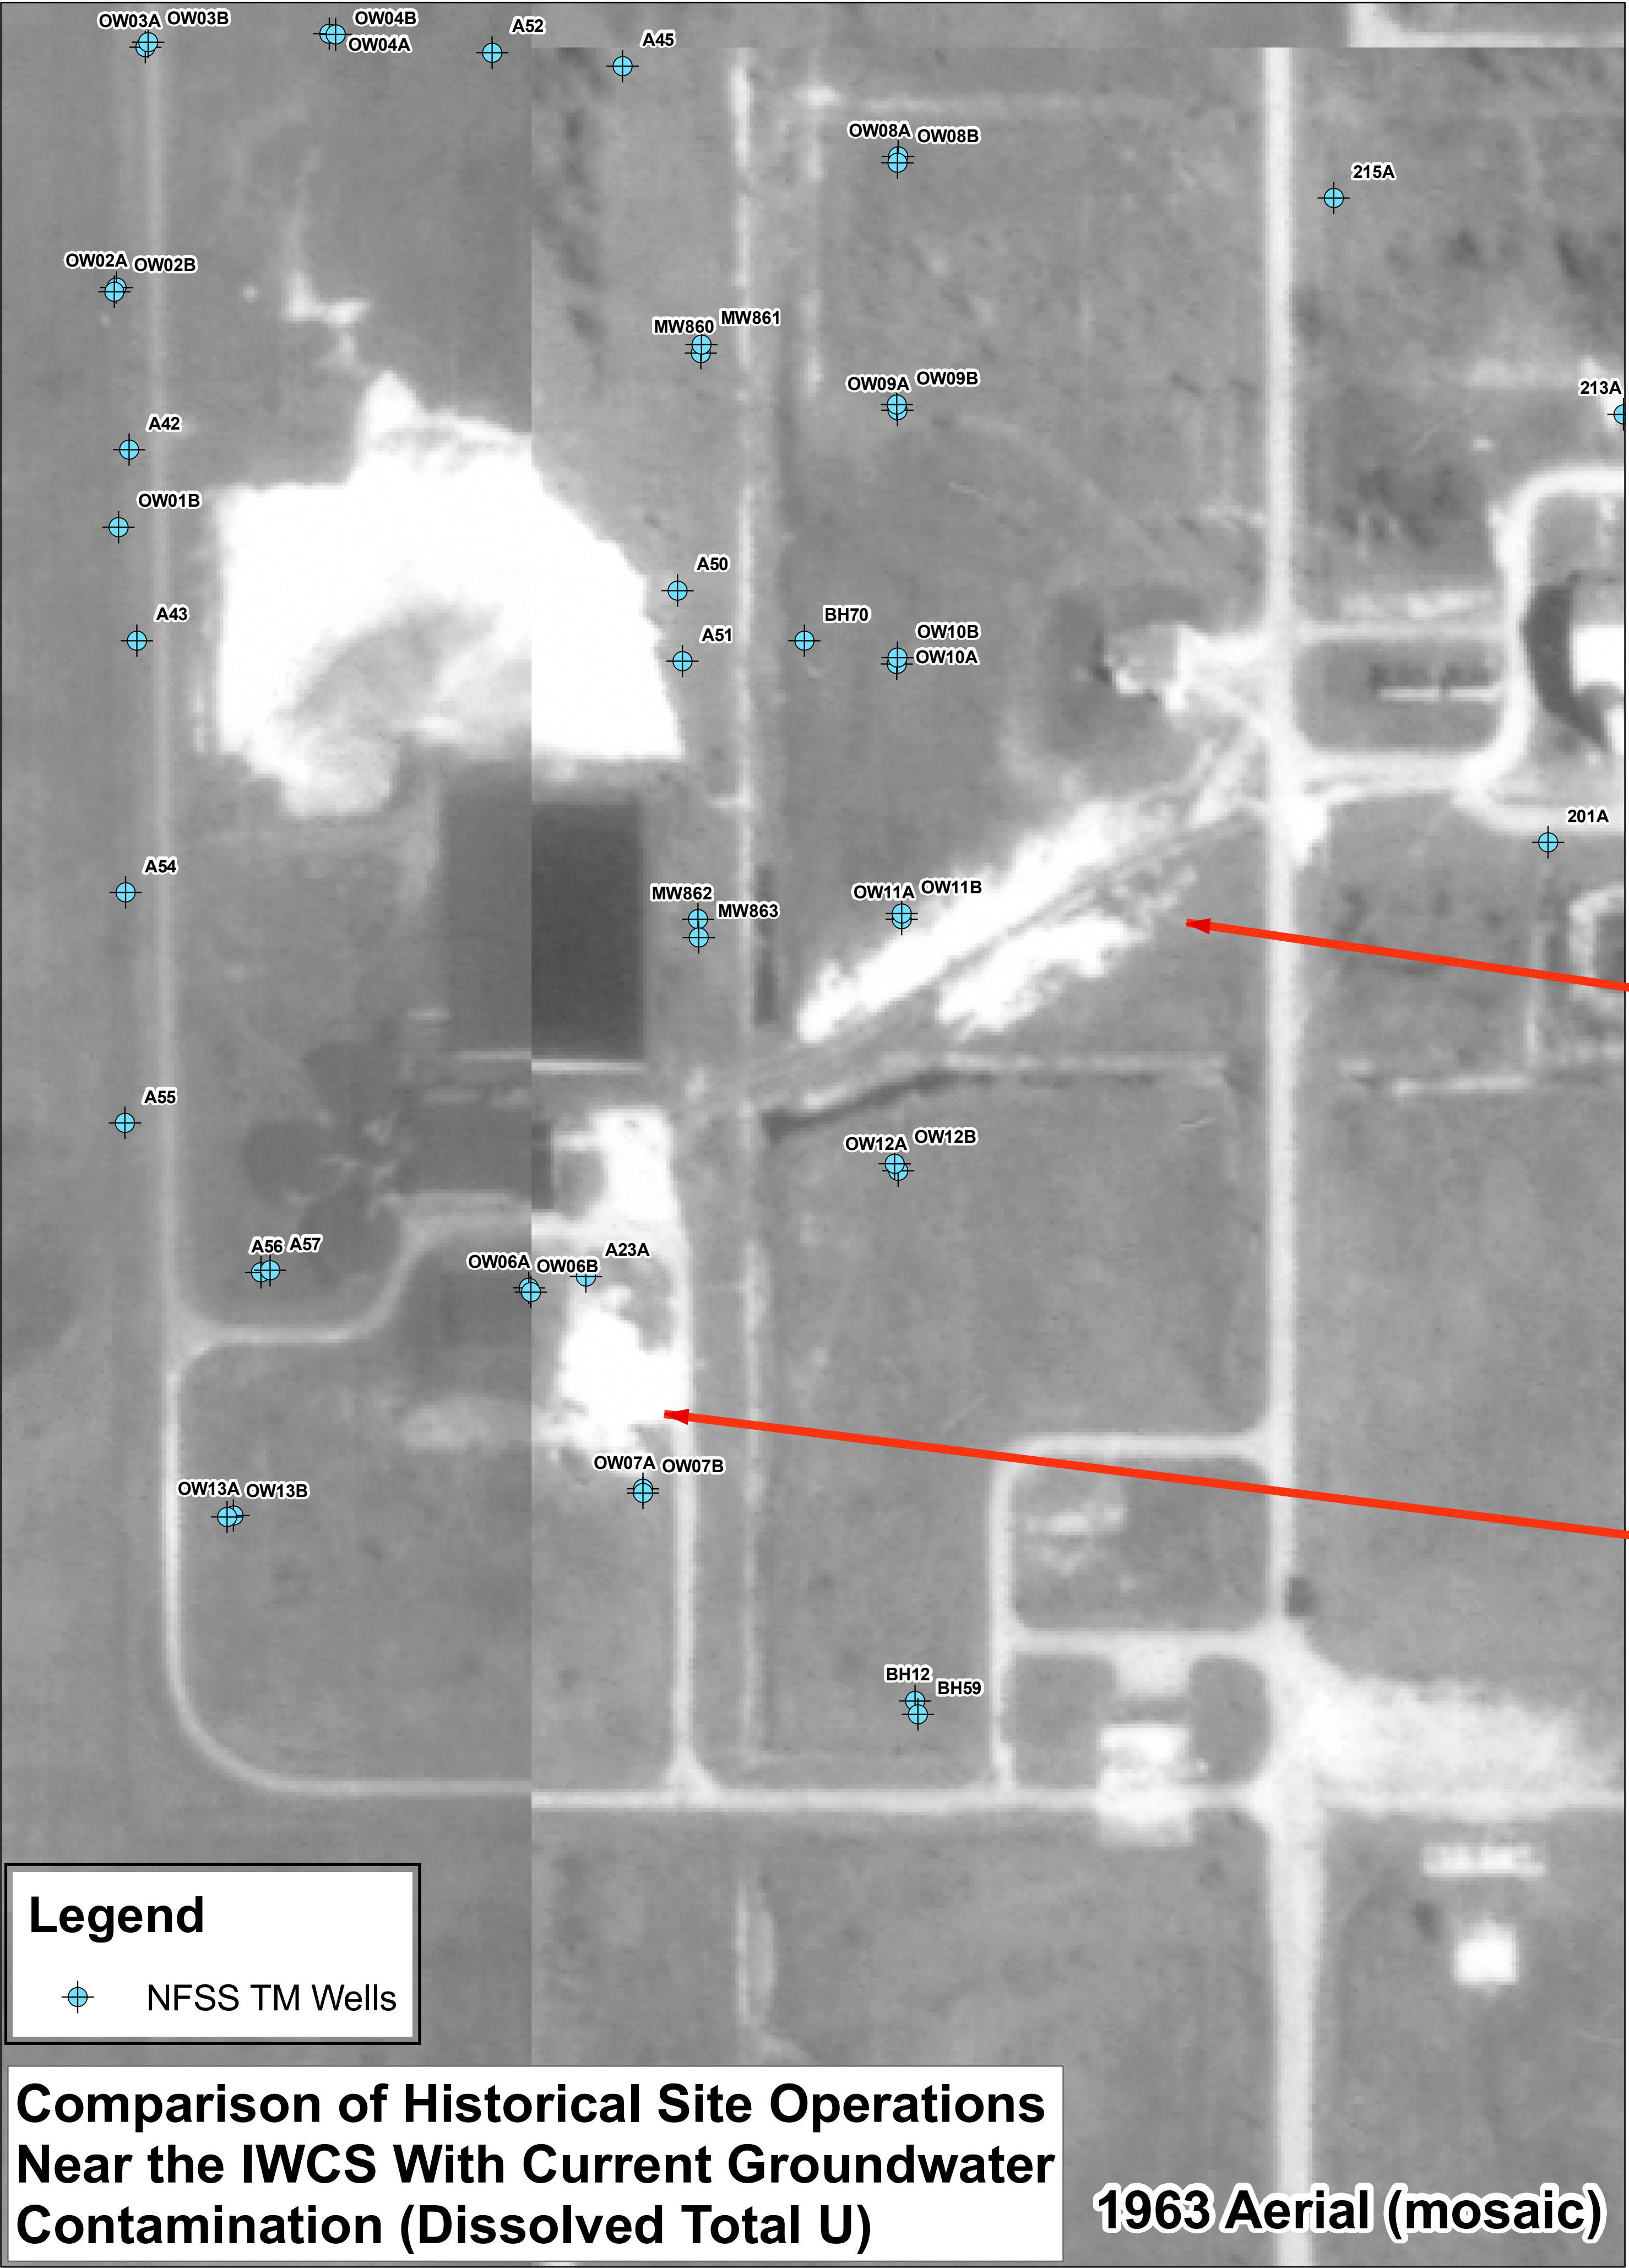
This area is crossed by various utilities, including the Sanitary Sewer line that is impacted from surface inflows from nearby operations that included decontamination pads, ground scaring from usage, and rail-line activities.

Material Storage Piles and Operations Evident Through 1981

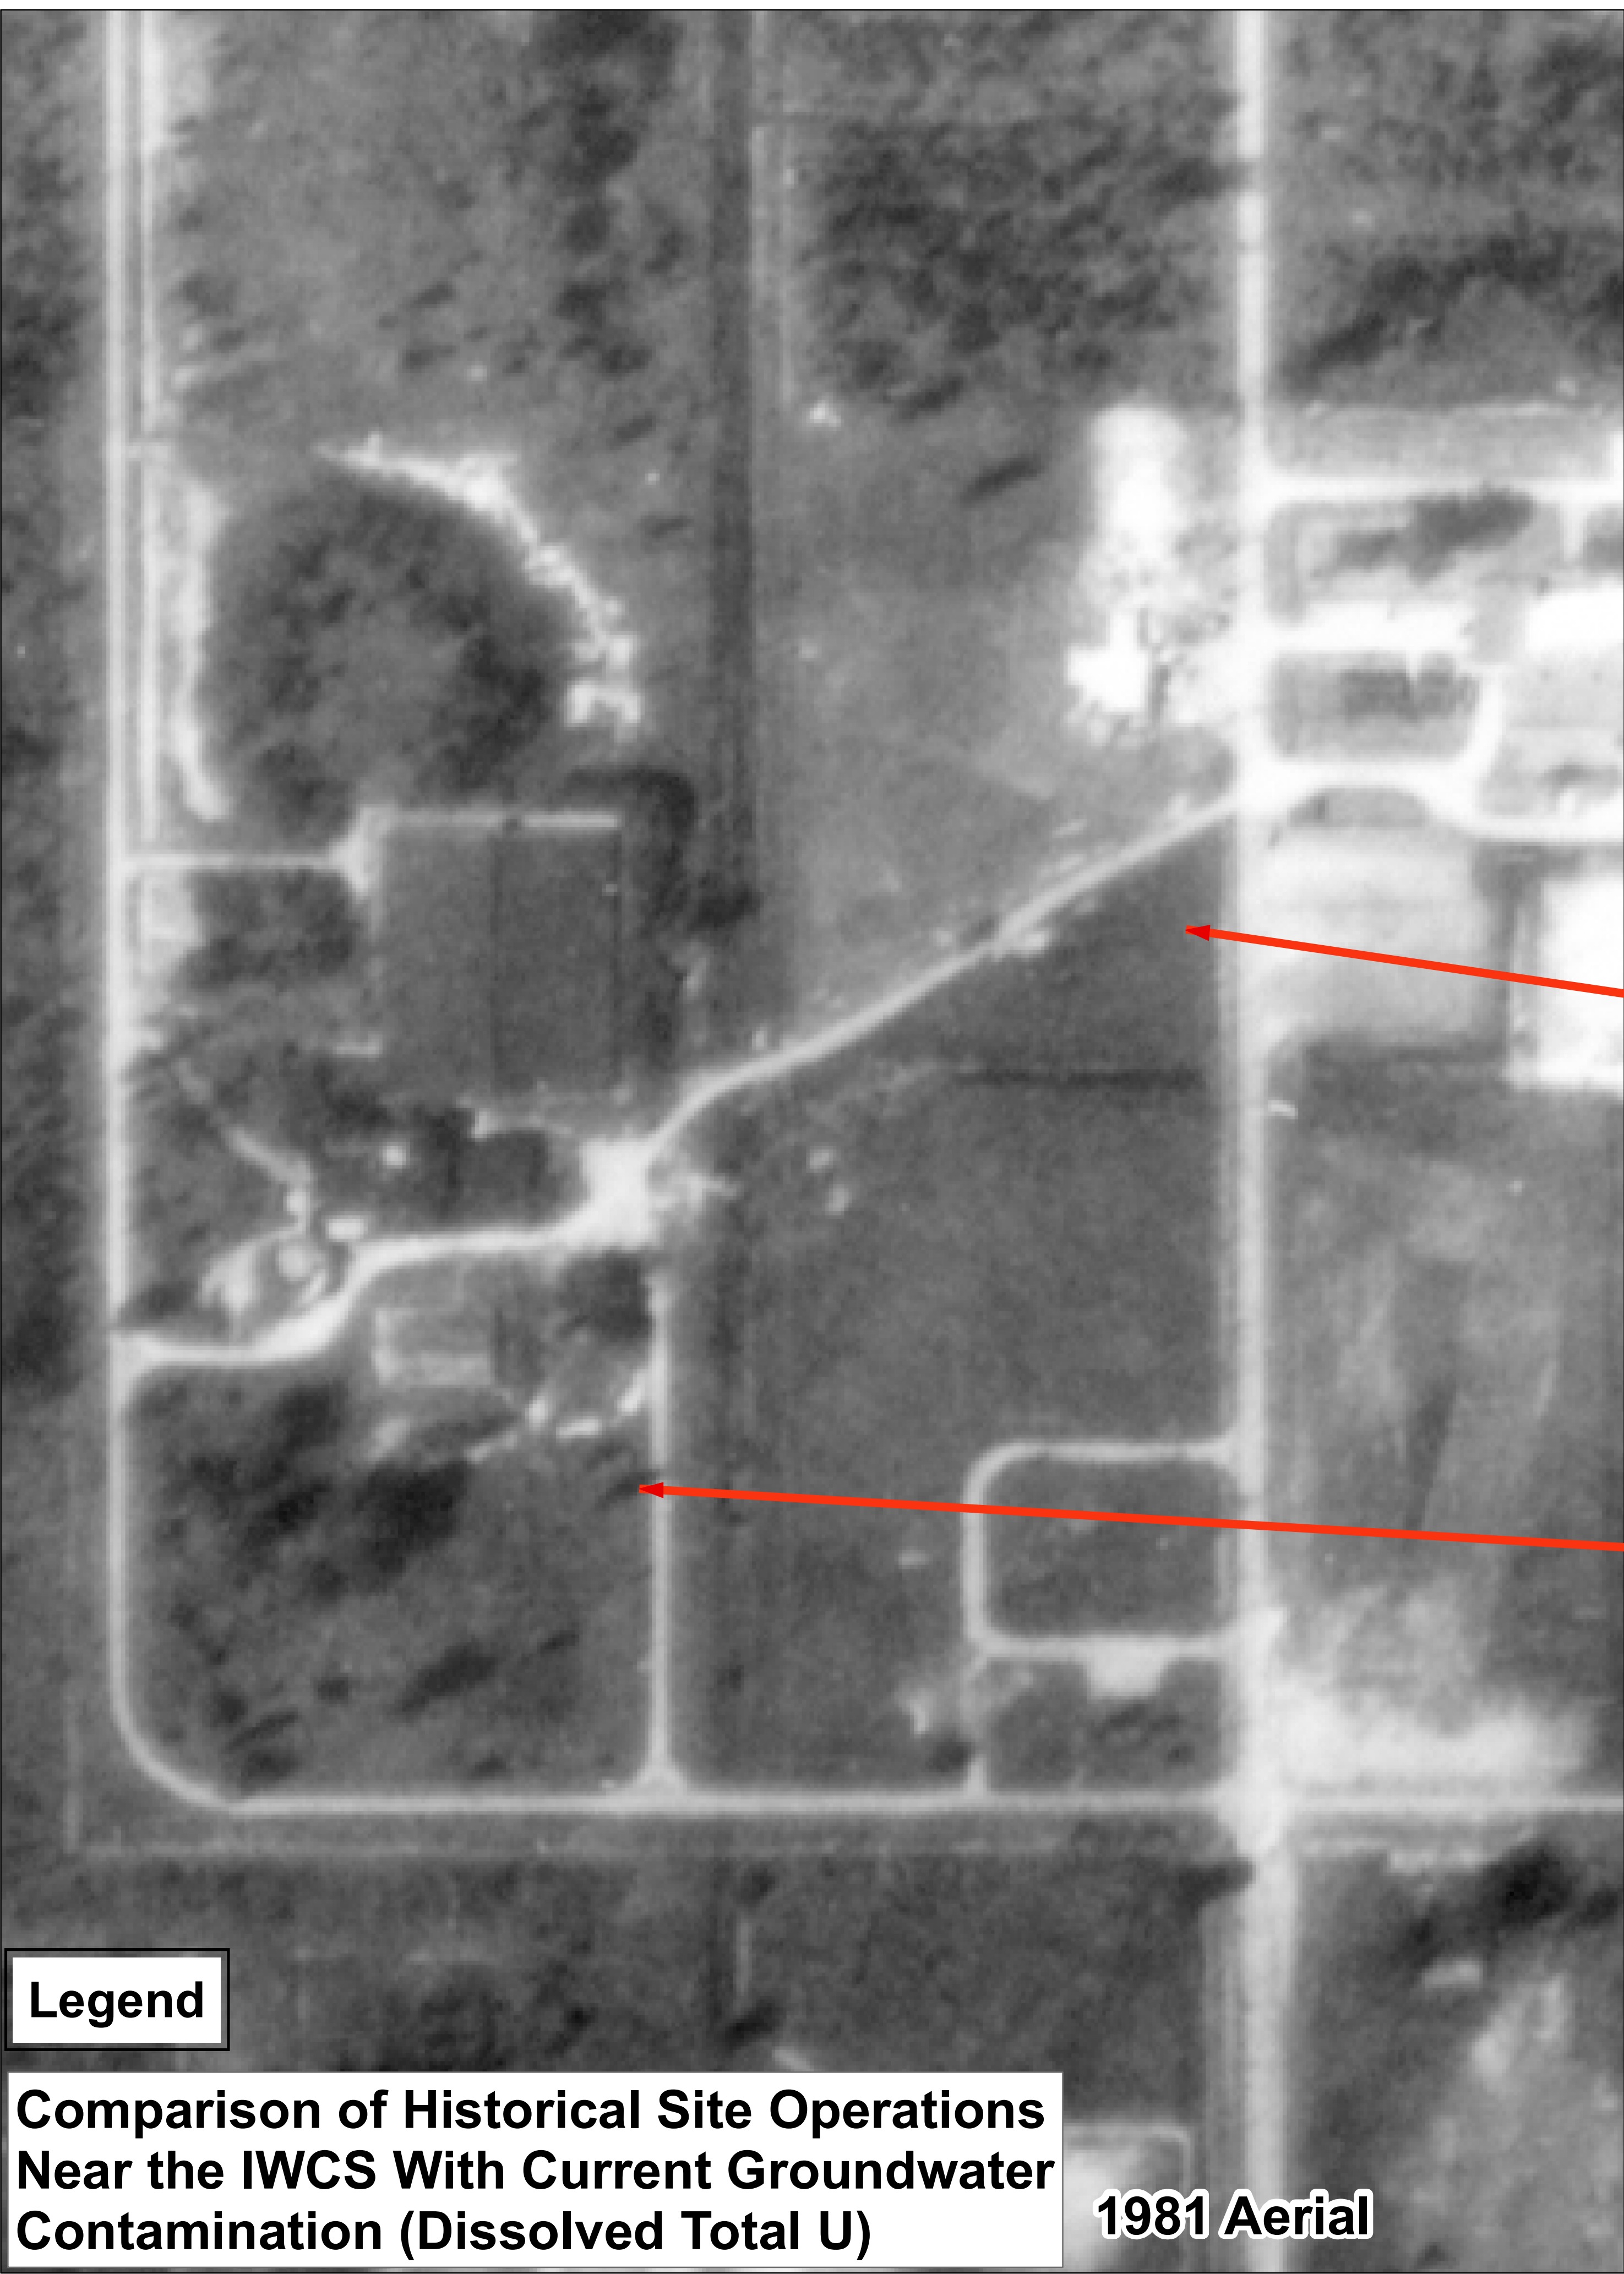
1981 Aerial

This area is crossed by various utilities, including the Sanitary Sewer line that is impacted from surface inflows from nearby operations that included decontamination pads, ground scaring from usage, and rail-line activities.

Material Storage Piles and Operations Evident Through 1981

**Comparison of Historical Site Operations
Near the IWCS With Current Groundwater
Contamination (Dissolved Total U)**
