Notice to

Navigation Interests

L 15 - 1	April 23, 2015
Notice No.	Date

Condition of Federal Navigation Channel
Cleveland harbor - Cuyahoga River, Ohio

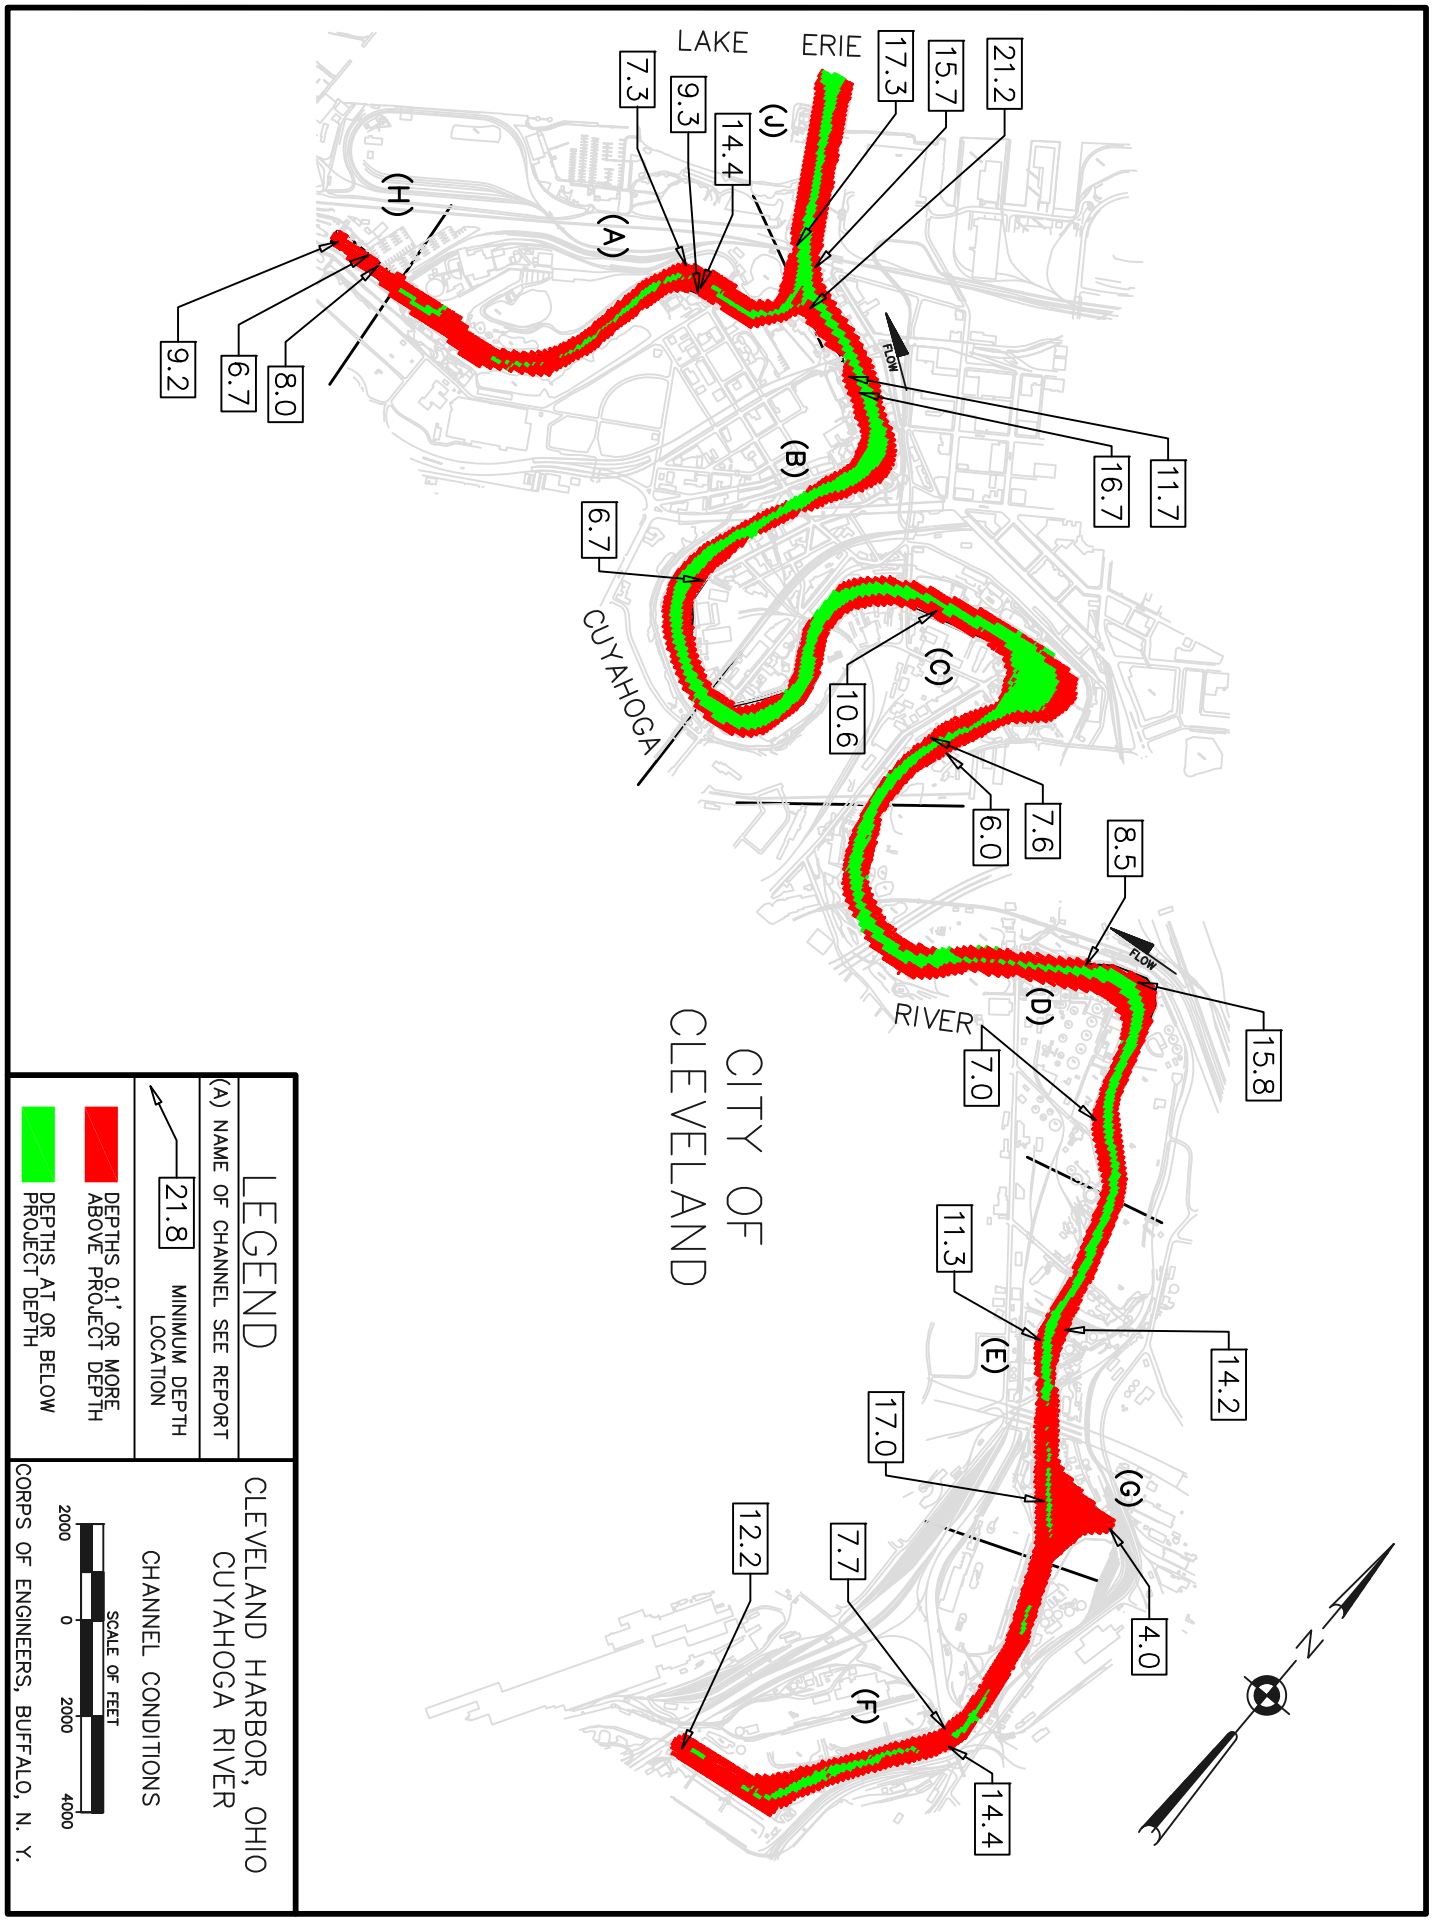
1. Condition surveys performed within the Federal Navigation Channel at Cleveland harbor - Cuyahoga River, Ohio during the month of April 2015 indicate shoaling has reduced depths to those shown on the attached standard tabular form and channel condition drawings.

LAKE ERIE
CUYAHOGA RIVER
CITY OF CLEVELAND
FLOW
FLOW
(A)
(B)
(C)
(D)
(E)
(F)
(G)
(H)
(J)
21.2
15.7
17.3
7.3
9.3
14.4
9.2
6.7
8.0
11.7
16.7
6.7
10.6
7.6
6.0
8.5
15.8
7.0
11.3
14.2
17.0
4.0
7.7
12.2
14.4
N
LEGEND
(A) NAME OF CHANNEL SEE REPORT
21.8 MINIMUM DEPTH LOCATION
DEPTHS 0.1' OR MORE ABOVE PROJECT DEPTH
DEPTHS AT OR BELOW PROJECT DEPTH
CLEVELAND HARBOR, OHIO
CUYAHOGA RIVER
CHANNEL CONDITIONS
SCALE OF FEET
2000 0 2000 4000
CORPS OF ENGINEERS, BUFFALO, N. Y.

3. Vessel operators are advised to use caution when navigating in this area.
