Post-Remedial Action Report
Area 9

Figure 4.9-1
Summary of Remedial Activities

Linde Site, Tonawanda, New York

Bechtel National, Inc.
FUSRAP Program

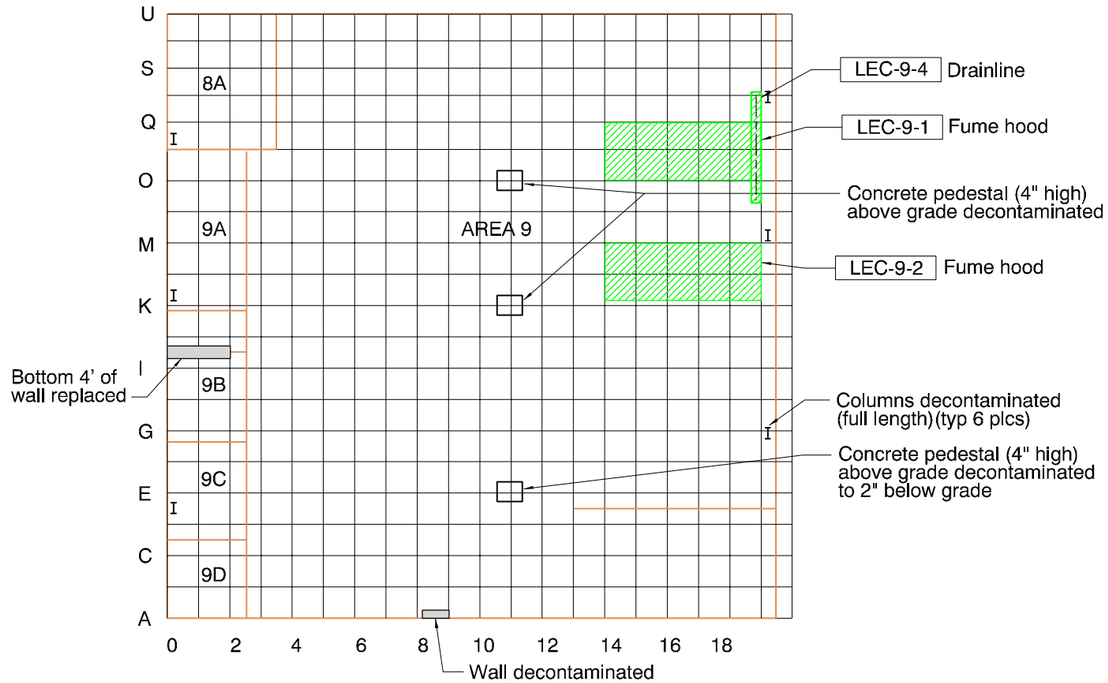
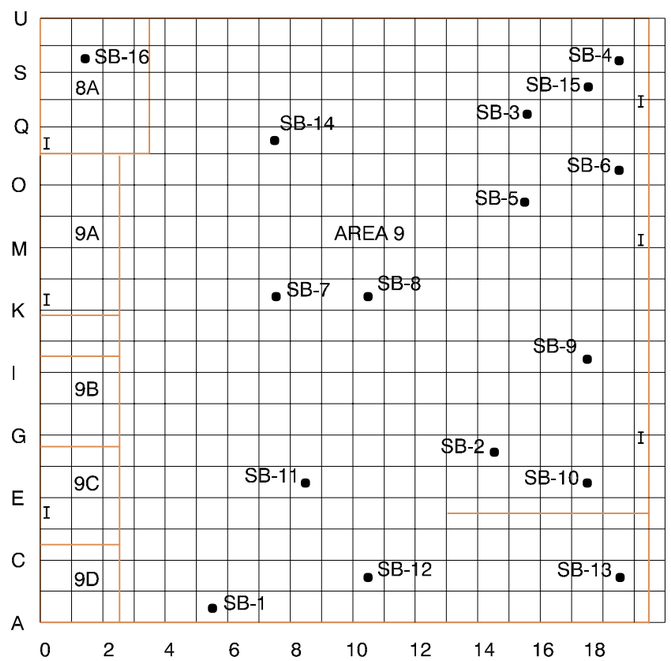
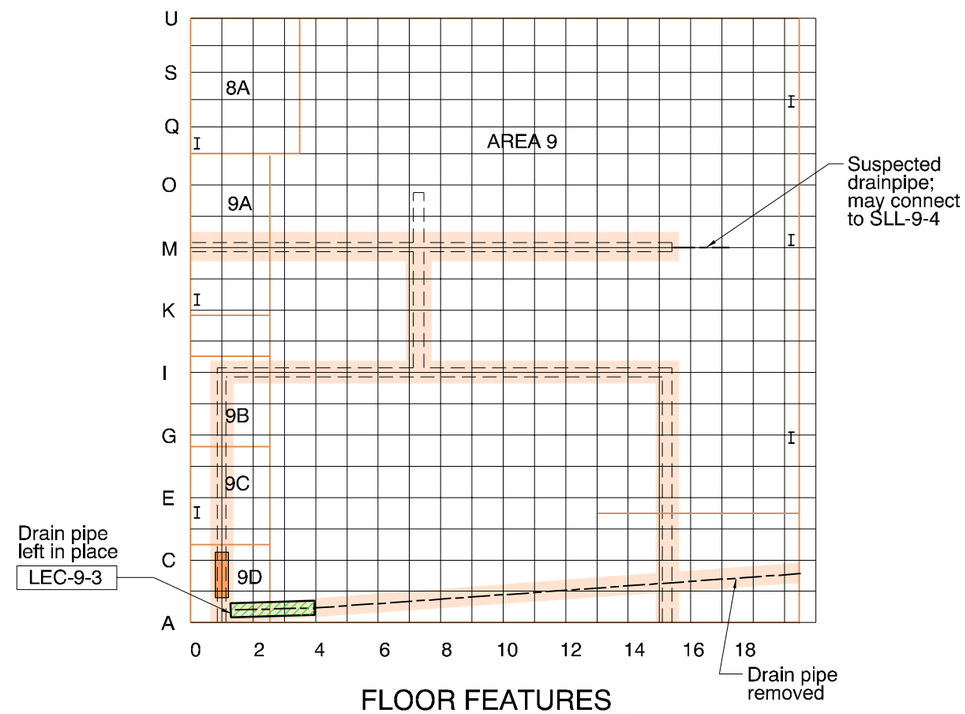
FLOOR FEATURES
AREA OF SOIL EXCAVATION
