**Remedial Design of Interim Remedial Measures
Operable Units 1 and 2
Former Lake Ontario Ordnance Works
Lewiston/Porter, Niagara County, NY**

**Asbestos Survey Report
Somerset Group Property**

June 1998

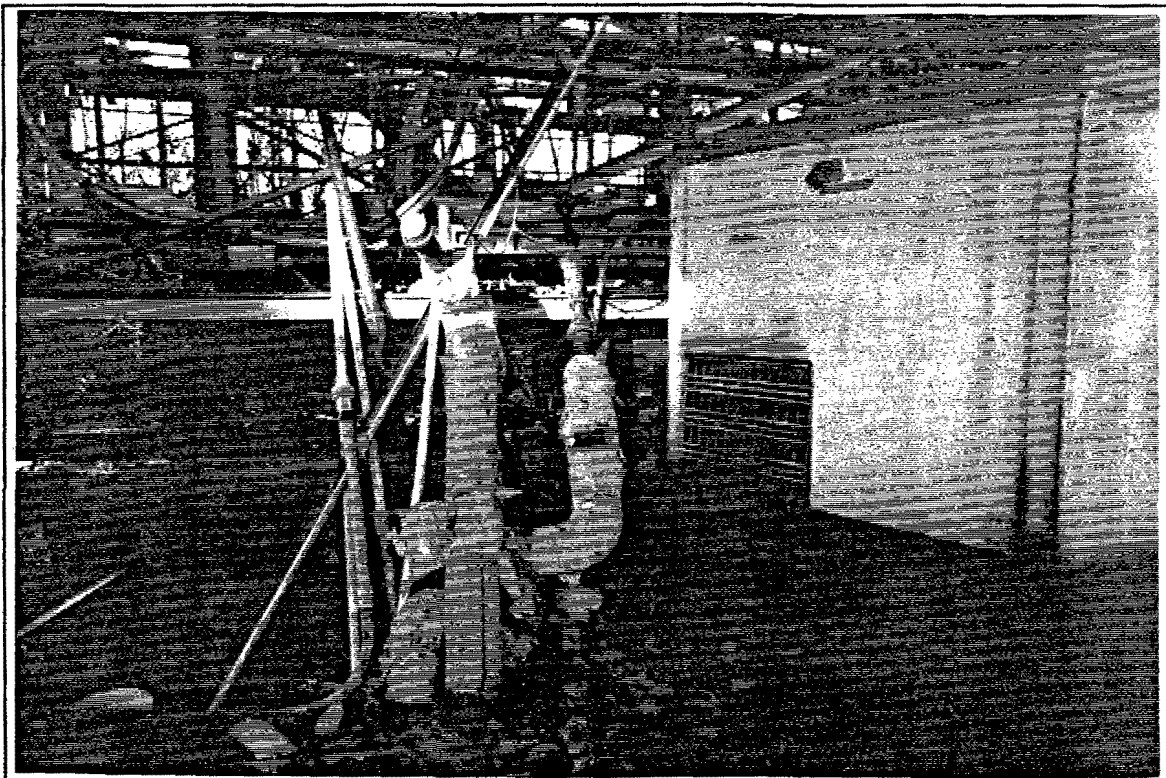
Photo 7 - Building 6-01 - East wing. Dismantling piping arrangement where Sample No. 1-006 was taken. Samples analyzed negative for asbestos.

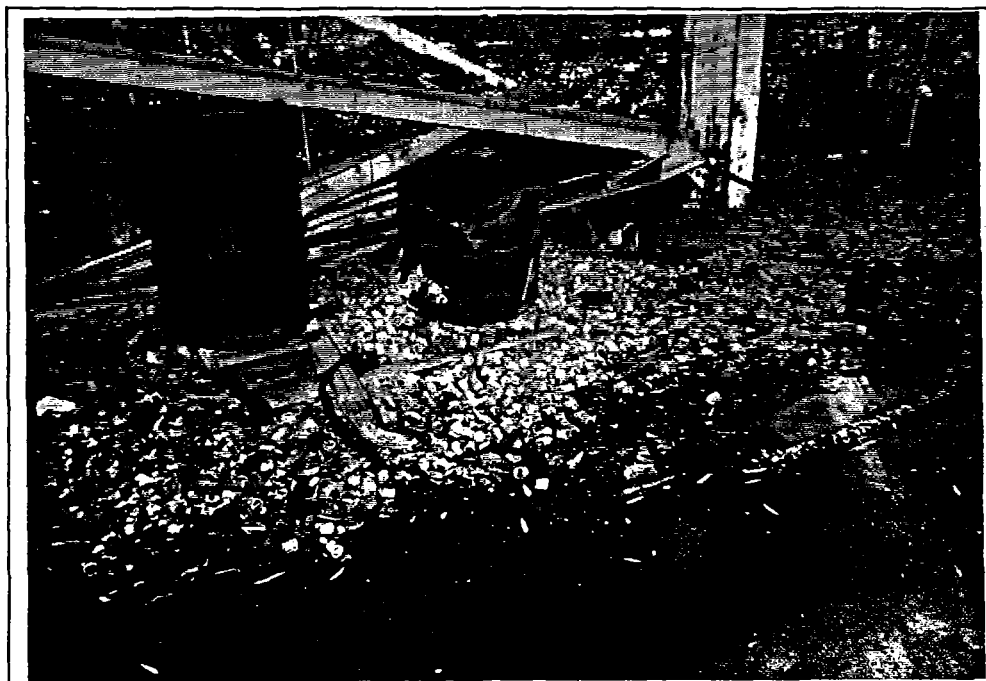
Photo 25 - Building 6-01 - West wing. Cylindrical, ceramic electrical insulators (Sample No. 1-007). Does not contain asbestos.

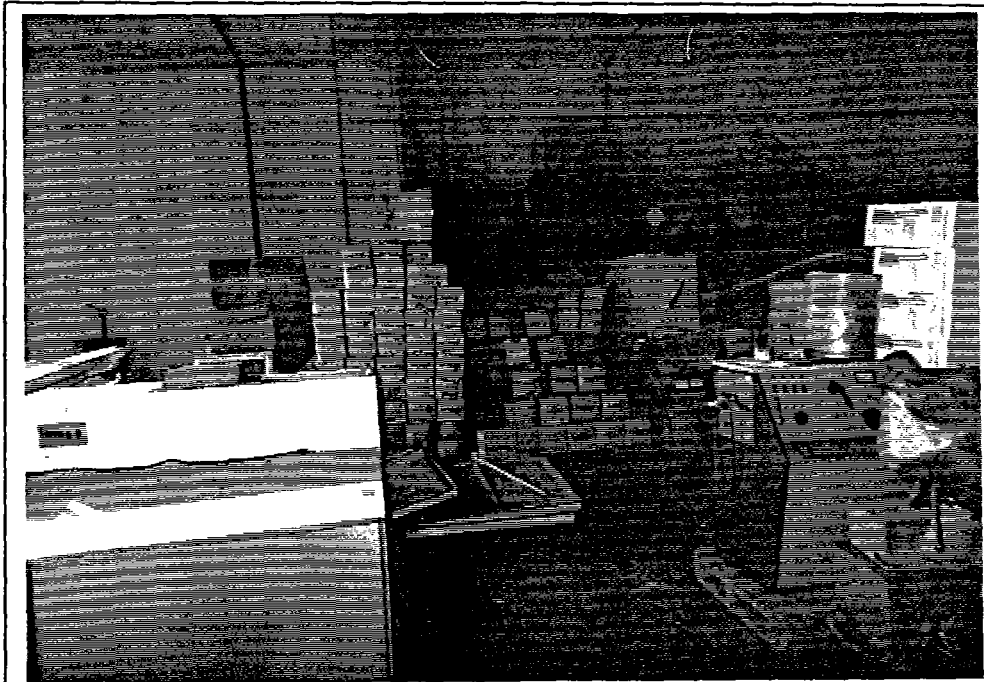
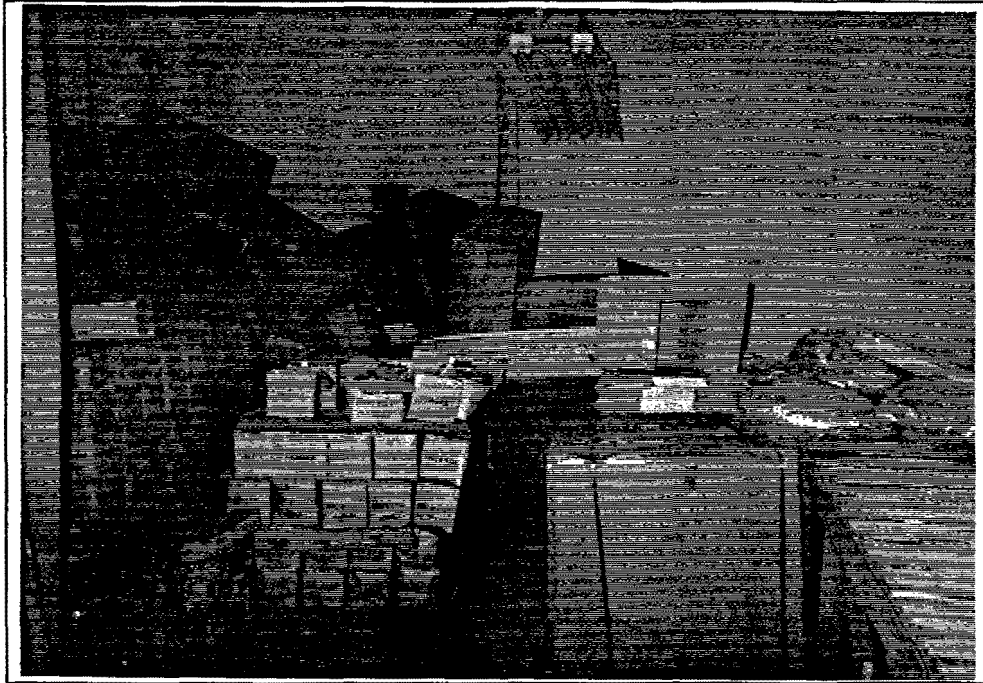
Photo 32 - Building 30 - Stockpiles of stored equipment in main area of warehouse where asbestos pipe TSI has fallen from piping and collected on top of stockpiles (Sample No. 1-022).

Photo 34 - Building 30 - Stockpiles of stored equipment in main area of warehouse where asbestos pipe TSI has fallen from piping and collected on top of stockpiles (Sample No. 1-022).

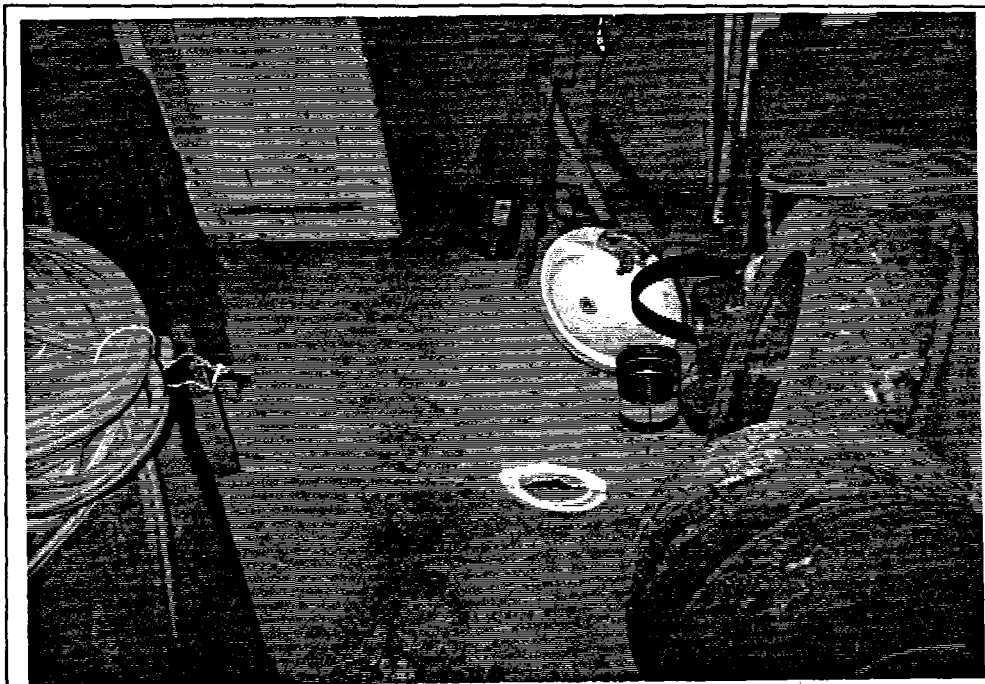
Photo 44 - Building 41 - 9 inch by 9 inch yellow VAT in area adjacent to bathroom area next to boiler room area (Sample No. 1-033).

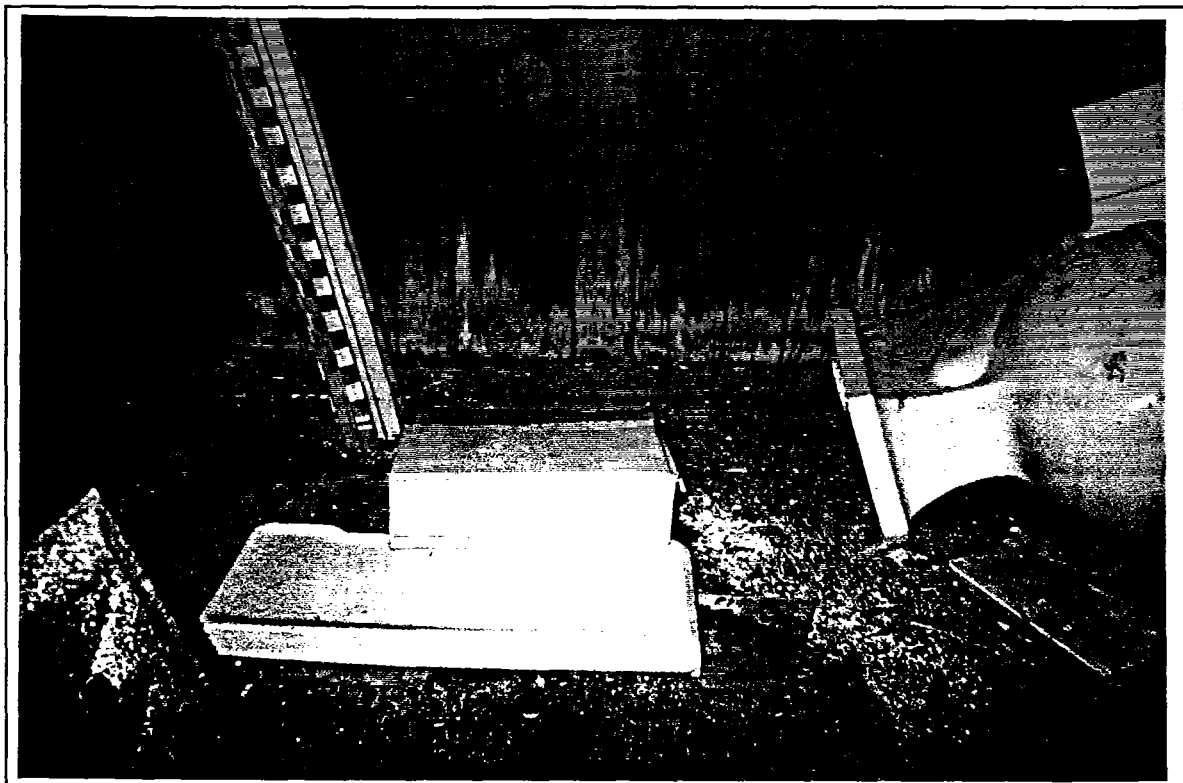
Photo 49 - Building 27 - Box of VAT matching pattern found in Building 30 (Sample No. 1-021).

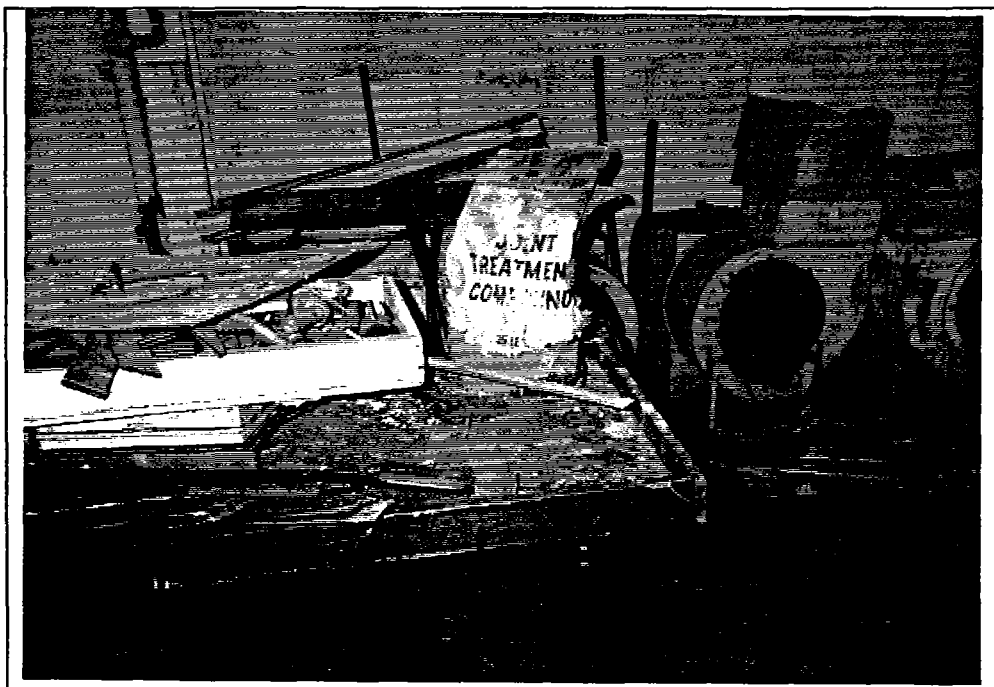
Photo 57 - Building 30A - Bag of non-asbestos joint compound sampled in Sample No. 1-041.

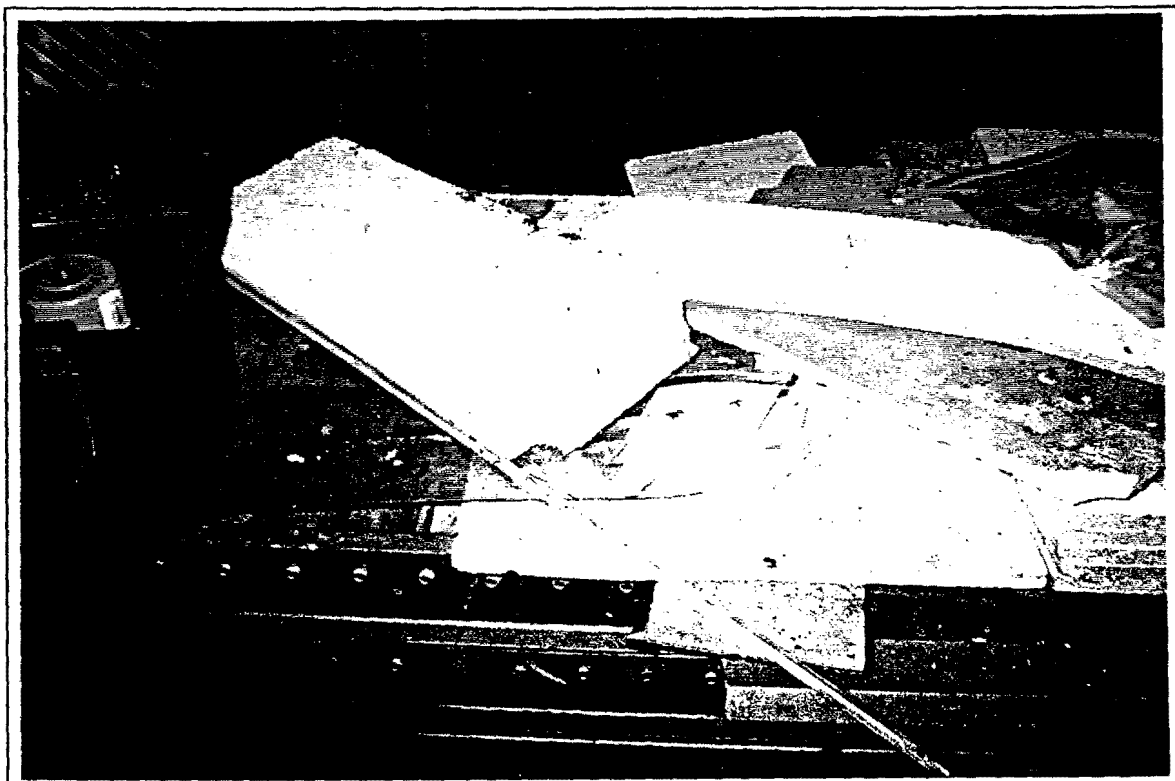
Photo 61 - Building 30A - Pre-cut non-asbestos ceiling tile panels found in box within building interior (Sample No. 1-040).

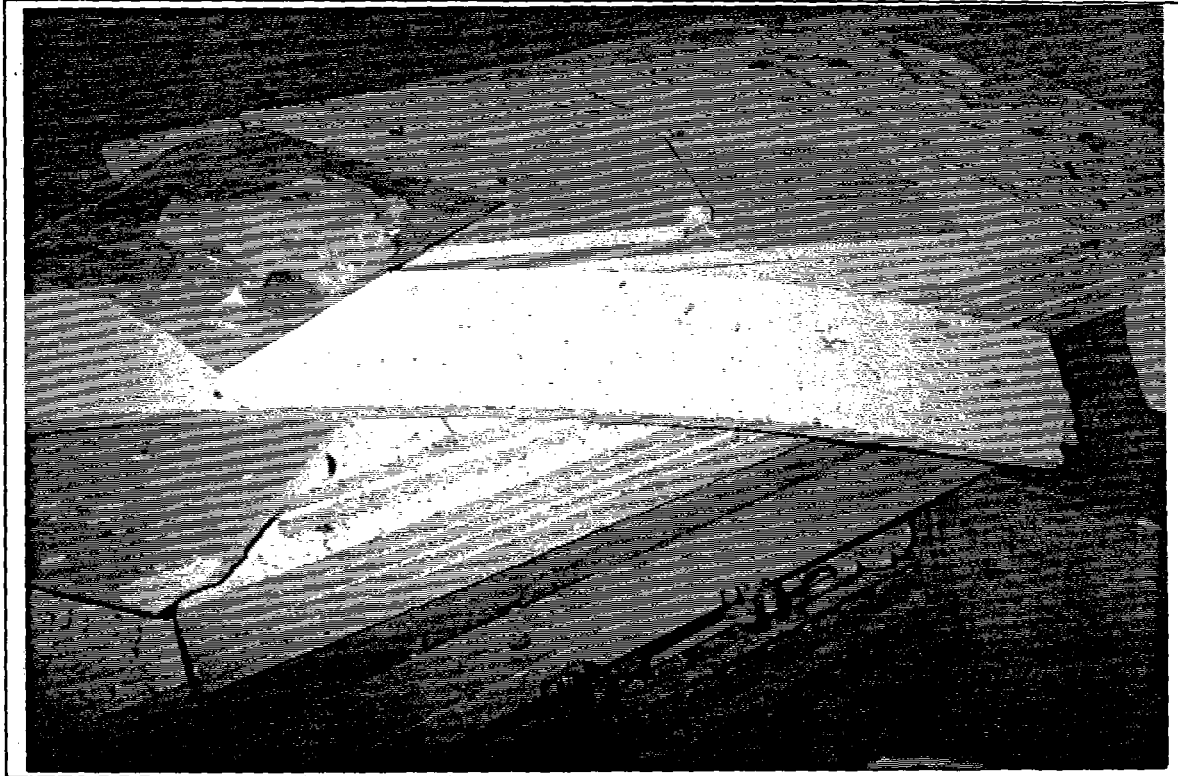
Photo 62 - Building 30A - Non-asbestos ceiling tile removed from building interior (Sample No. 1-039).

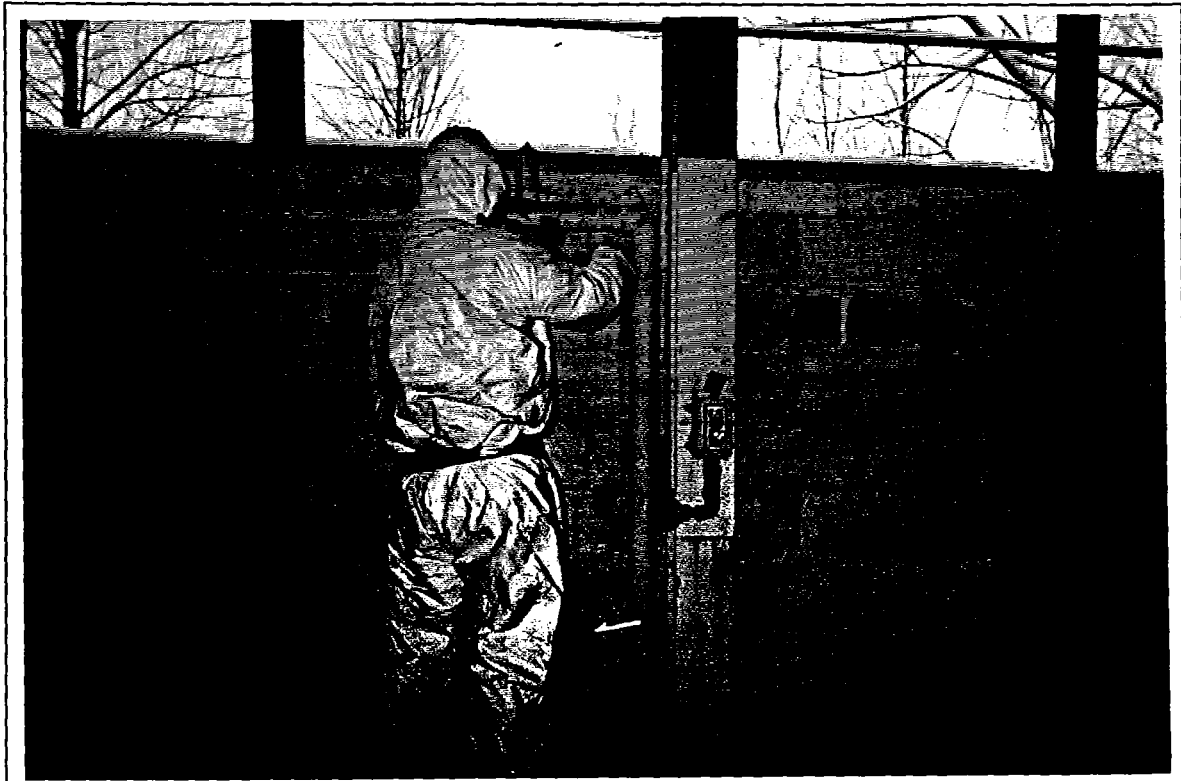
Photo 63 - Building 30A - Pipe elbow where Sample No. 1-045 was taken.

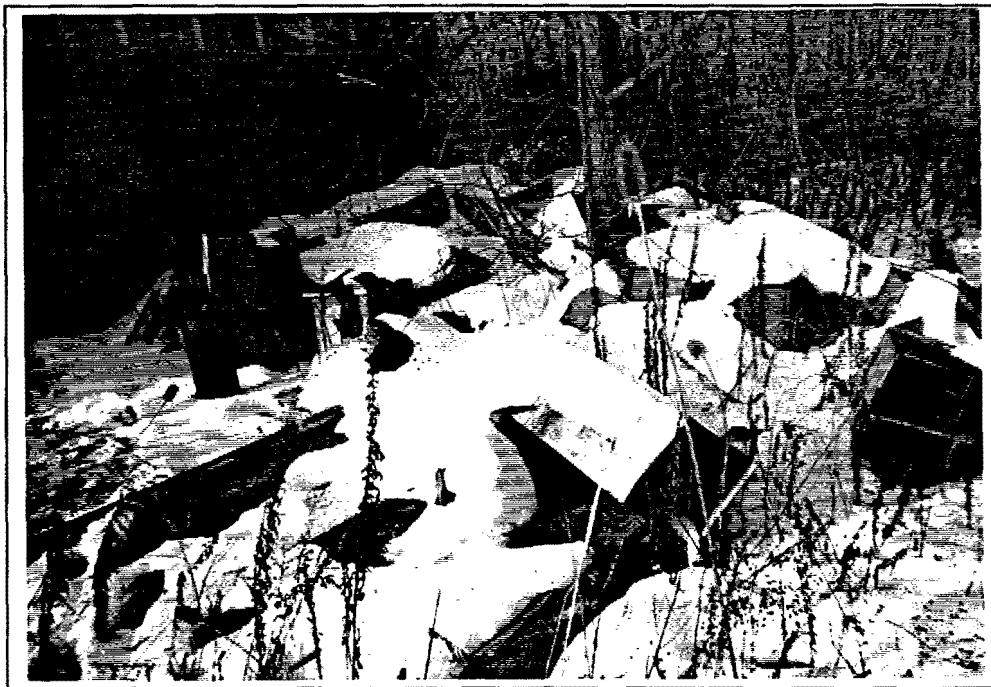
Photo 65 - Building 30A - Building exterior, north side of building where large amount of accumulated debris has been placed. Unclear if any consists of ACM.

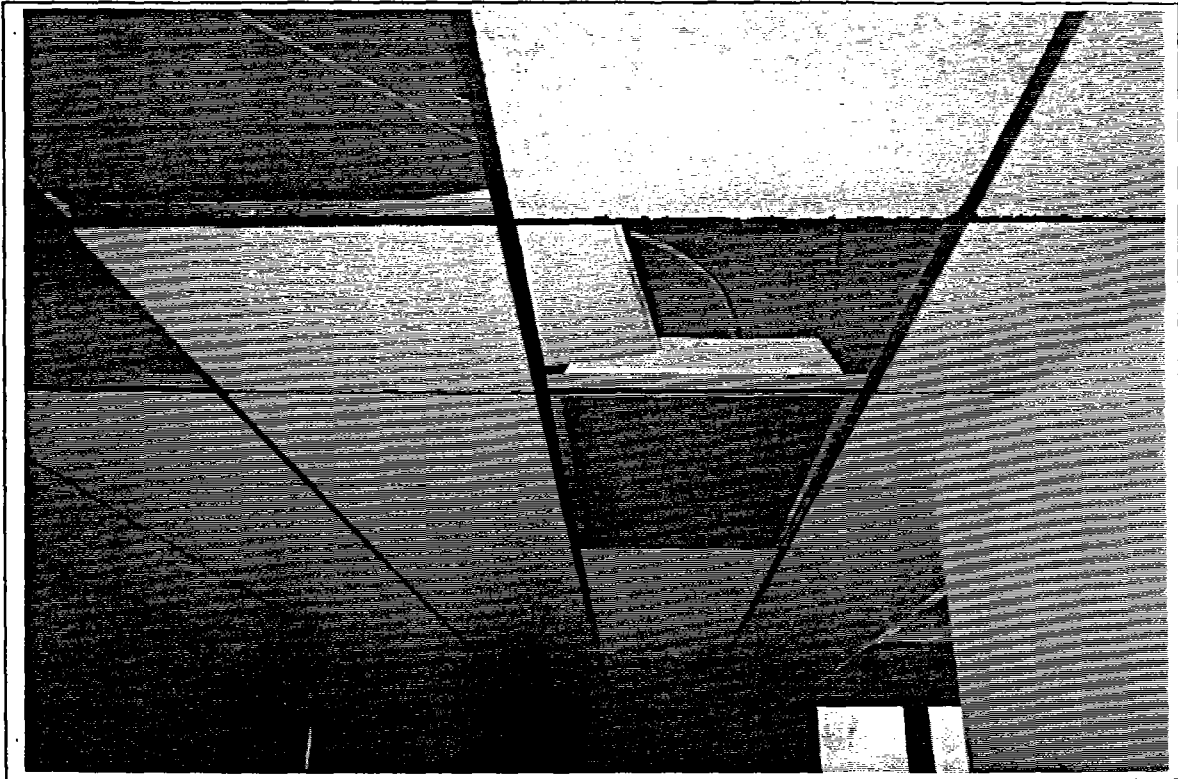
Photo 69 - Building 31 - 2 ft x 2 ft non-asbestos ceiling tile from south side office (Sample No. 1-057).

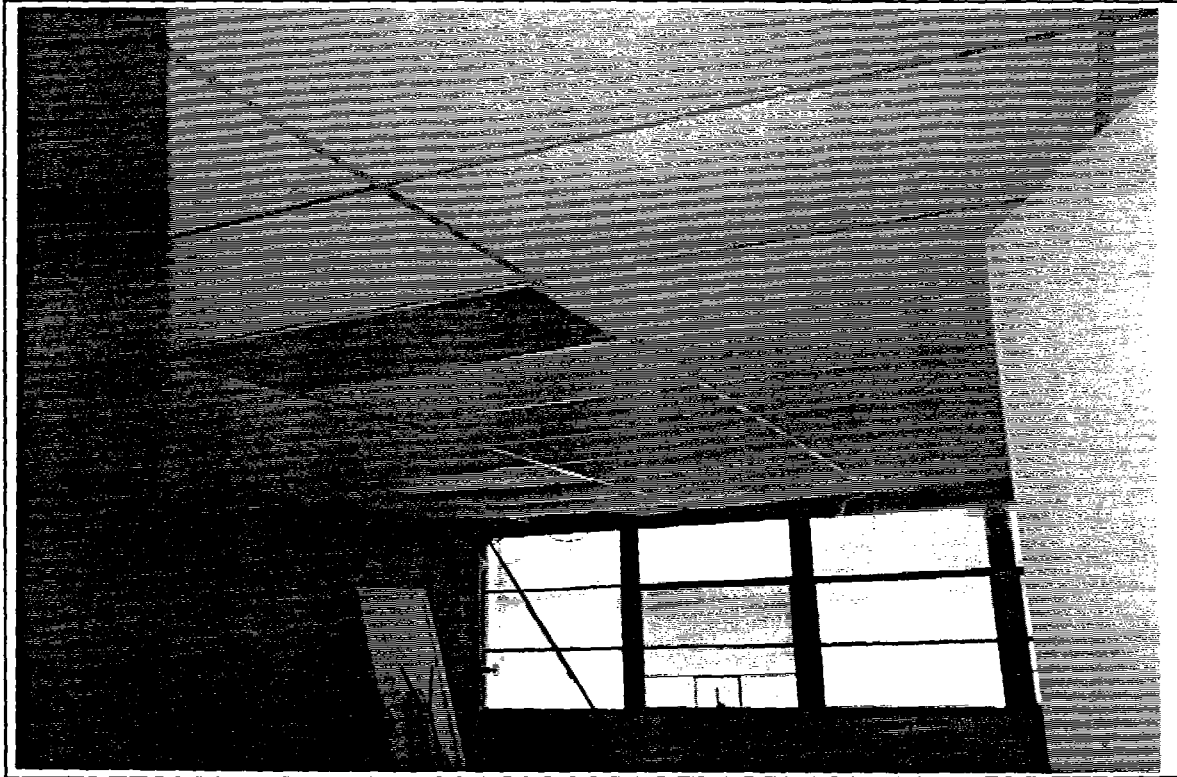
Photo 71 - Building 31 - 2 ft x 4 ft non-asbestos white ceiling tile from south side office (Sample No. 1-059).

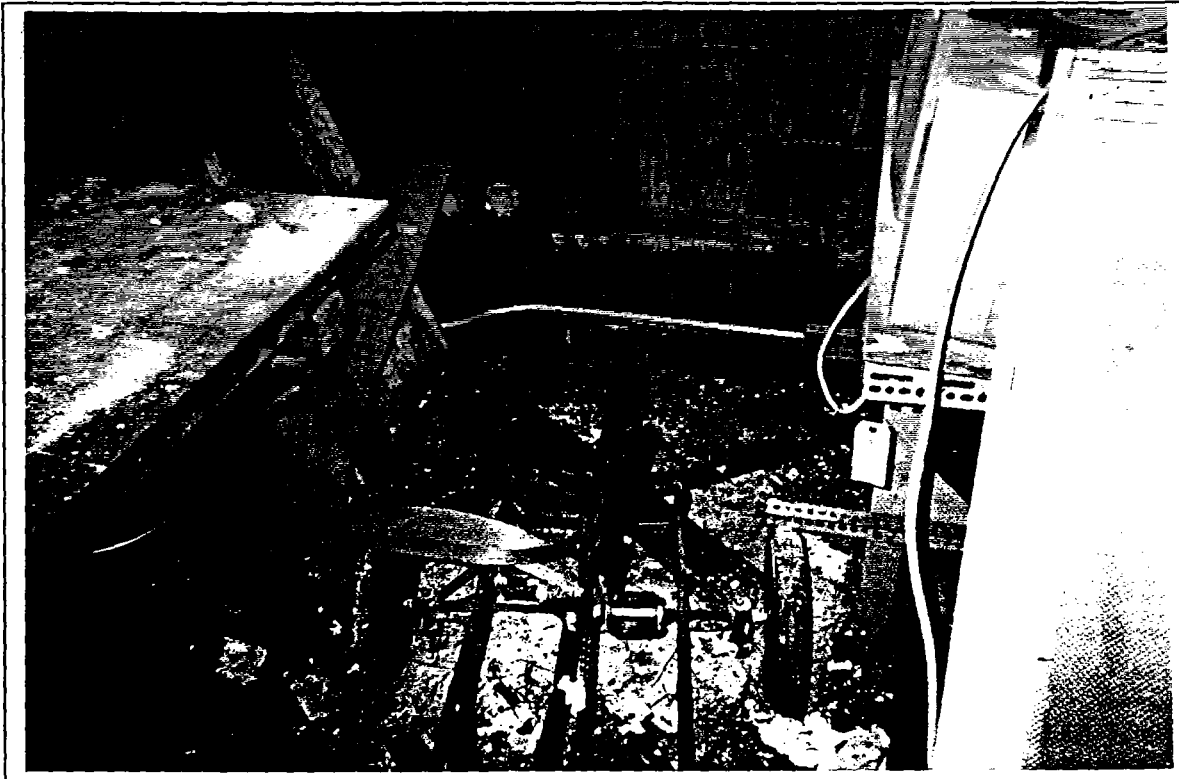
Photo 72 - Building 31 - 4-inch black non-asbestos cove base in northwest corner room (Sample No. 1-060).

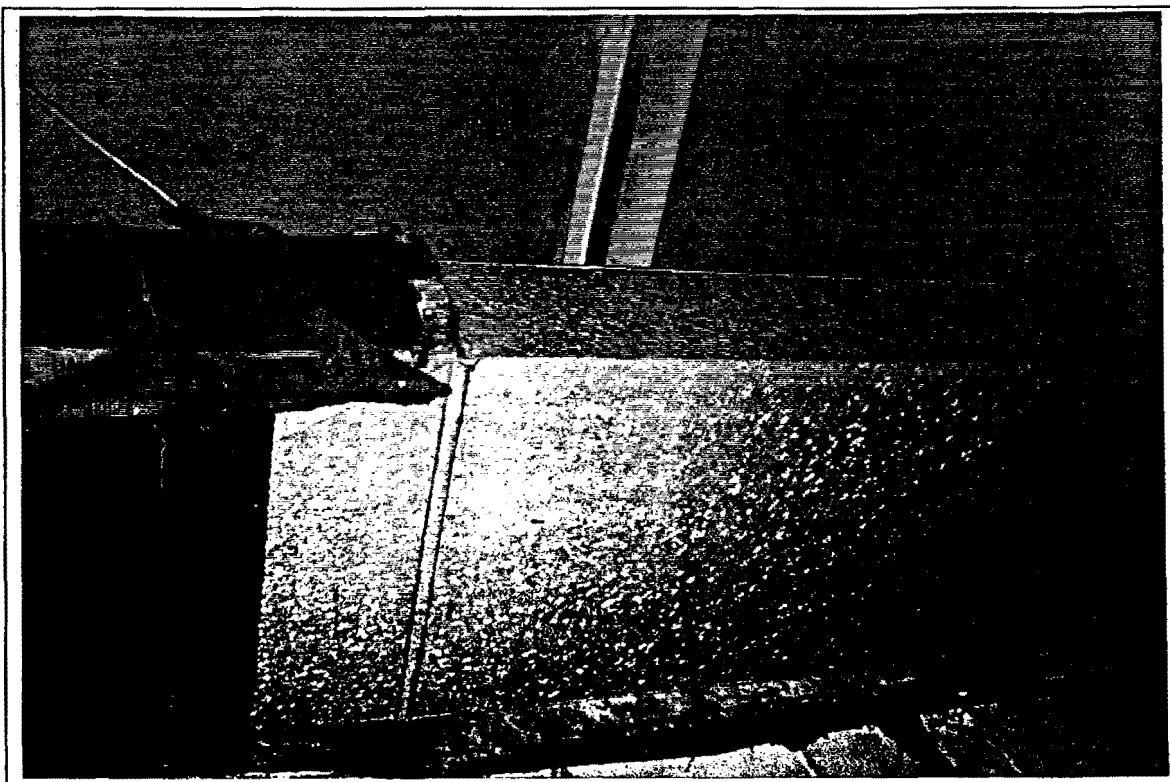
Photo 74 - Building 31 - Galvanized ductwork non-asbestos TSI paper taken from main corridor (Sample No. 1-062).

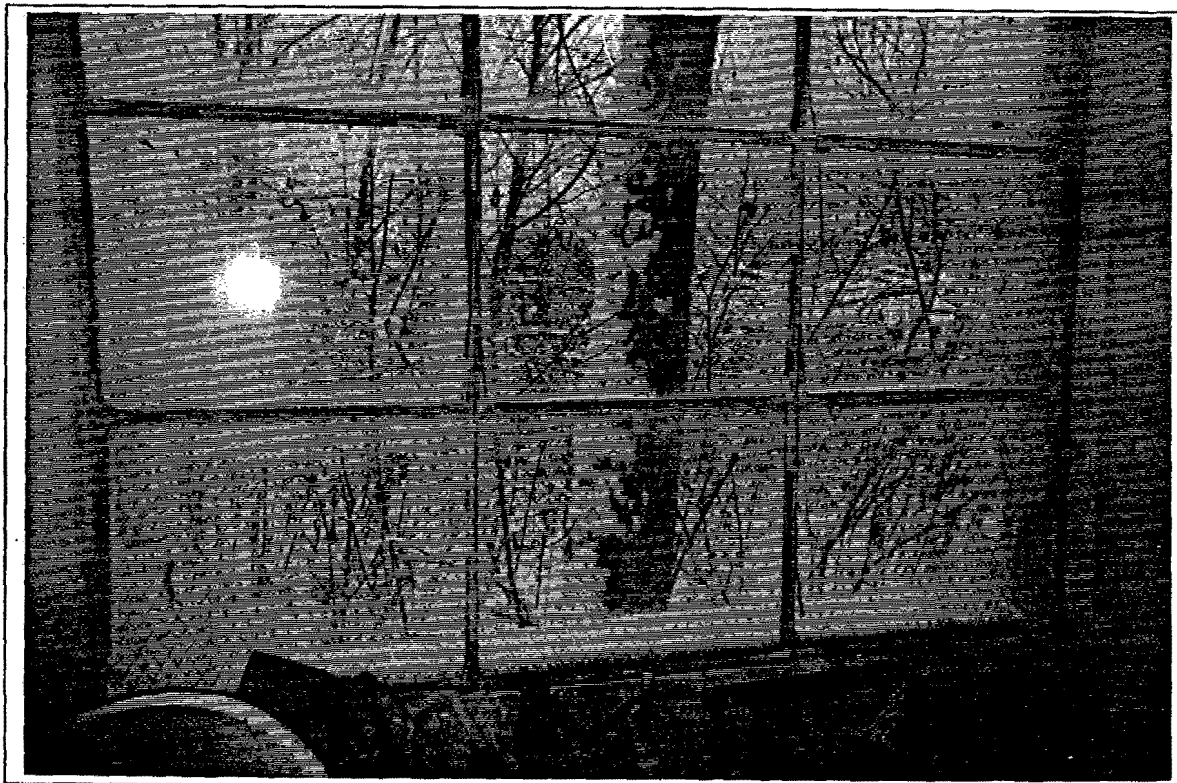
Photo 76 - Building 3 - West side window where Sample No. 1-053 was taken. Sample analyzed negative for asbestos.

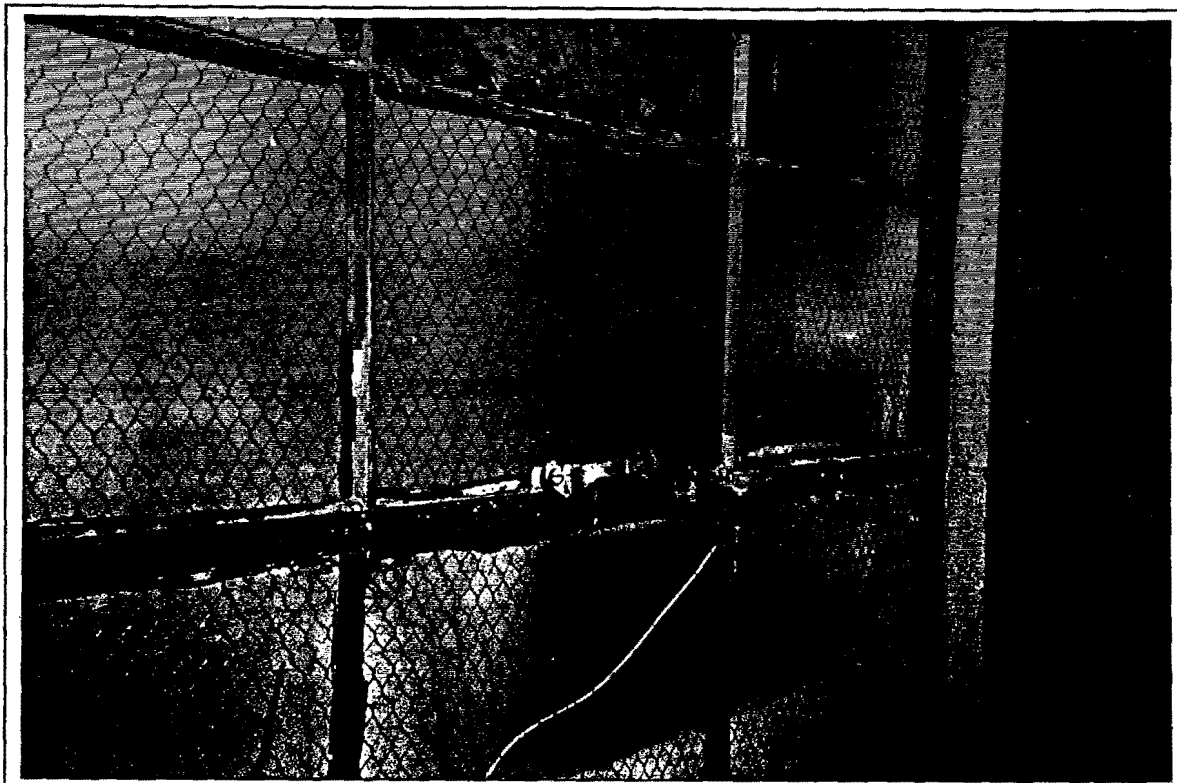
Photo 77 - Building 5 - North side window where Sample No. 1-054 was taken. Sample analyzed negative for asbestos.

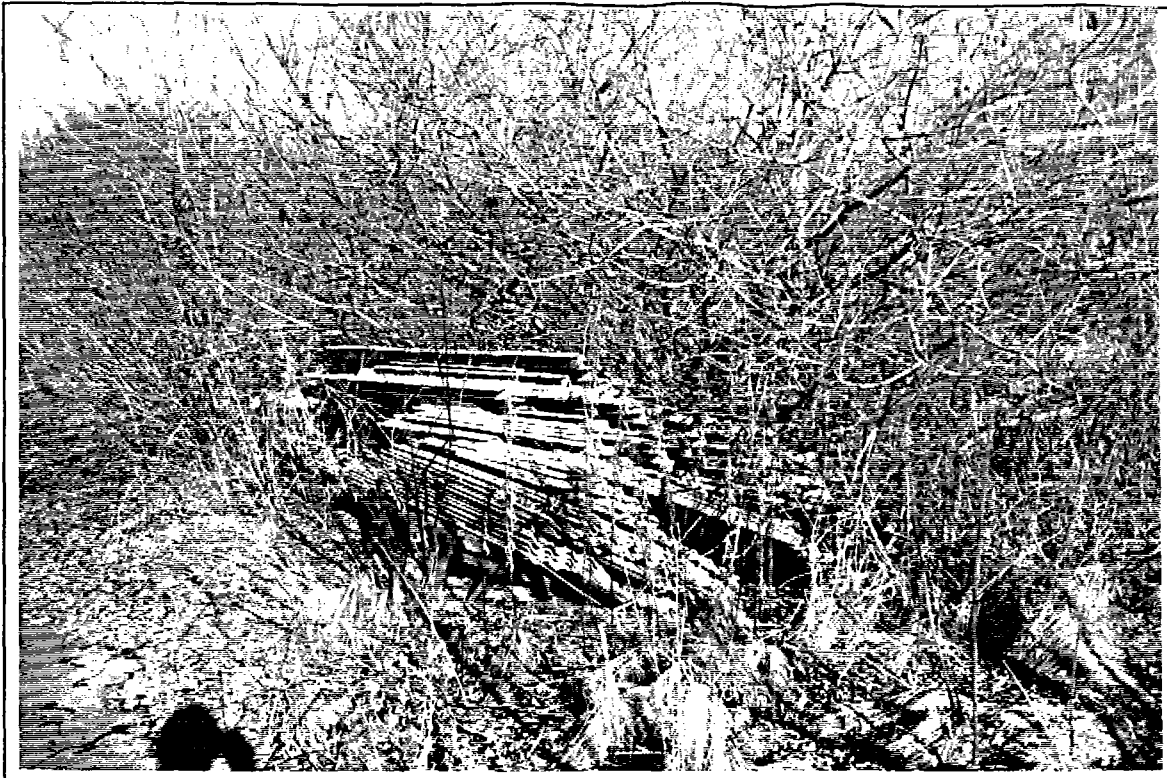
Extensive PACM debris was found outside surrounding Building 3-01, particularly on the north, west, and south sides. Along the west side, PACM debris was spread across the process area foundations almost to the main access road that bisects the property into east and west portions. To the south, the debris is spread across pipe footers and is present within and to the south of the former tank farm. PACM debris consists primarily of steam pipe insulation, water pipe insulation, pipe elbows, and transite panels, and is mixed amongst scrap metal and building debris. The building debris includes structural steel, concrete, and masonry that ranges in size from small rubble to large chunks of concrete and steel weighing several tons. The heterogeneous mixture of the debris made a detailed estimation of PACM difficult for this area.

Photo 82 - Vicinity of Building 3-01. North side of Building 3-01 looking west. Accumulation of large corrugated asbestos transite panels.

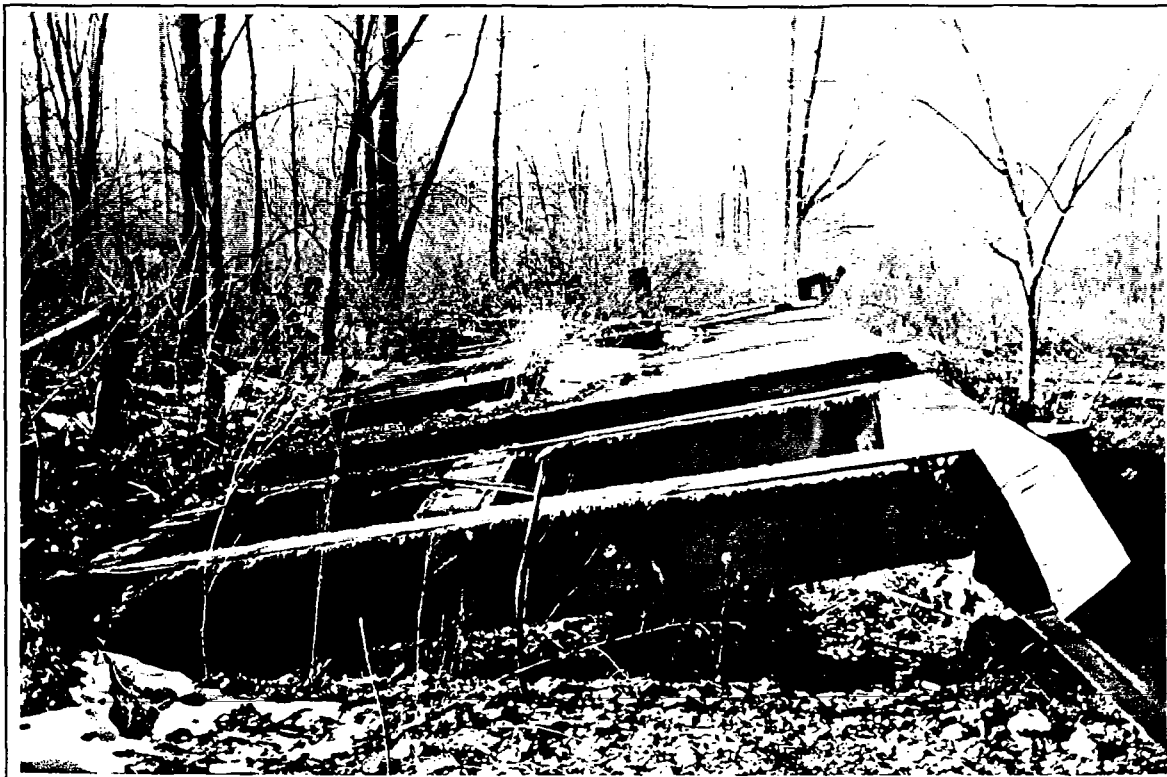
Photo 83 - Vicinity of Building 3-01. West side of Building 3-01 looking west. Large construction and demolition debris.
