US Army Corps of Engineers
Buffalo District

NFSS and Surrounding Properties (LOOW)

**Niagara Falls Storage Site
Gamma Walkover Survey**

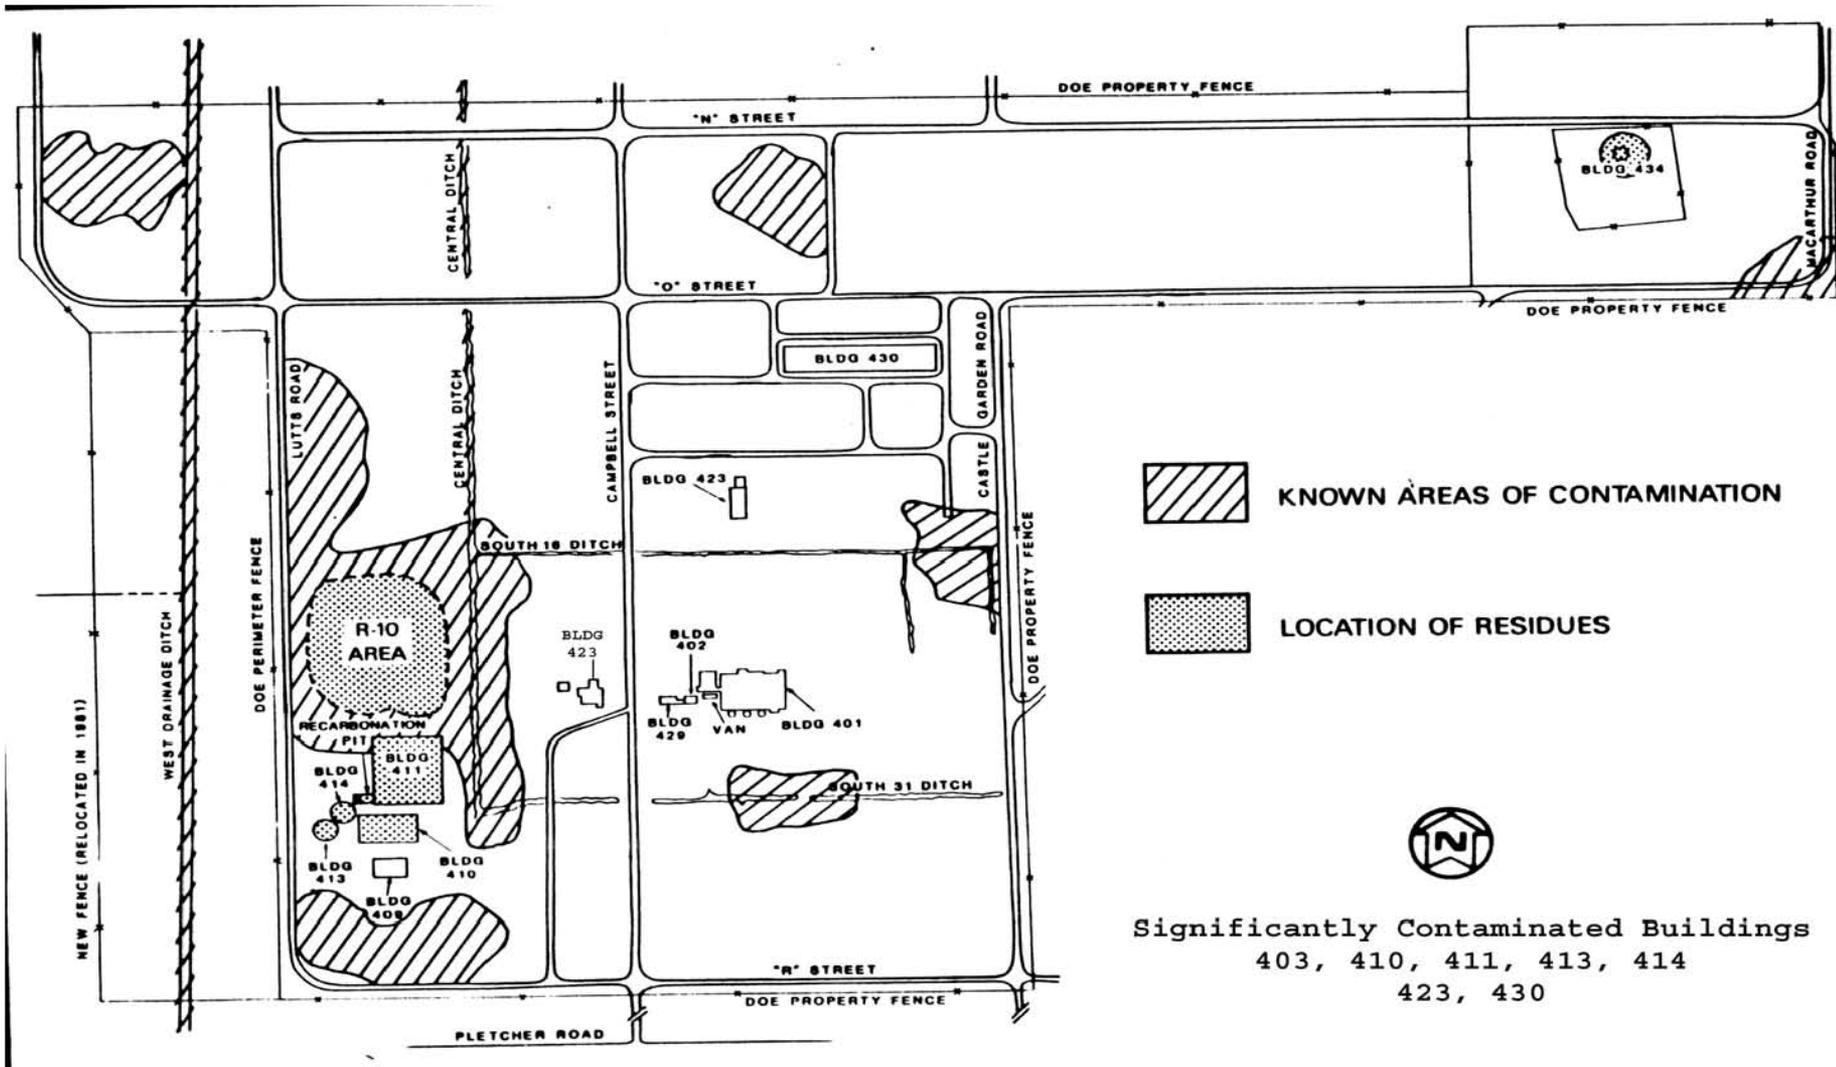
PROJECT NO. 15892 FIGURE #: 1-8

Significantly Contaminated Buildings
 403, 410, 411, 413, 414
 423, 430

RADIOLOGICALLY CONTAMINATED AREAS IN 1979

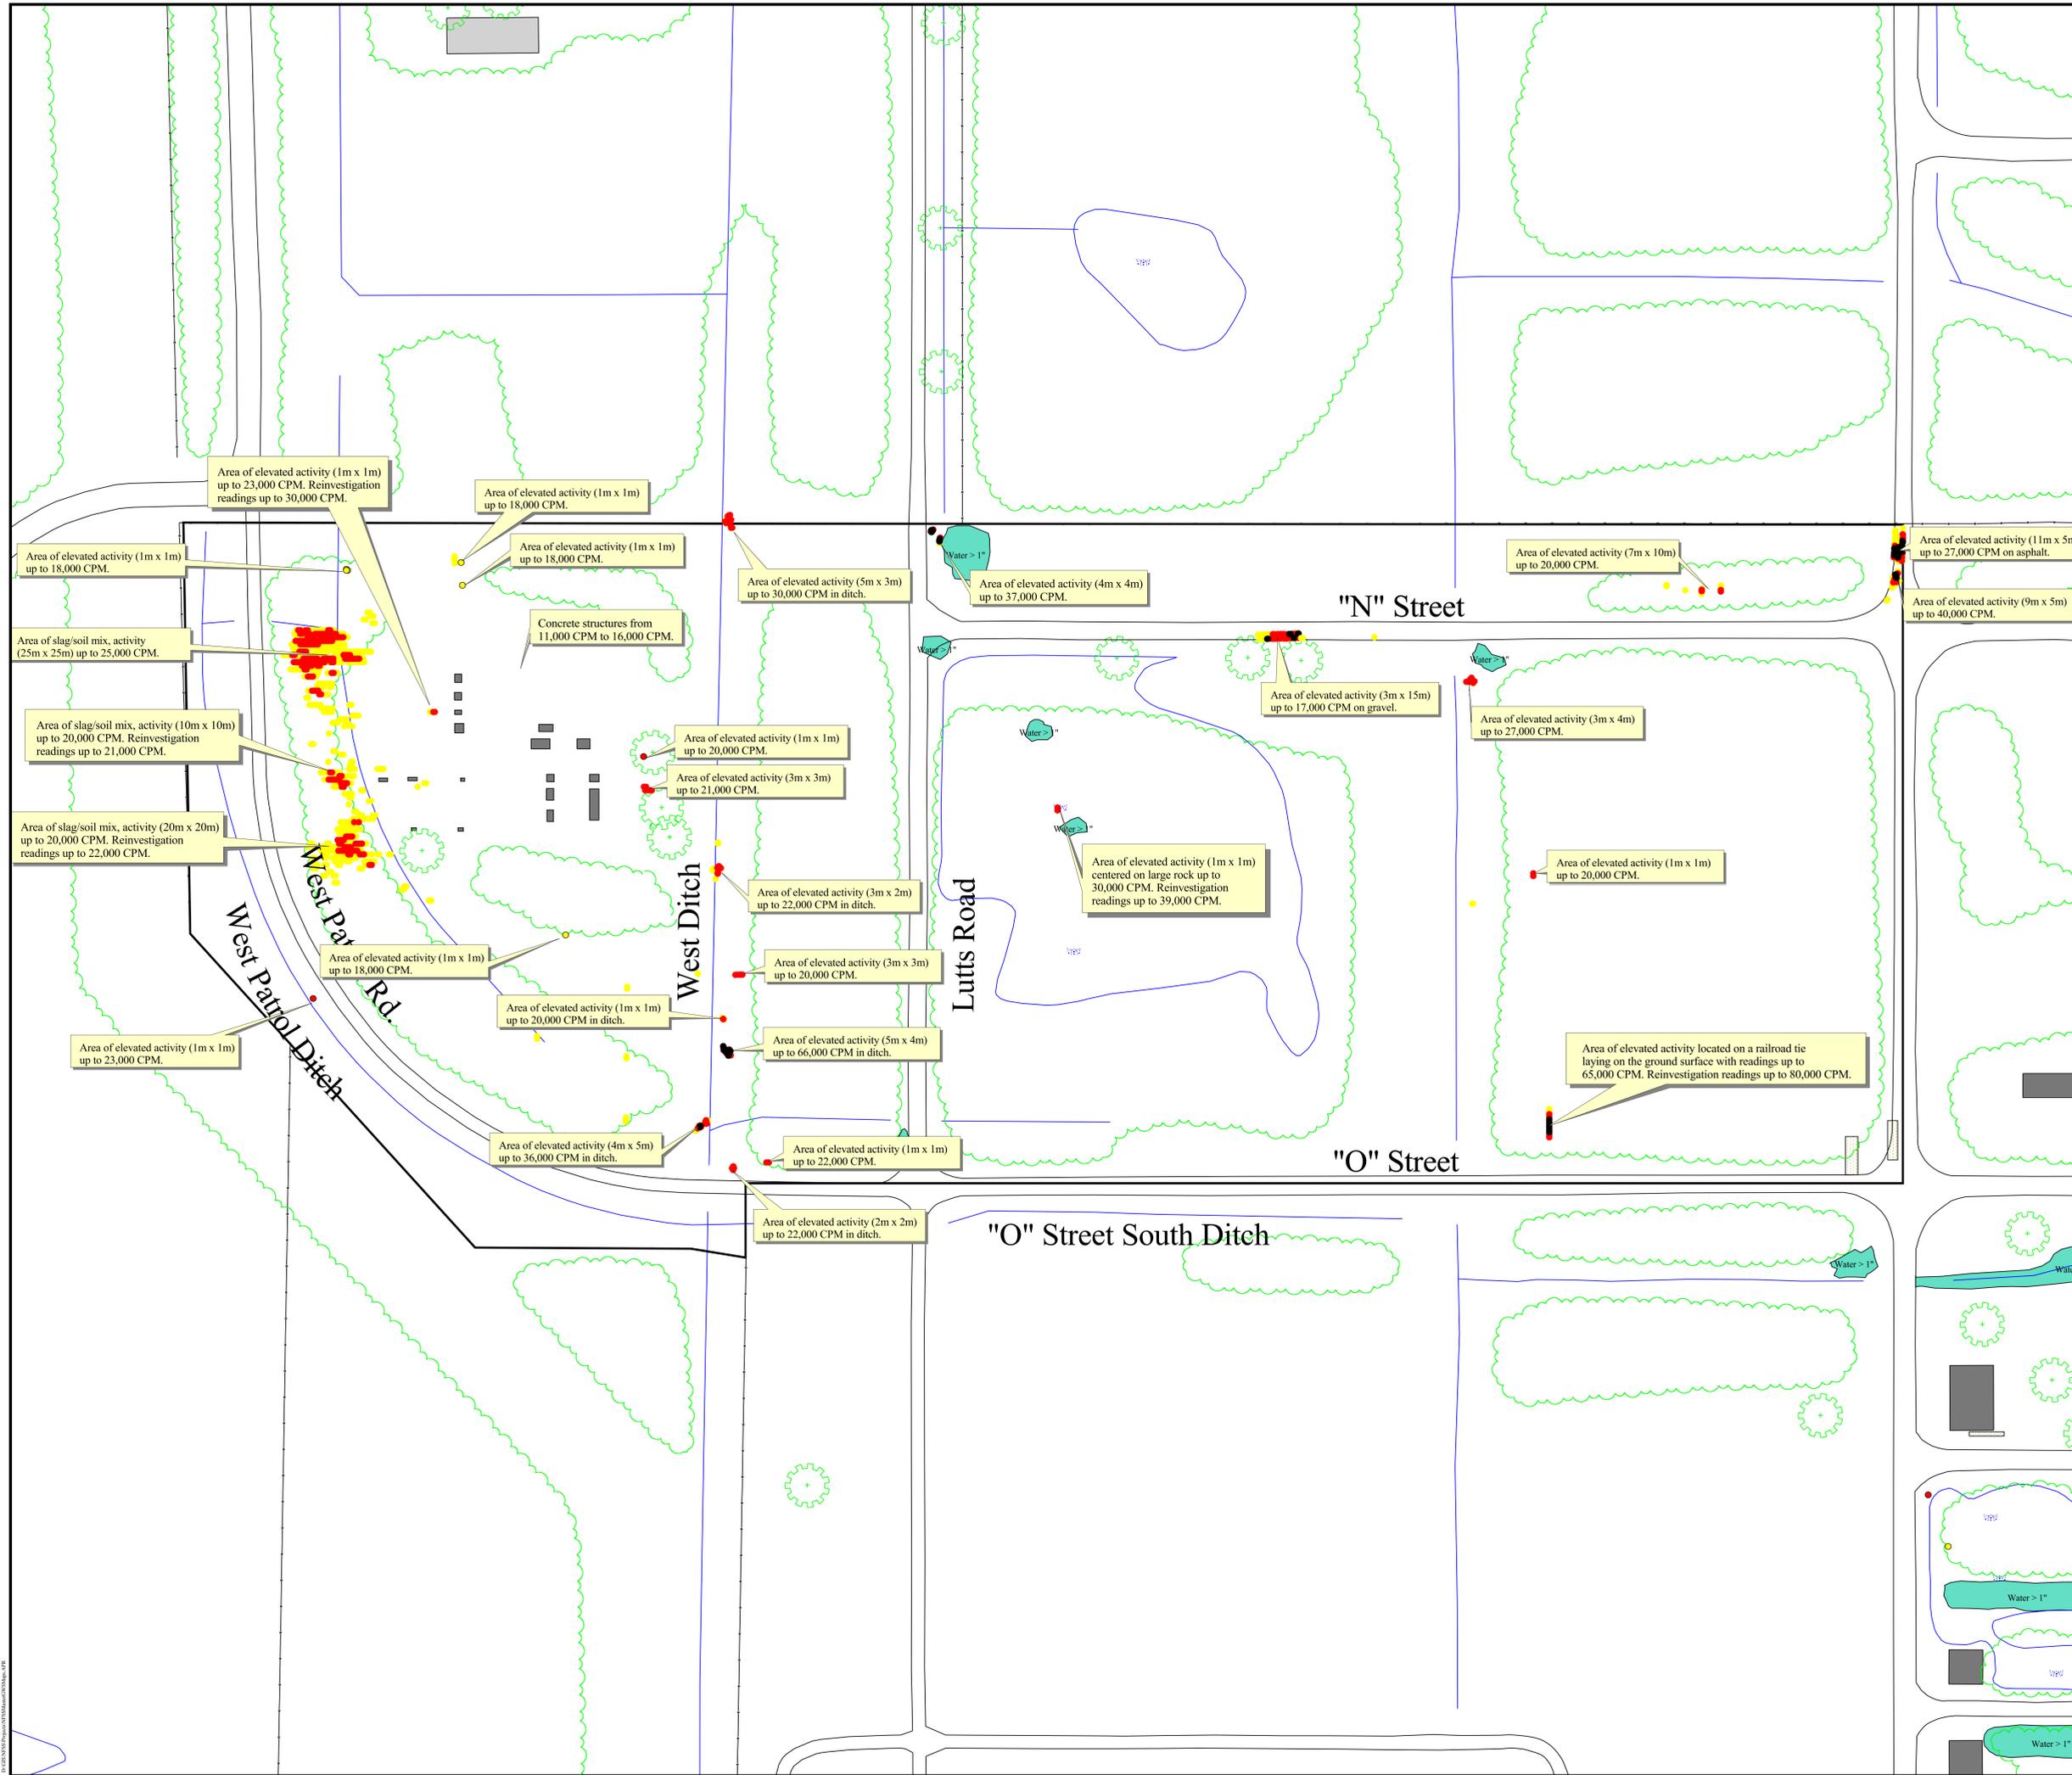
FIGURE 3-1

General Notes:
 1) Outlined circles depict elevated activity identified beyond walkover survey path.

Niagara Falls Storage Site
 Gamma Walkover Survey
 Elevated Areas in Sector 1
 Lewiston, New York
 Source: SAIC 2003

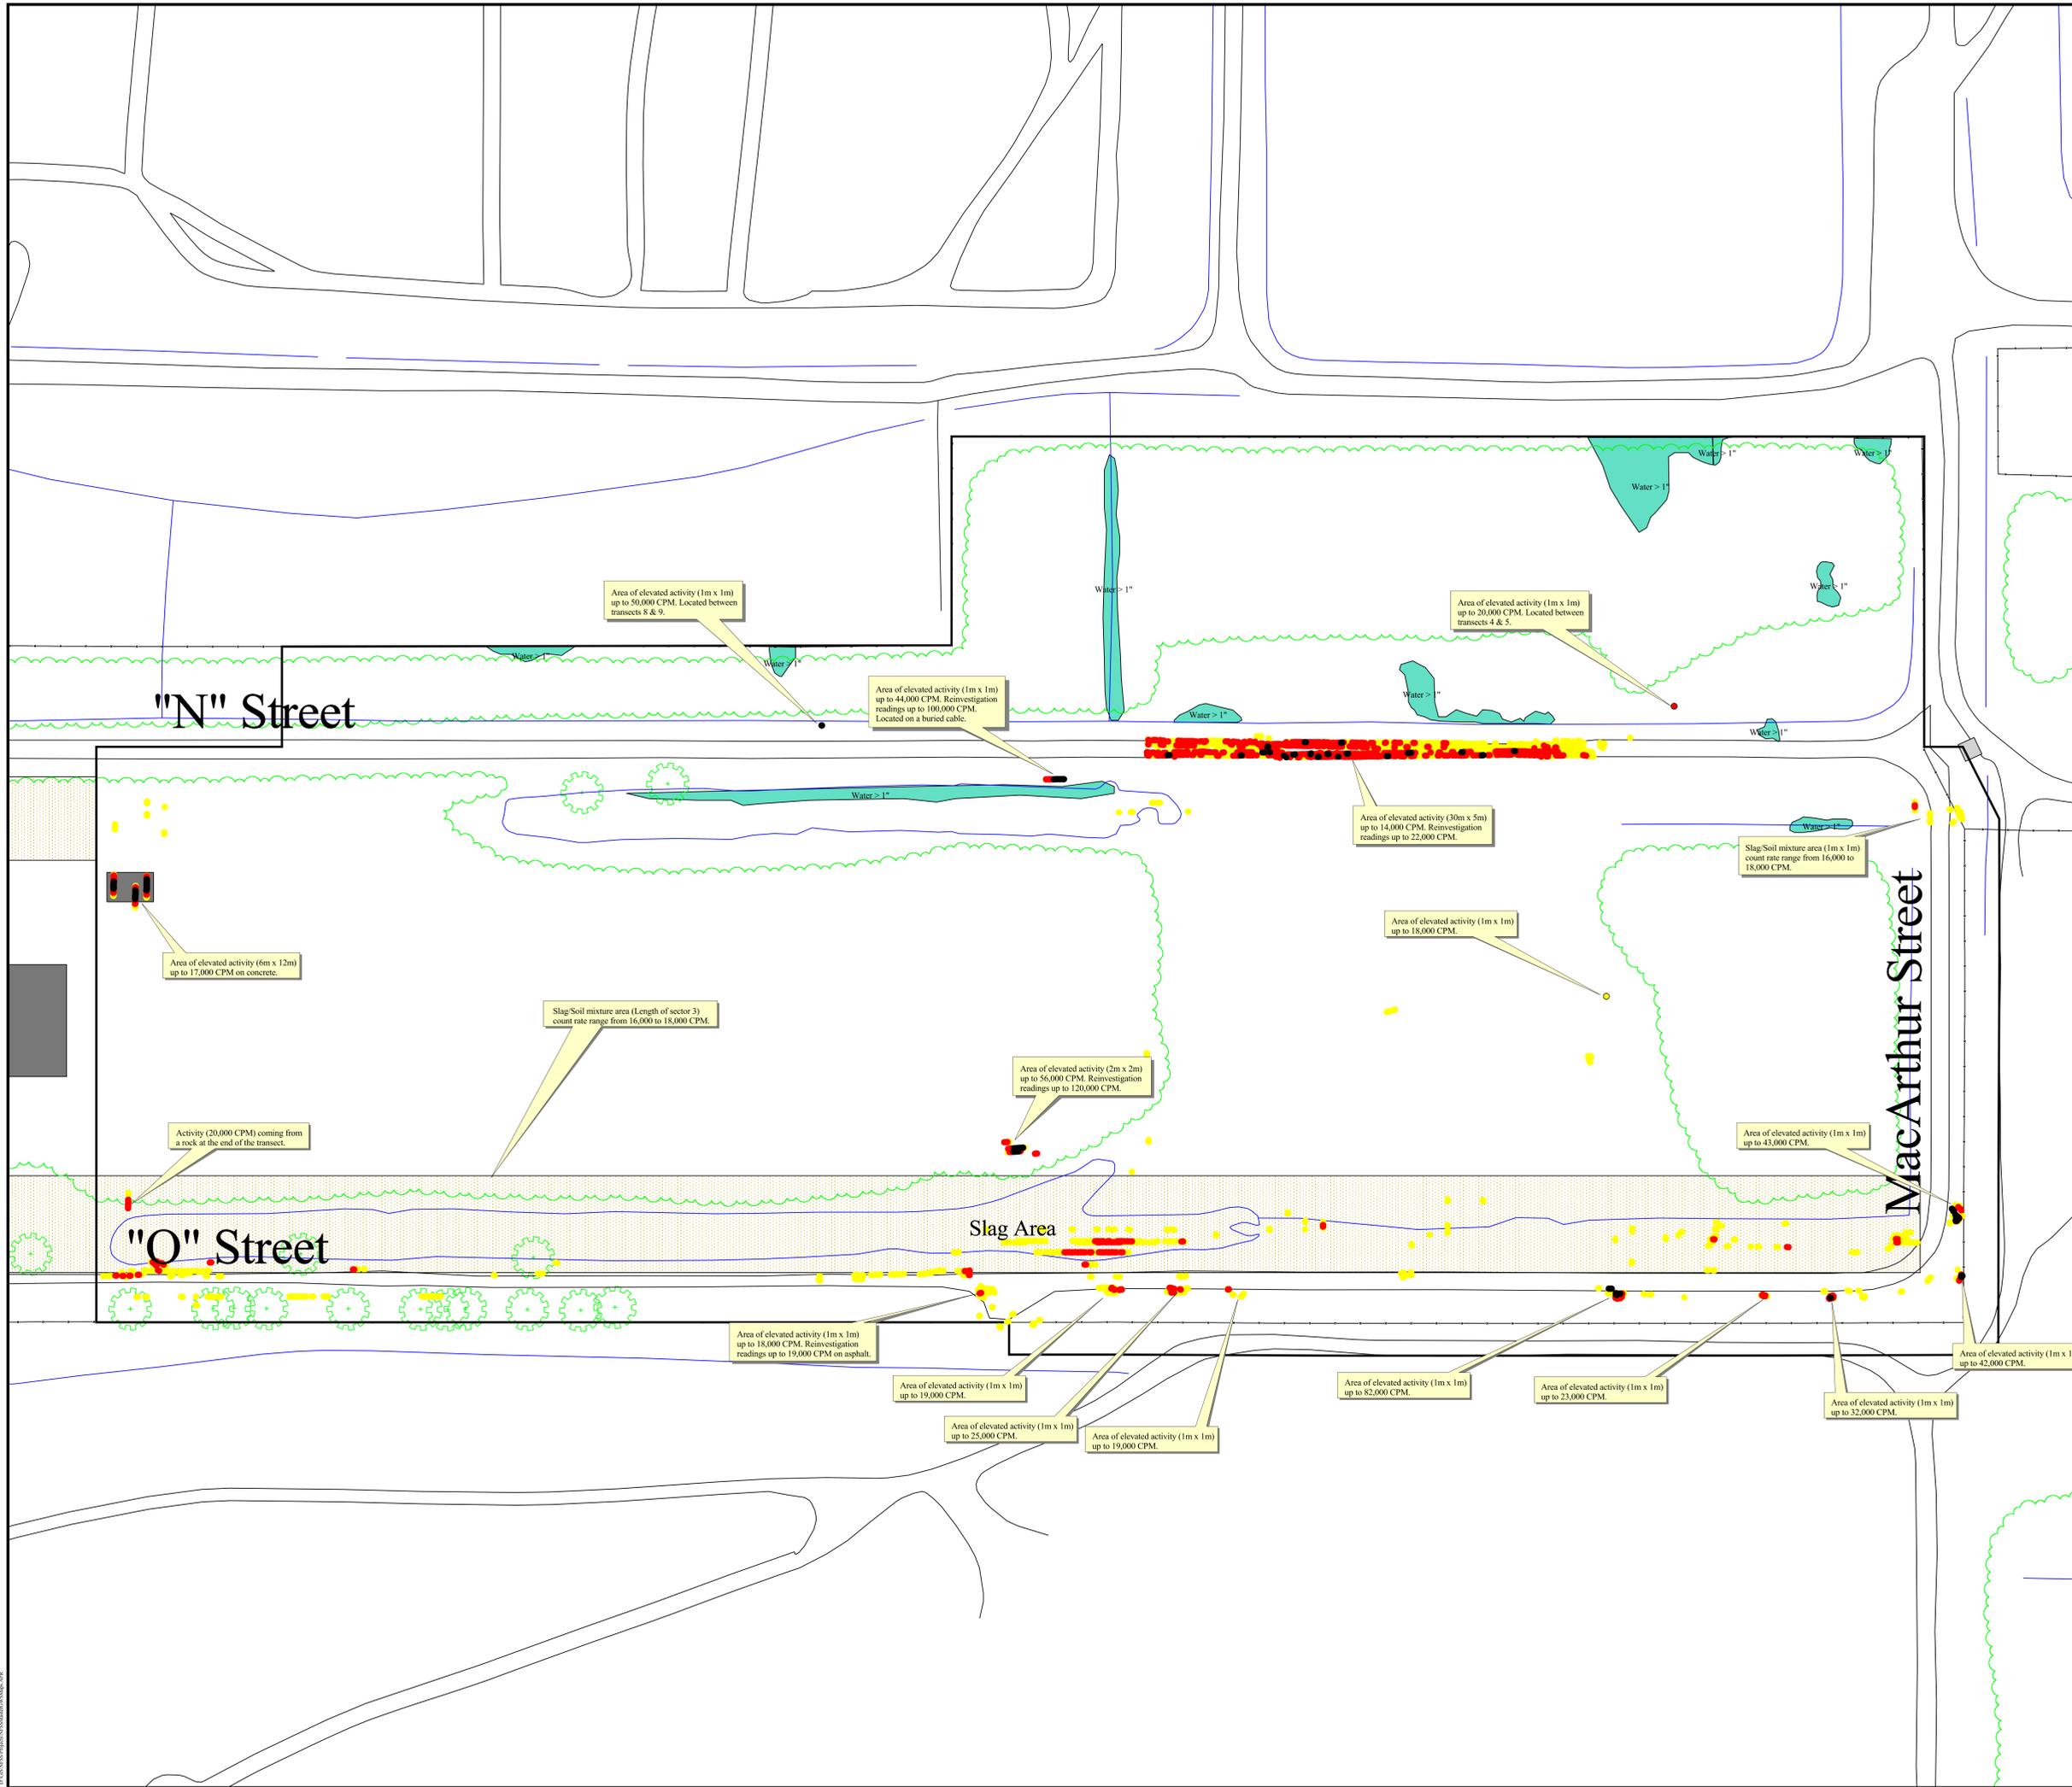
Figure 3-3

Niagara Falls Storage Site
Gamma Walkover Survey
Elevated Areas in Sector 3
Lewiston, New York
Source: SAIG 2003

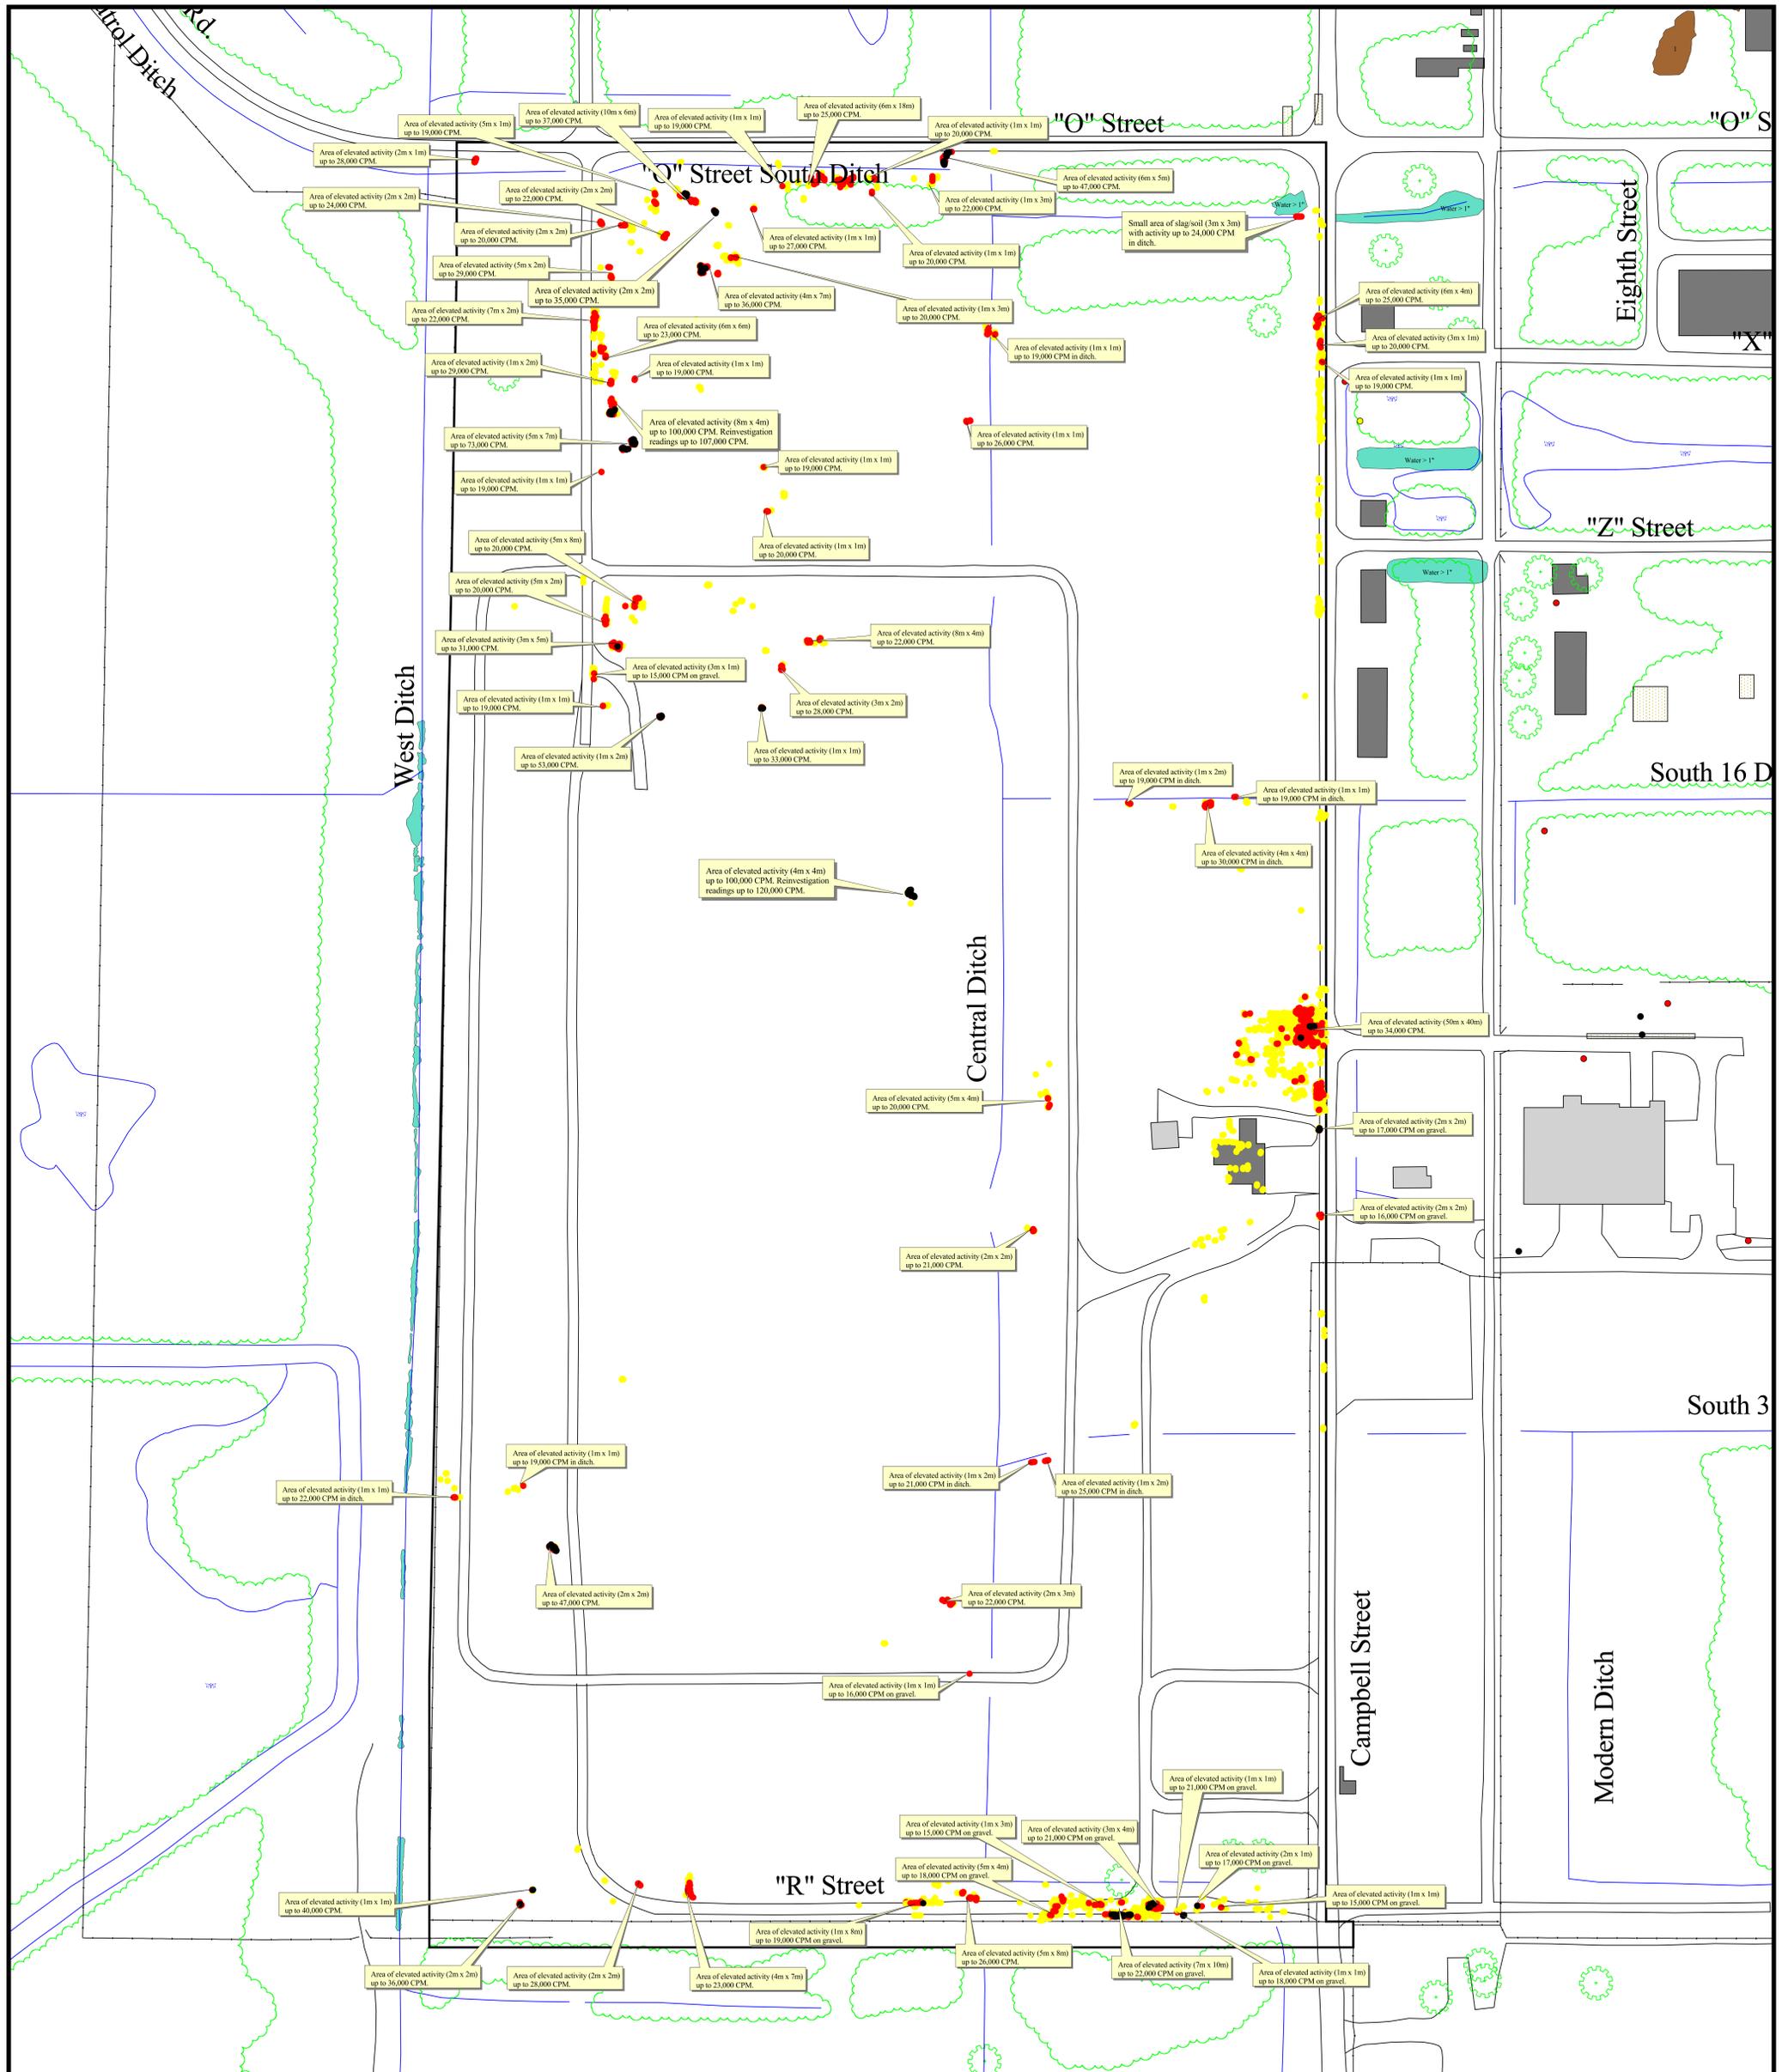
Figure 3-4
Source: SAIC 2003

Niagara Falls Storage Site
Gamma Walkover Survey
Elevated Areas in Sector 4
Lewiston, New York

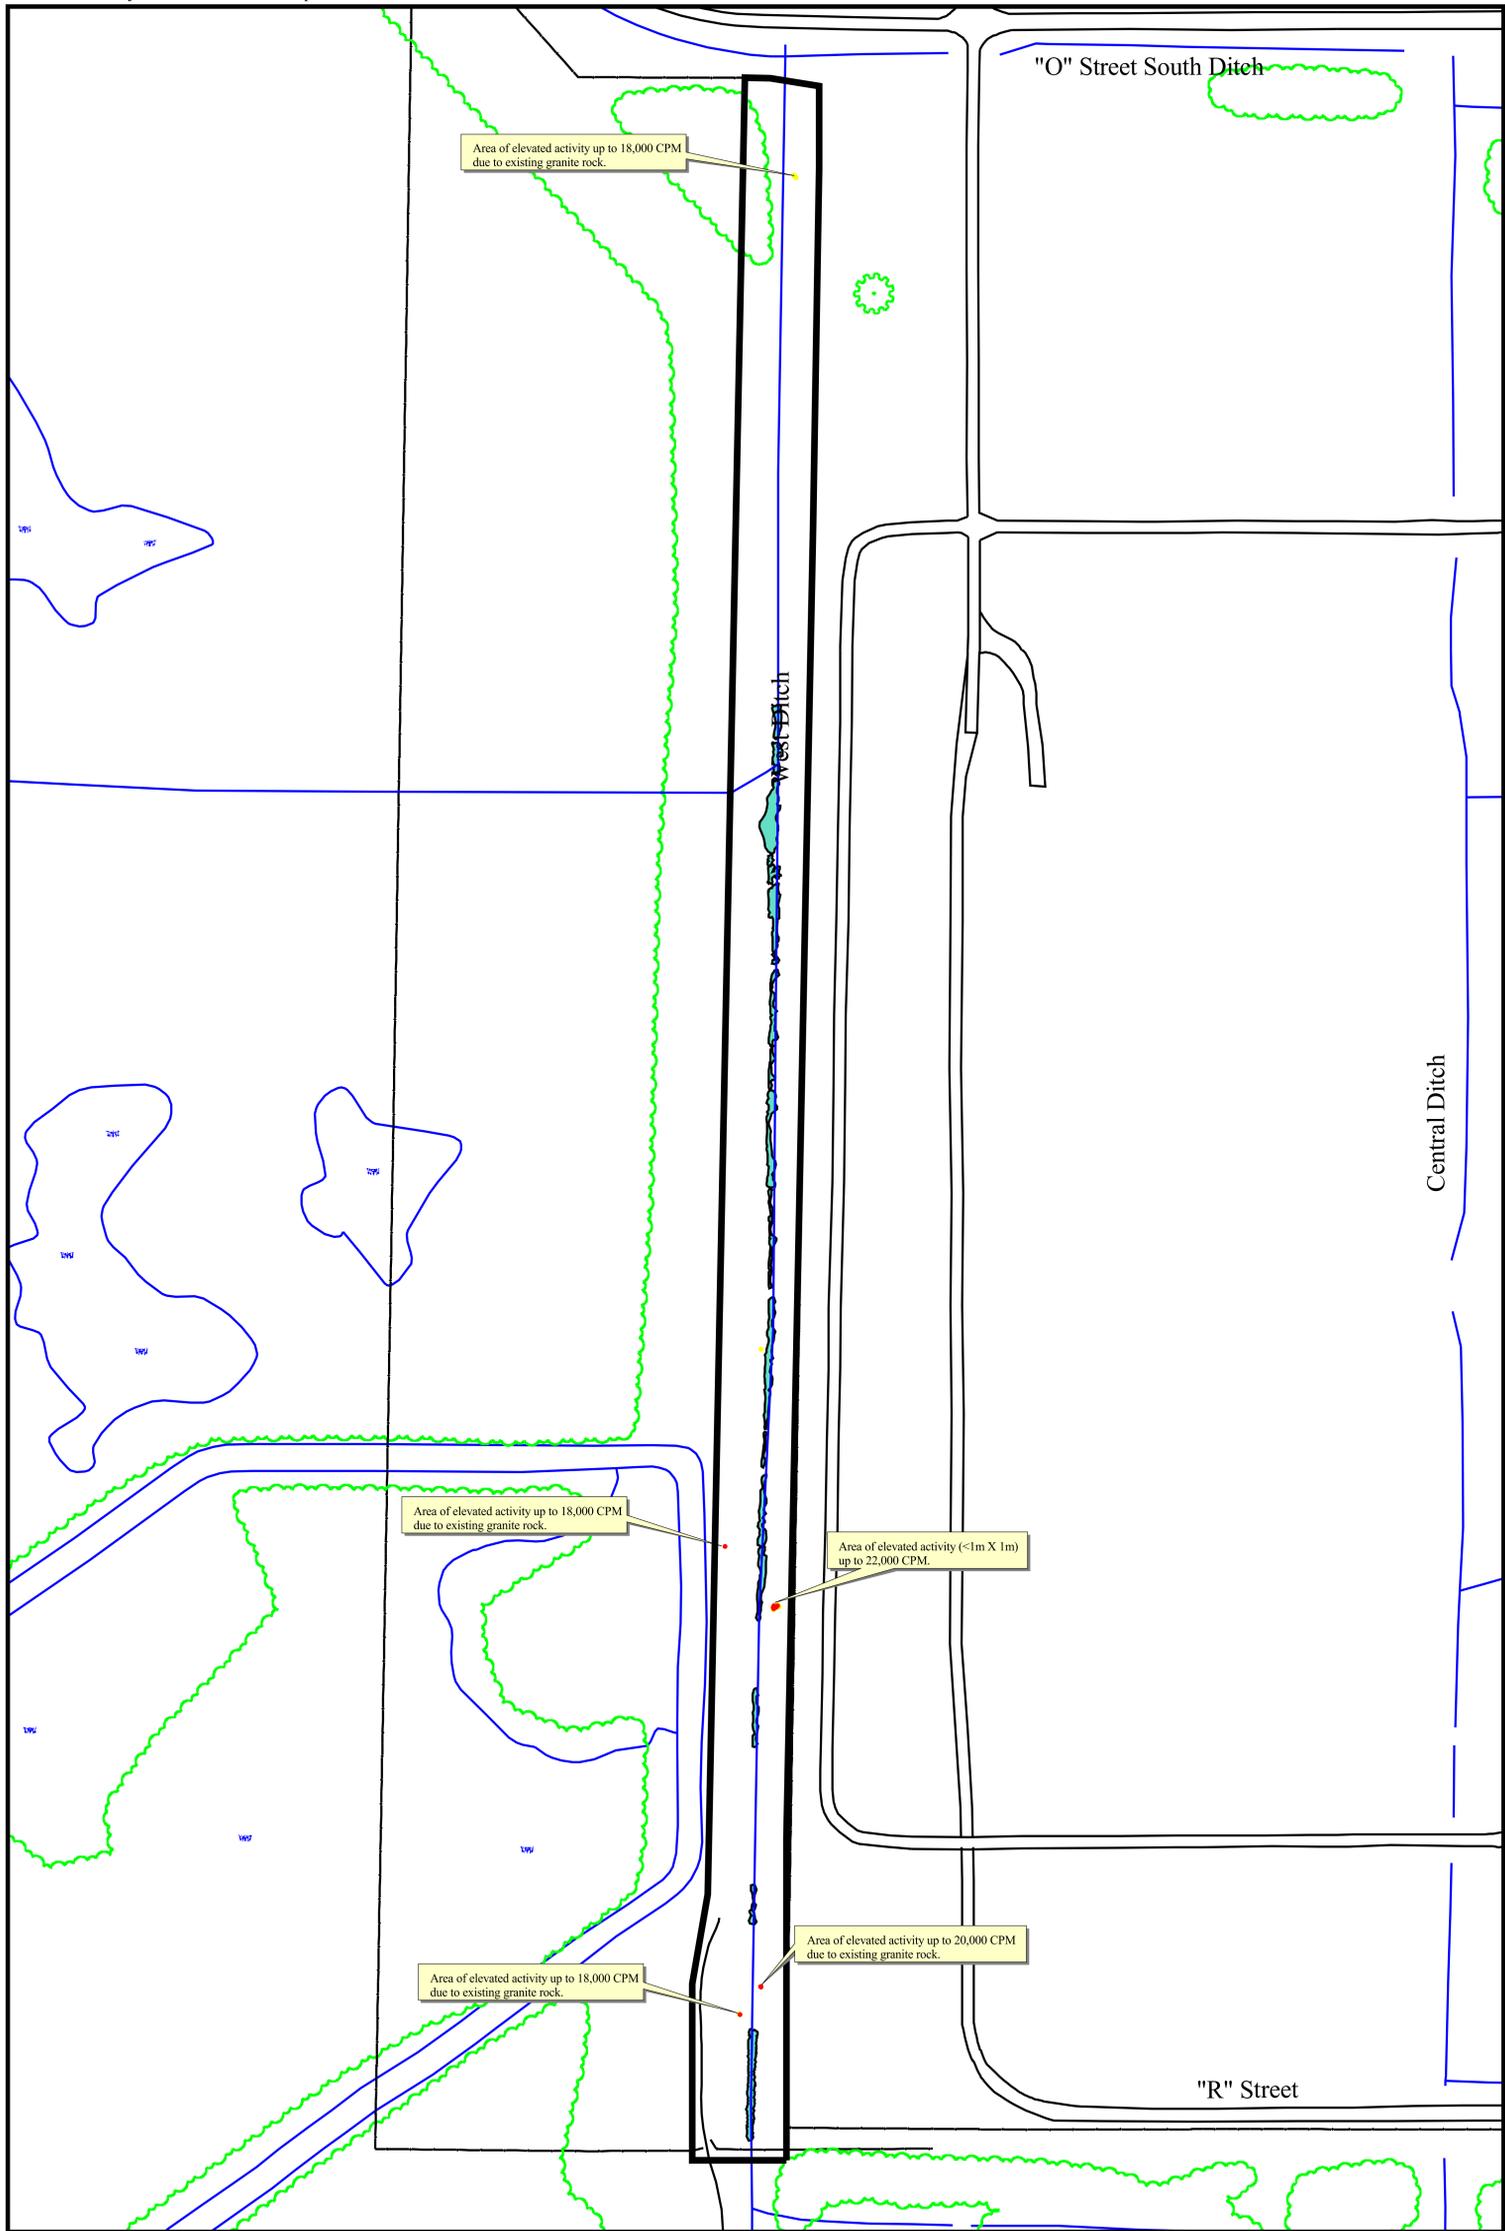
Figure 3-6
 Source: SAIC 2003

Niagara Falls Storage Site
 Gamma Walkover Survey
 Elevated Areas in Sector 6
 Lewiston, New York

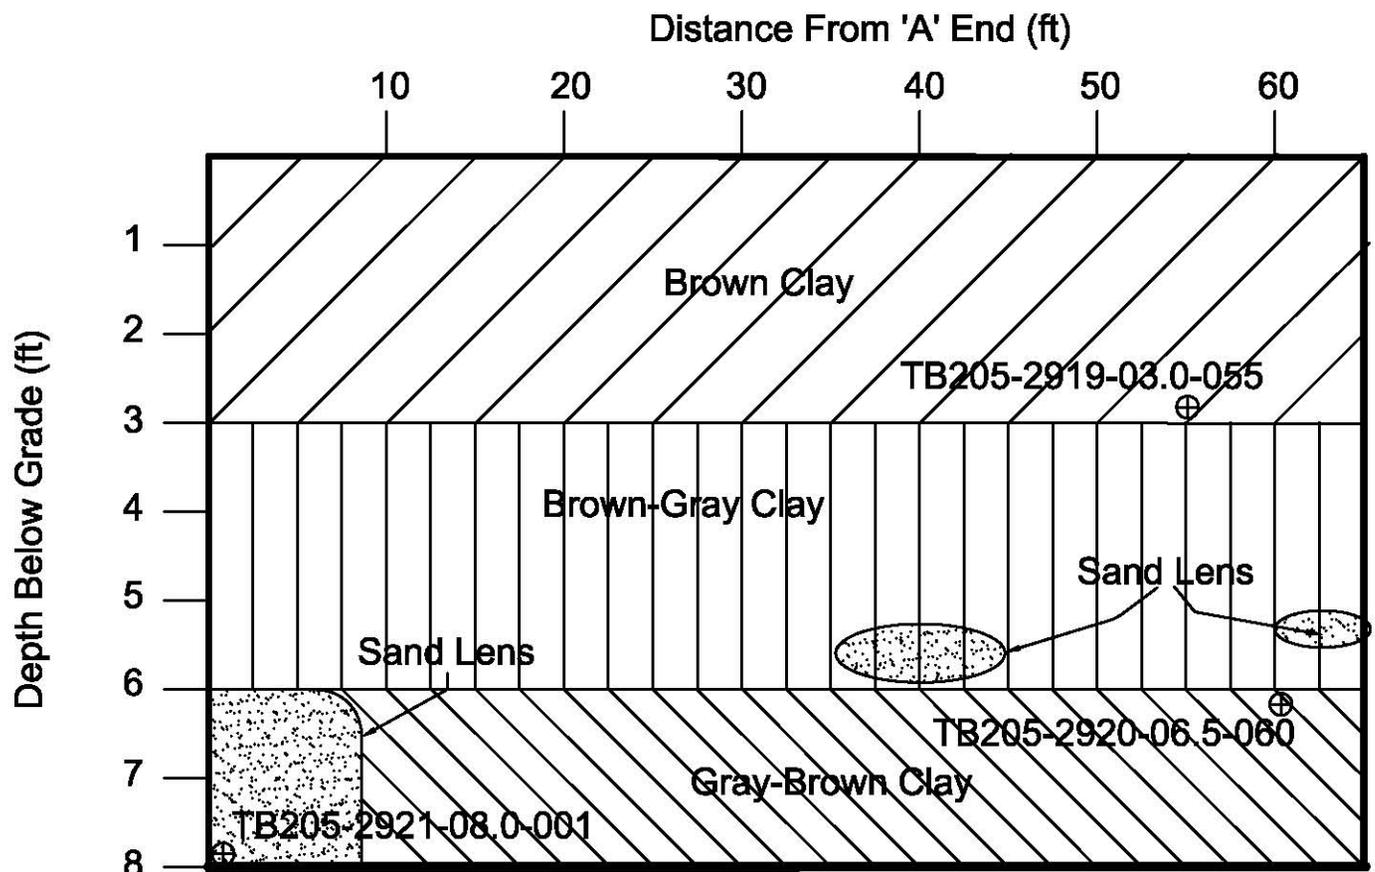
TRENCH 205
 NIAGARA FALLS STORAGE SITE

Trench 205
 Trench Length 65'
 Trench Depth 8'

Notes: No Magnetic Anomalies
 No Gamma Radiation Above
 Background

Numerous PID measurements slightly
 elevated above background. Maximum
 PID measurement was 34ppm. Sample
 2920 collected from location of this
 elevated PID measurement.

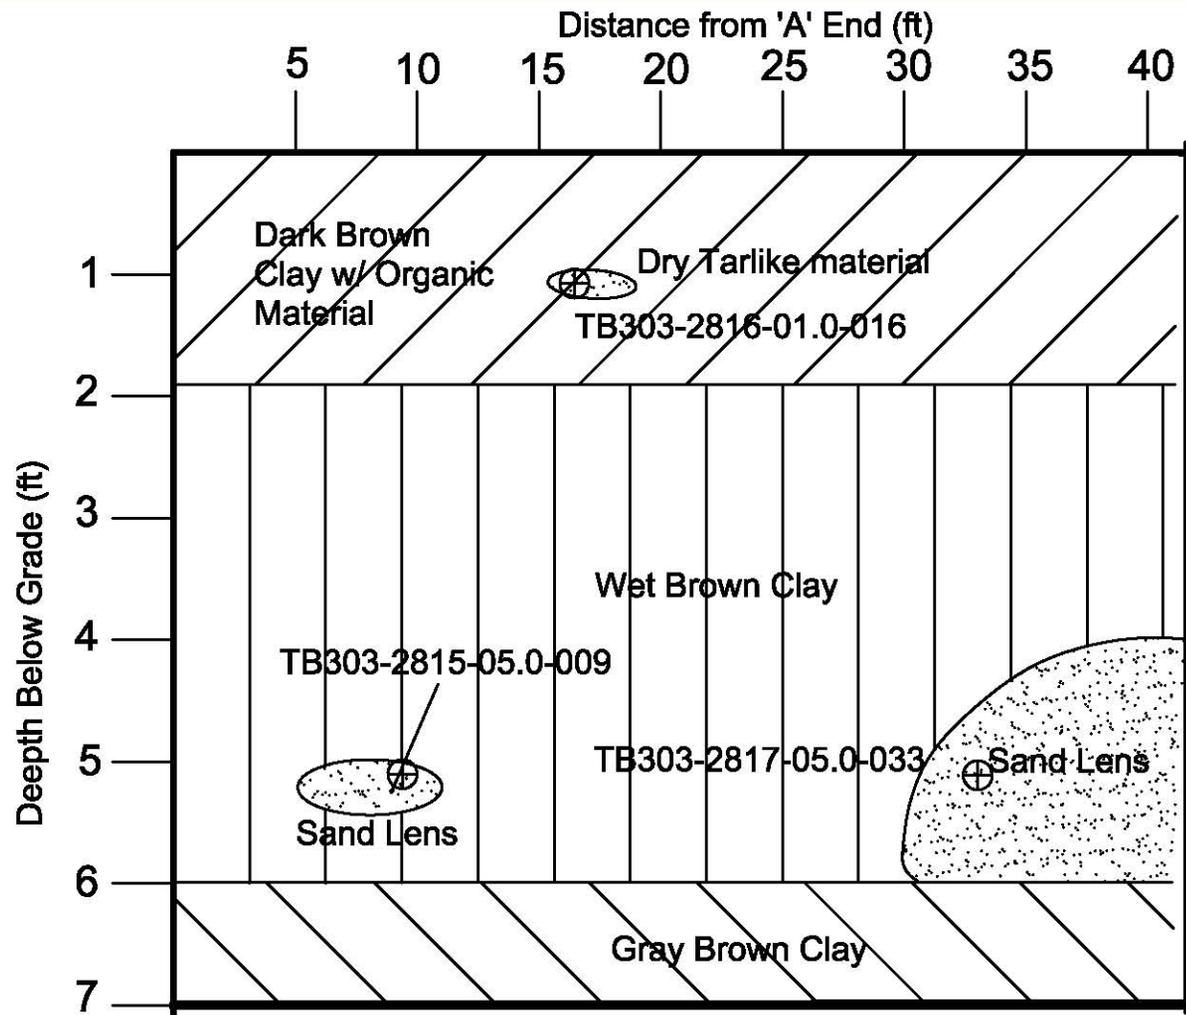
TRENCH 303
NIAGARA FALLS STORAGE SITE

Trench 303
Trench Length: 42'
Trench Depth: 7'

Notes: No Magnetic Anomalies detected
No Gamma Radiation above background
No elevated PID measurements

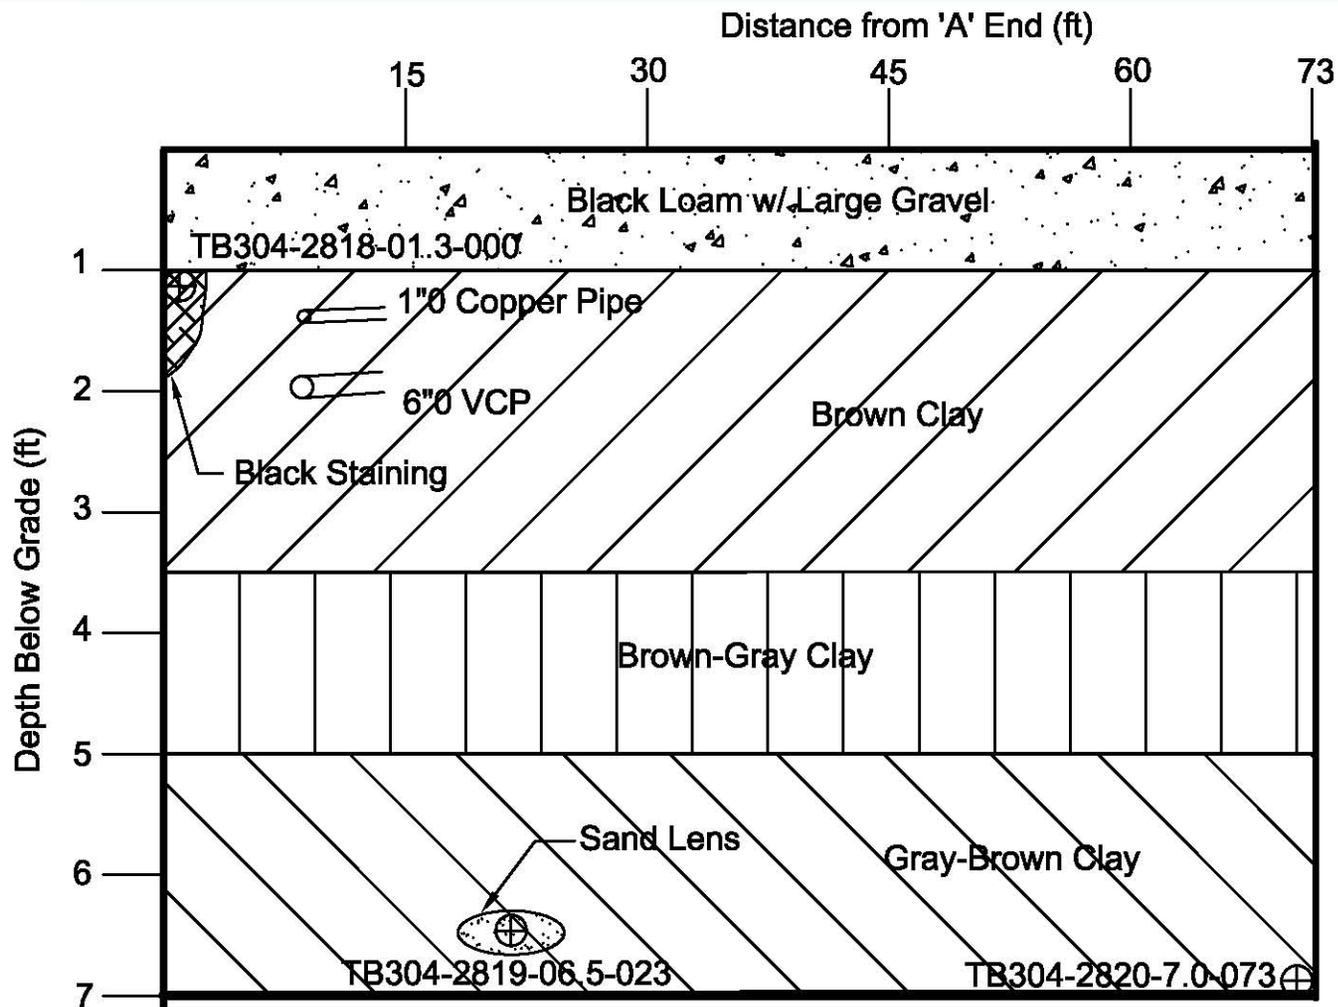
TRENCH 304
 NIAGARA FALLS STORAGE SITE

Trench 304
 Trench Length: 73'
 Trench Depth: 7'

Notes: 1"0 Copper Pipe and 6"0 VCP Intersect trench between 0+06 and 0+12'
 No Magnetometer Anomalies
 No Gamma Radiation Above Background
 No Elevated PID Measurements

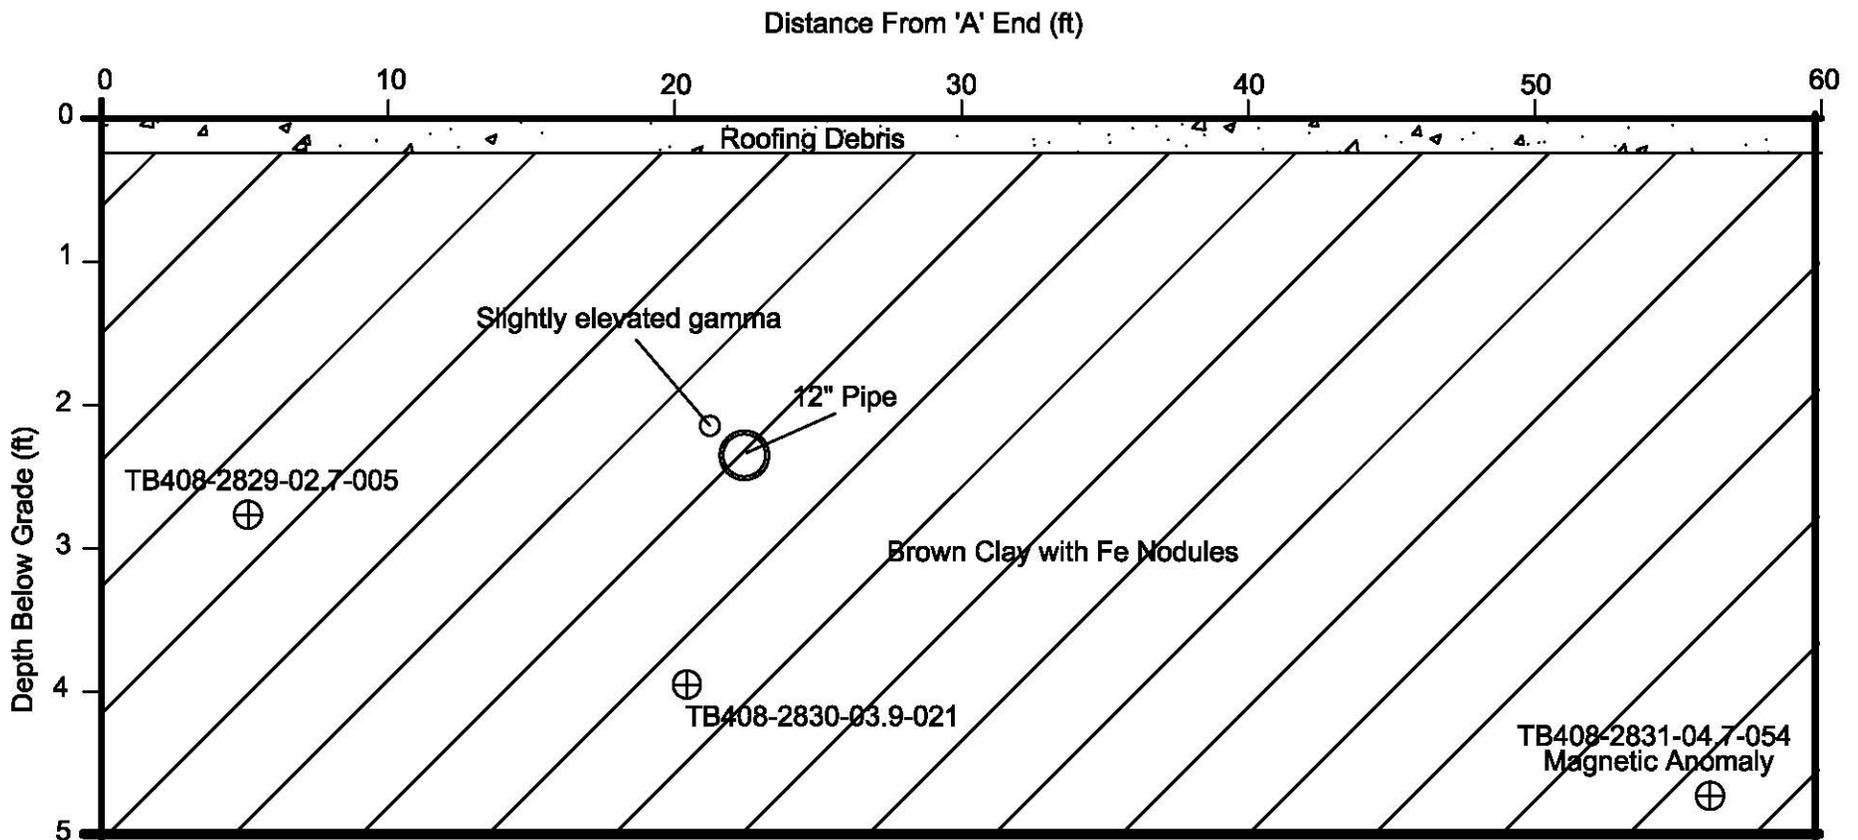
TRENCH 408
 NIAGARA FALLS STORAGE SITE

Trench 408
 Trench Length: 60'
 Trench Depth: 5'

Notes: Several small magnetic anomalies.
 Slightly elevated gamma readings in trench wall at 0+21, 2.3' deep.
 No elevated PID readings.
