US Army Corps of Engineers
Buffalo District

NFSS and Surrounding Properties (LOOW)

**Niagara Falls Storage Site
Gamma Walkover Survey**

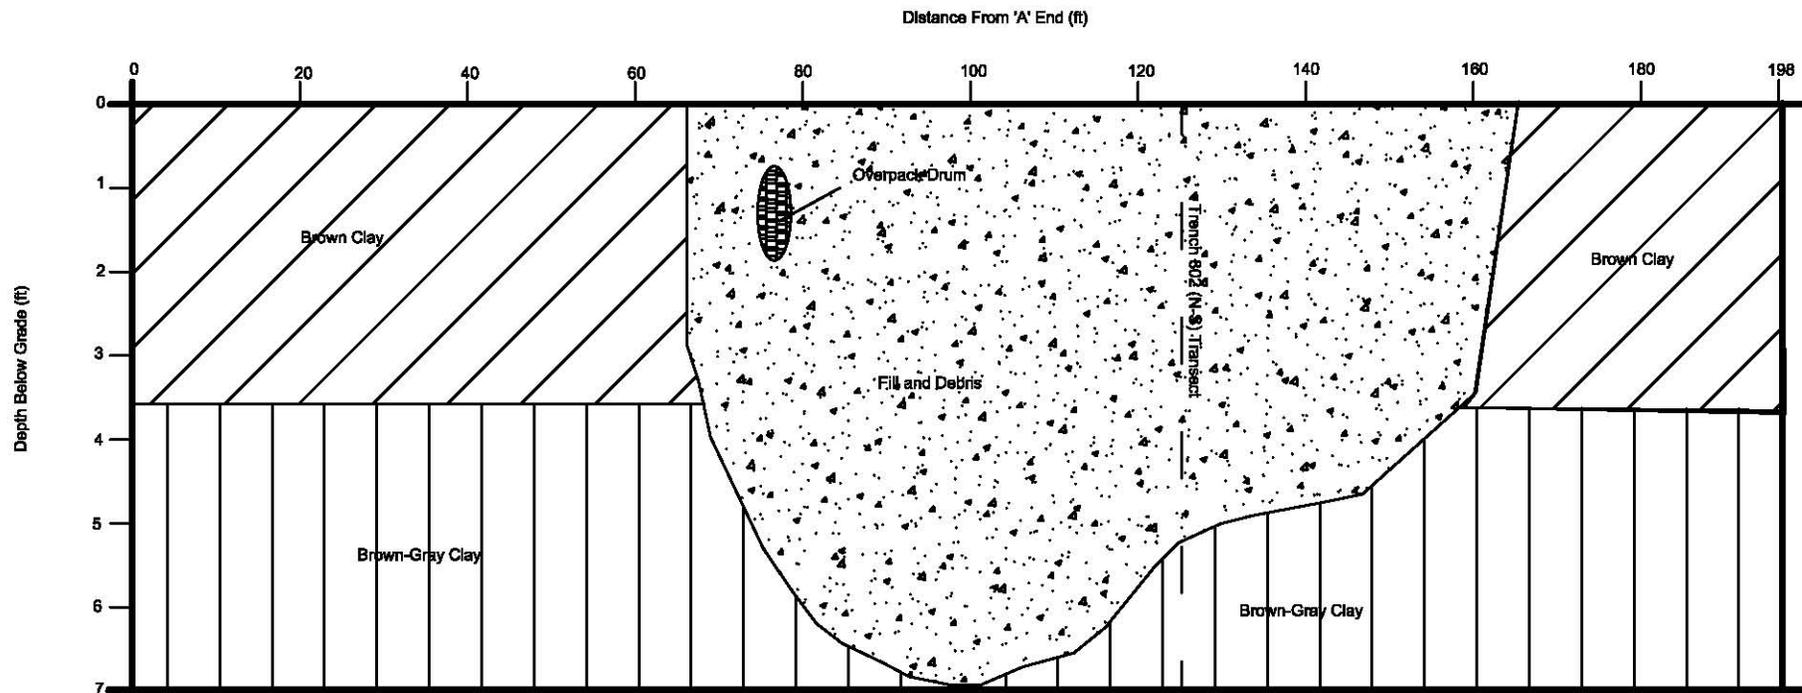
TRENCH 802 (E-W)
 NIAGARA FALLS STORAGE SITE

Trench 802 (E-W)
 Trench Length: 198'
 Trench Depth: 3-7'

Notes: Several magnetic anomalies from debris.
 Some slightly elevated (2x background) gamma readings from trench.
 Fill and debris from 0+65 to 0+165, surface to approx 6'.
 No samples were collected in this trench.

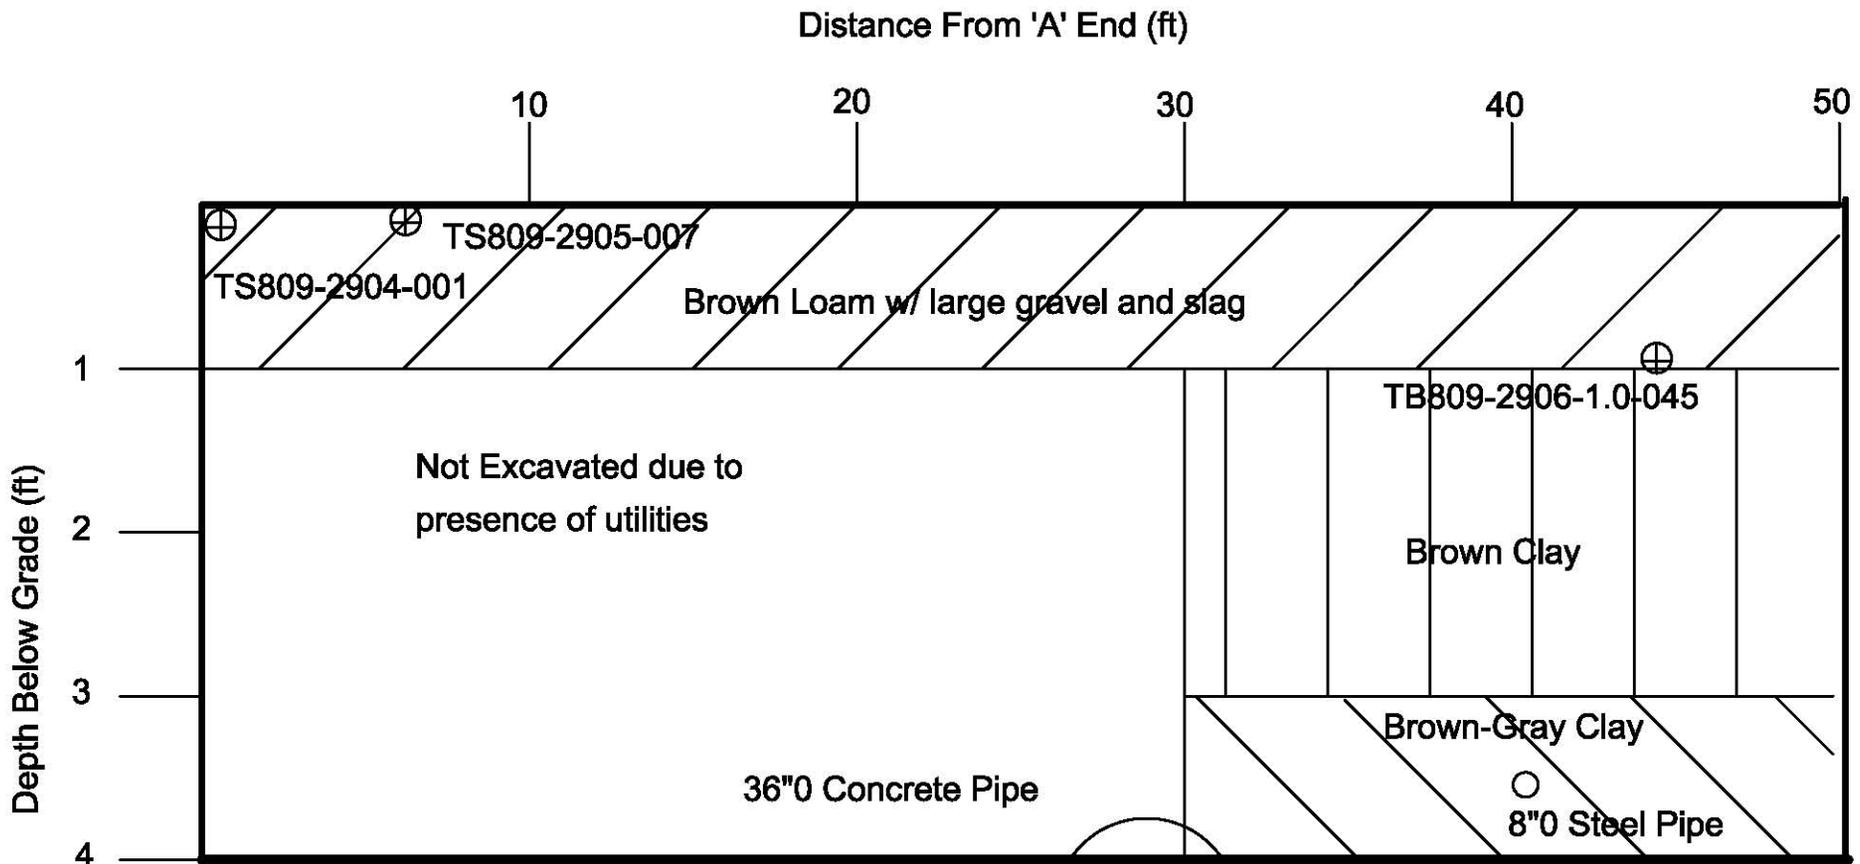
TRENCH 809
 NIAGARA FALLS STORAGE SITE

Trench 809
 Trench Length: 50'
 Trench Depth: 4'

Notes: Numerous small magnetic anomalies in top 1'. Magnetic anomaly at +30' attributed to reinforcement in concrete pipe
 Elevated gamma radiation (20 kcpm) on surface at 0+07'
 Elevated gamma radiation (50 kcpm) at 1' Bgl at 0+45'
 No Elevated PID measurements

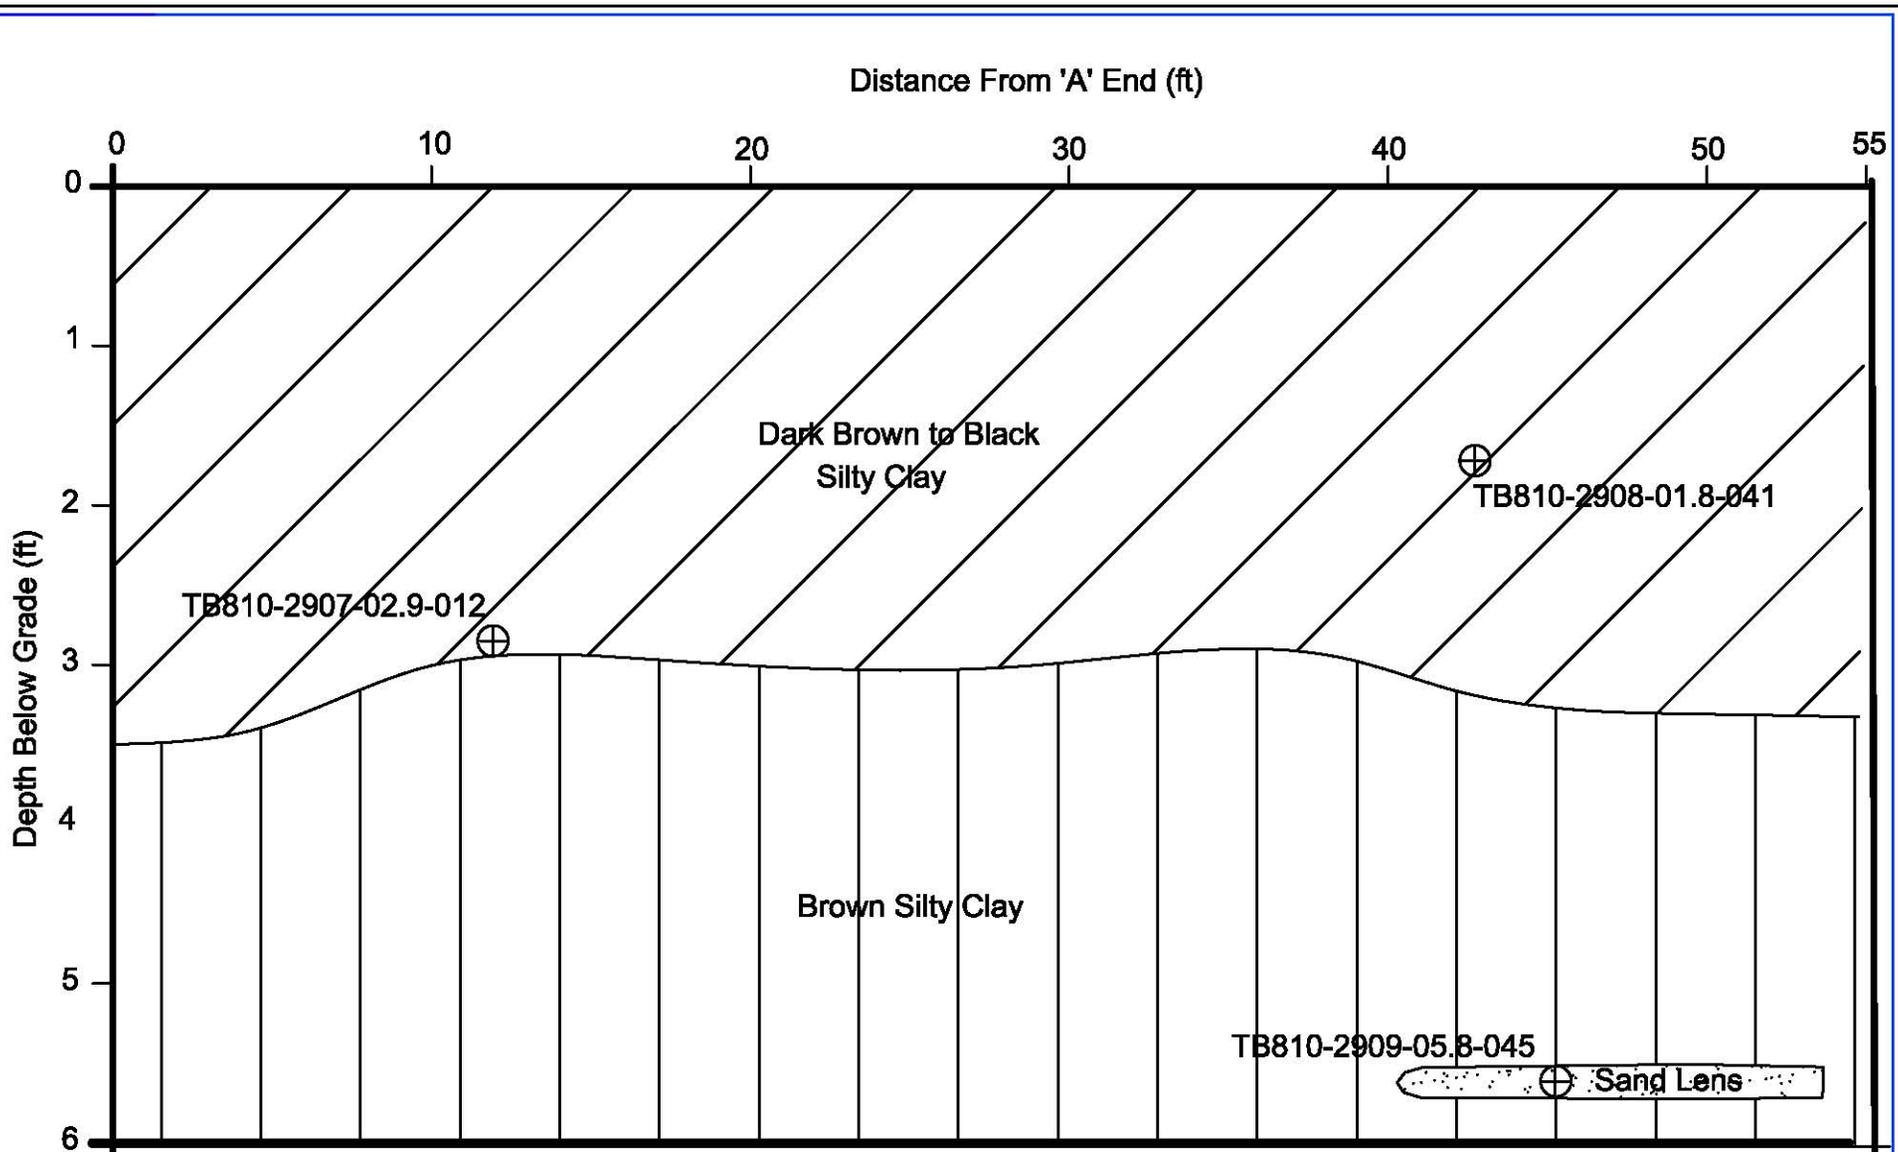
TRENCH 810
 NIAGARA FALLS STORAGE SITE

Trench 810
 Trench Length: 55'
 Trench Depth: 5.5'-6.0'

Notes: Disturbed Soil at 0'-3' deep.
 Elevated gamma reading in sidewall at 0+41", 1.8' deep.
 No elevated PID readings.
