**U.S. Department of Energy  
Office of Environmental Management**

**Type B Accident Investigation Report**

**Radiological Contamination Event  
During Separations Process Research  
Unit Building H2 Demolition  
September 29, 2010**

**November 23, 2010**

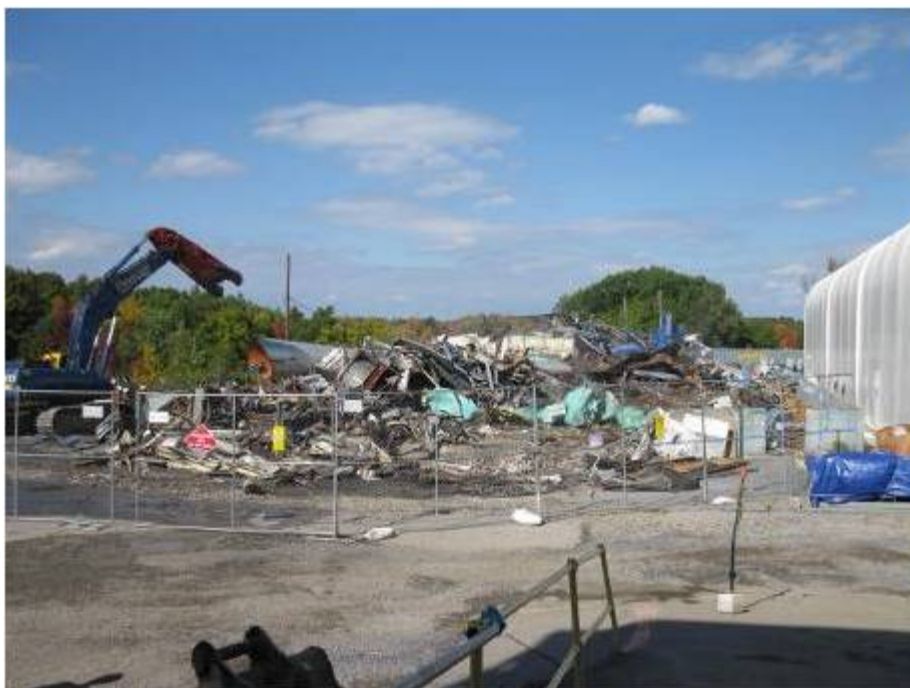
**Figure 2-1: Facing North of the Building H2 on the Afternoon of September 25, 2010**

Prior to September 29, 2010, demolition of Building H2 had progressed to the point where the roof structure, the stack, and the exterior and interior walls with the exception of the north end above the 332' building elevation had been demolished. Some of the demolition debris had been placed in intermodal containers for disposal. Demolition crews had removed an interior wall along the west half of the north end of the building the day before and were in the process of removing six evaporator system columns that extended above and below the 332' elevation along the north-most outer wall.

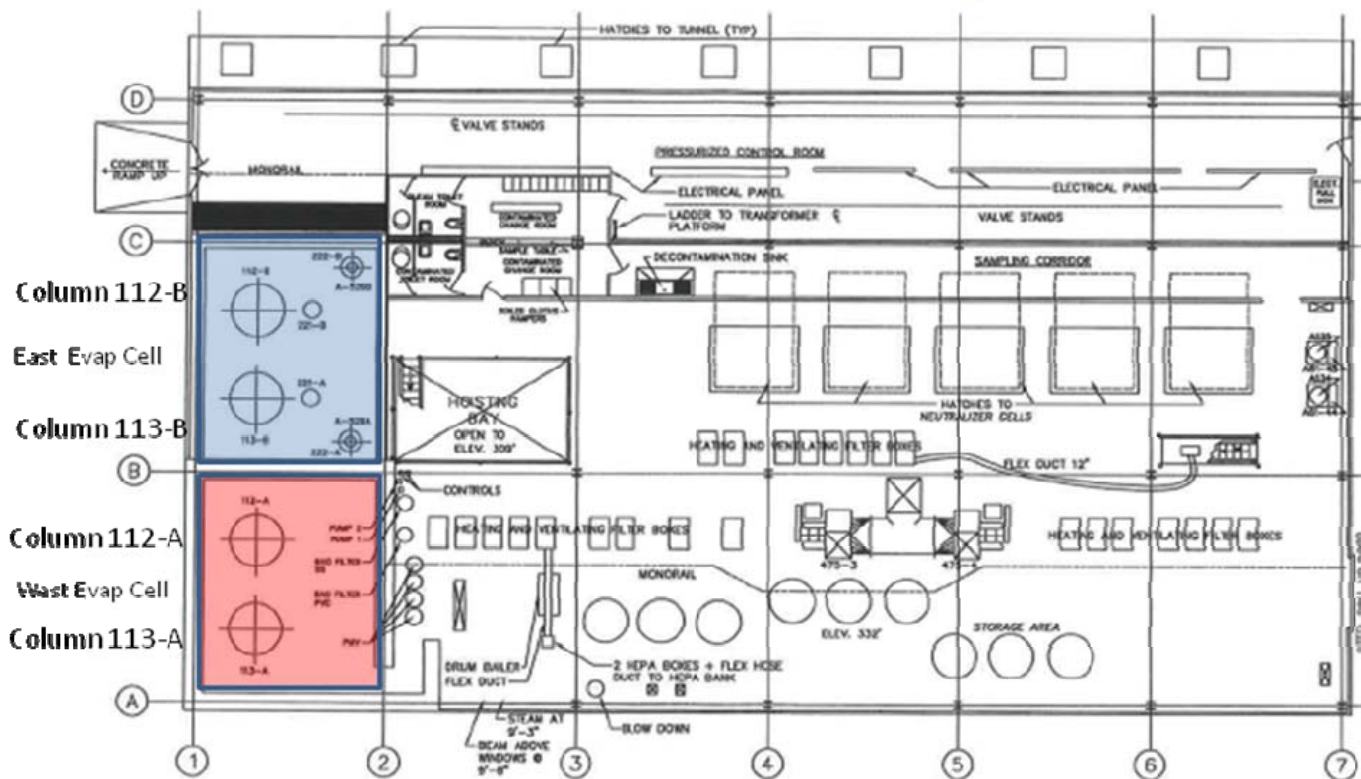
**Figure 2-2: Building H2 332' Elevation**

The DOE ESH&Q Manager was at the 0800 meeting on September 29, 2010, when the request was made to remove the evaporator system components that extended above the 332' elevation. He did not know if this action was appropriate and later that morning, passed the information to the DOE SPRU Facility Representative who communicated the information to the DOE SPRU Manager. Based on this discussion, though, the DOE SPRU Manager did not believe that contaminated components were being removed.
