APPENDIX E

Subject: Friable Asbestos Survey Performed on the Guterl Steel Mill

**Building Feature Survey
Remedial Investigation
Former Guterl Specialty Steel Corporation FUSRAP Site
Lockport, New York
May, 2009**

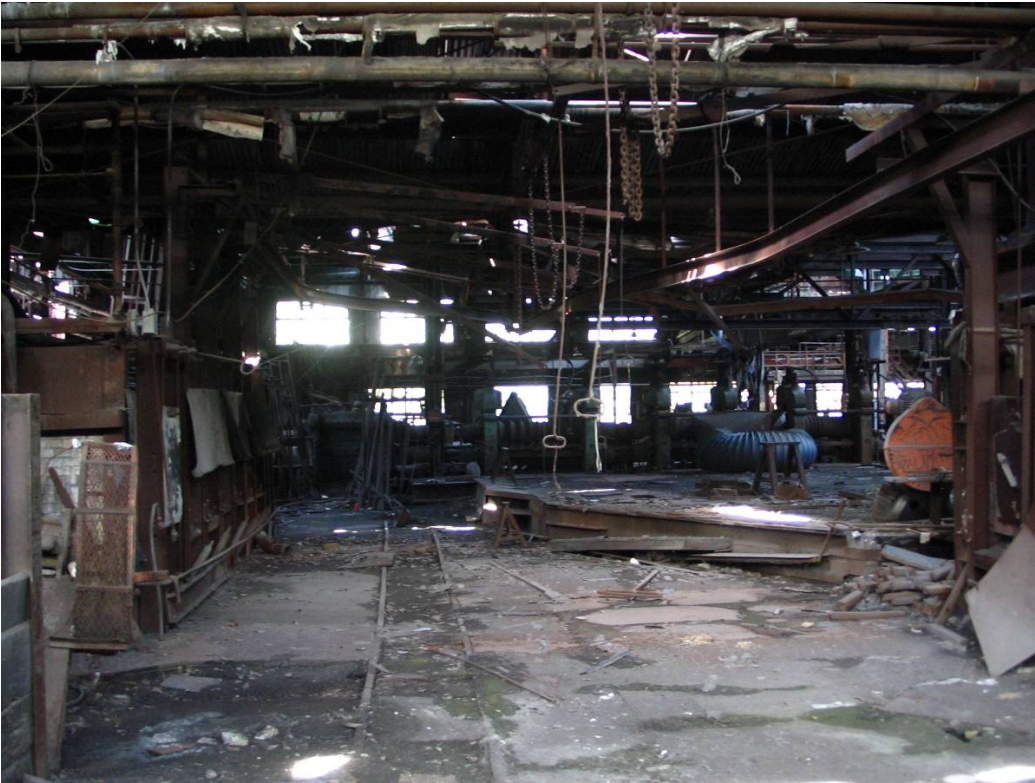
B8P1W

Building 8: This building had several pipes where the insulation was in very bad condition. Insulation had fallen off pipes in large chunks, some of which have acquired a darkened color from being mixed in the dirt on the floor.

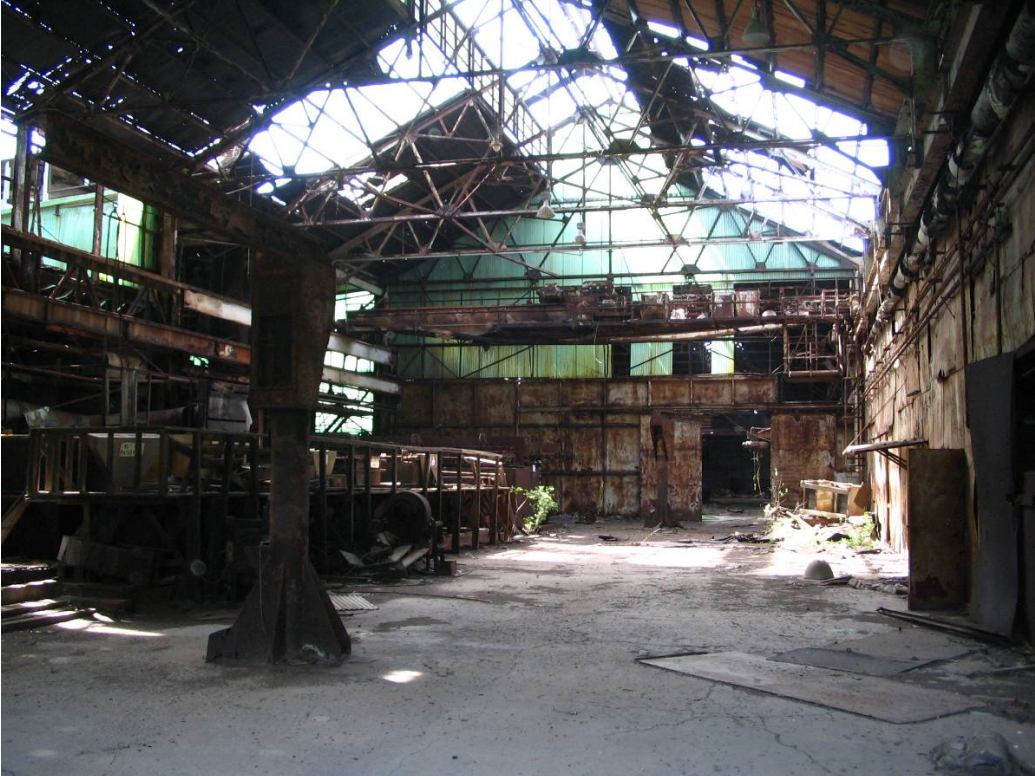
B2P1S

Building 2: There is a boiler room in this building that contains two fairly large asbestos spills from deteriorating pipe insulation that has fallen off and accumulated on the floor. All pipes in this room are in poor condition (with the asbestos insulation no longer being held together with a protective coating, open to the elements and easily friable). There is also one tank in the middle of the room on a second story that is completely covered in a potentially asbestos containing coat of material, which is also deteriorating and falling apart. This room should also be considered extremely hazardous and it is recommended that no personnel should be allowed in there without proper asbestos PPE including tyvek and a respirator with at least P-100 cartridges.

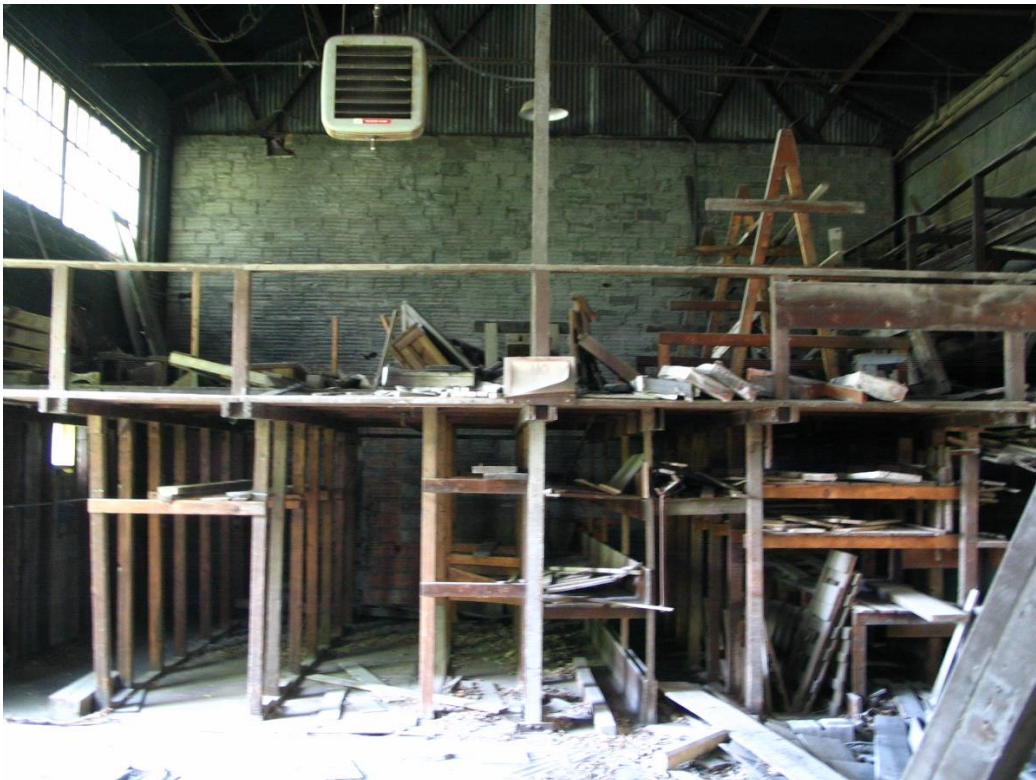
B1P2S

Building 1: This building was mostly clean until you get to the room farthest south, labeled the work room. In the work room boxed insulation and bricks were found in a pile covering most of the room's floor. All of the boxes were breaking down, as was the asbestos products in them. Boxes are labeled with 85% Magnesia. This whole room should be considered extremely hazardous, and no personnel should be allowed in there without proper asbestos PPE including tyvek and a respirator with at least P-100 cartridges.
