# Appendix J

## Pipeline Excavation Logs

## EXCAVATION LOG

**Project:** Niagara Falls Storage Site  
(Lewiston, NY) BOP Field Investigation

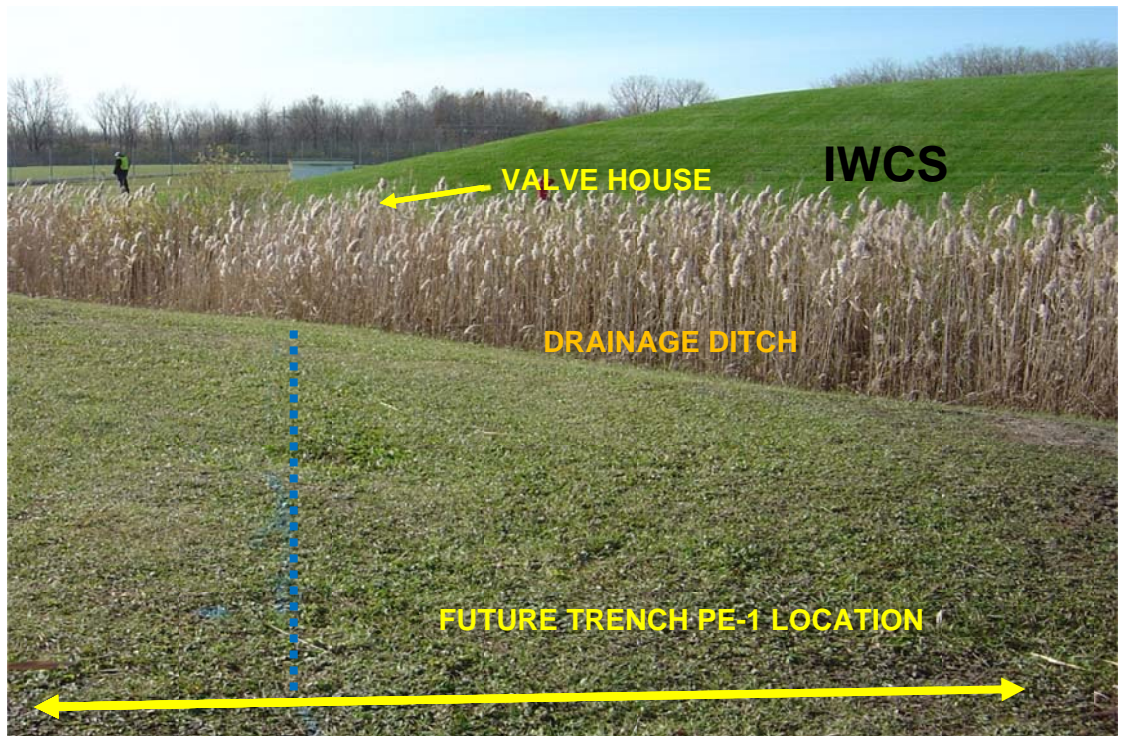
A southwestward view from just inside the IWCS fenceline near the southeast corner of the IWCS (EU 10) showing the geophysical survey markout (blue line) for the suspected water line at location PE-1.

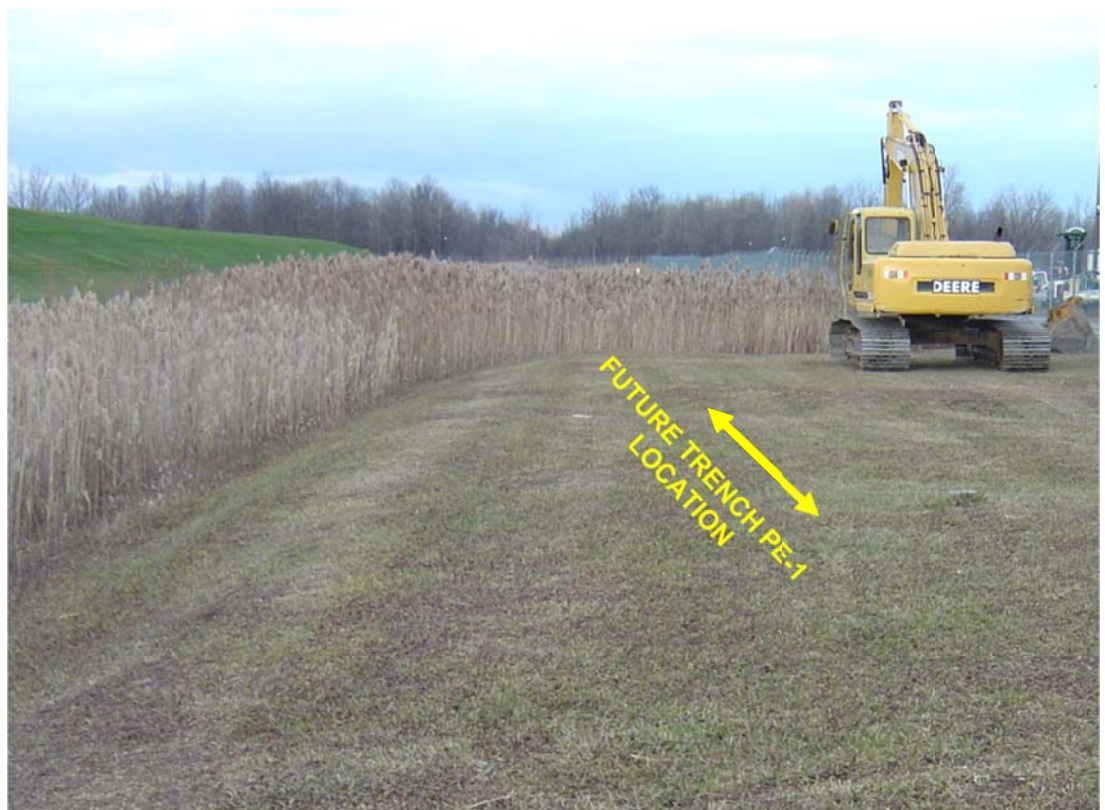
A northward view showing location PE-1 just before excavation activities commenced.

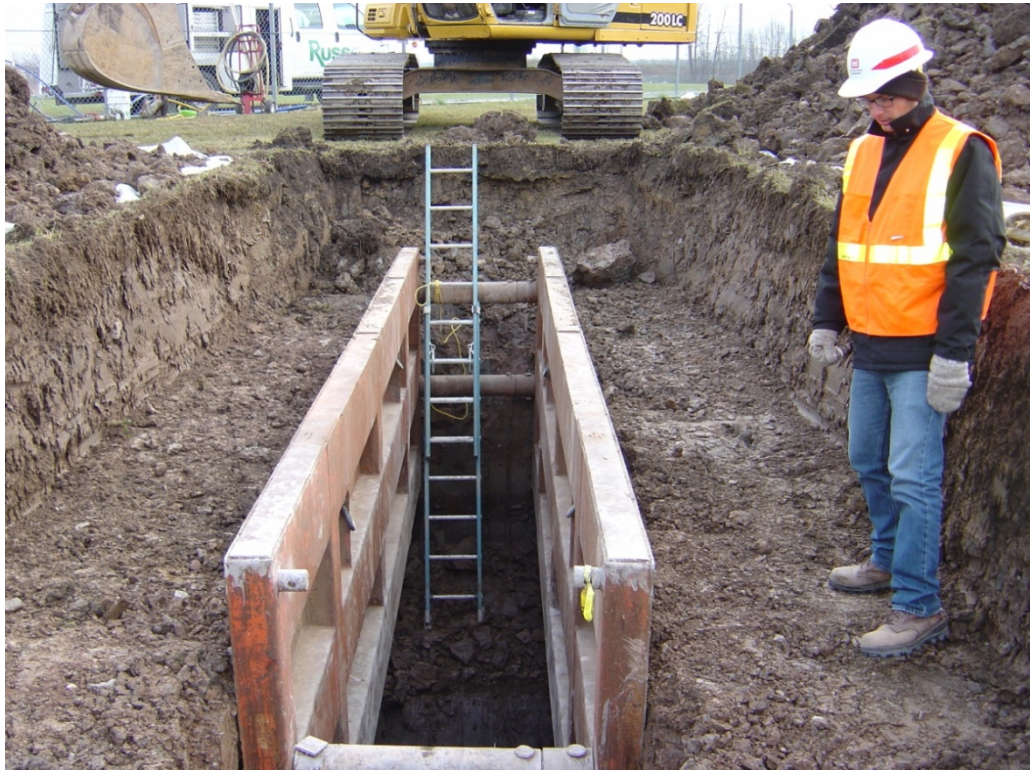
**Photo No.**  
PE1-3

A southeastward view of the equipment set up at location PE-1 during excavation of the trench.

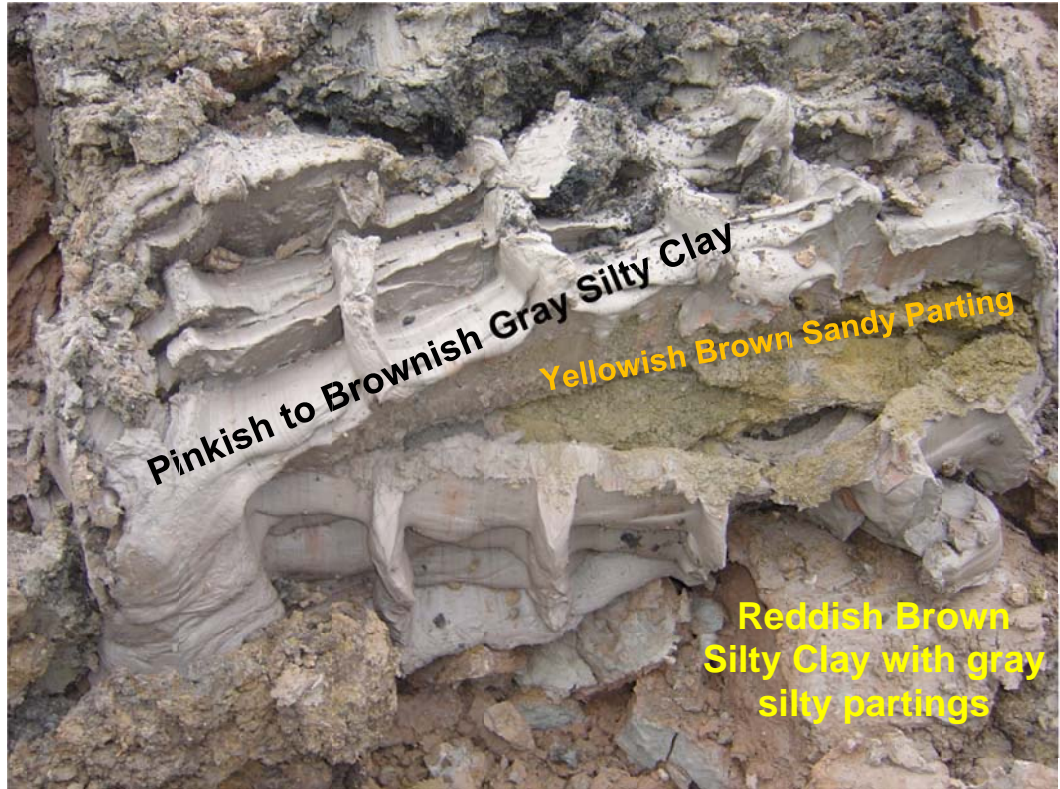
A view of materials excavated from PE-1 showing the pinkish to brownish gray very plastic silty clay with yellowish brown sandy parting (center of photo) and overlying reddish brown silty clay with gray silty-fine sandy partings (lower center left corners of photo) encountered at location PE-1.

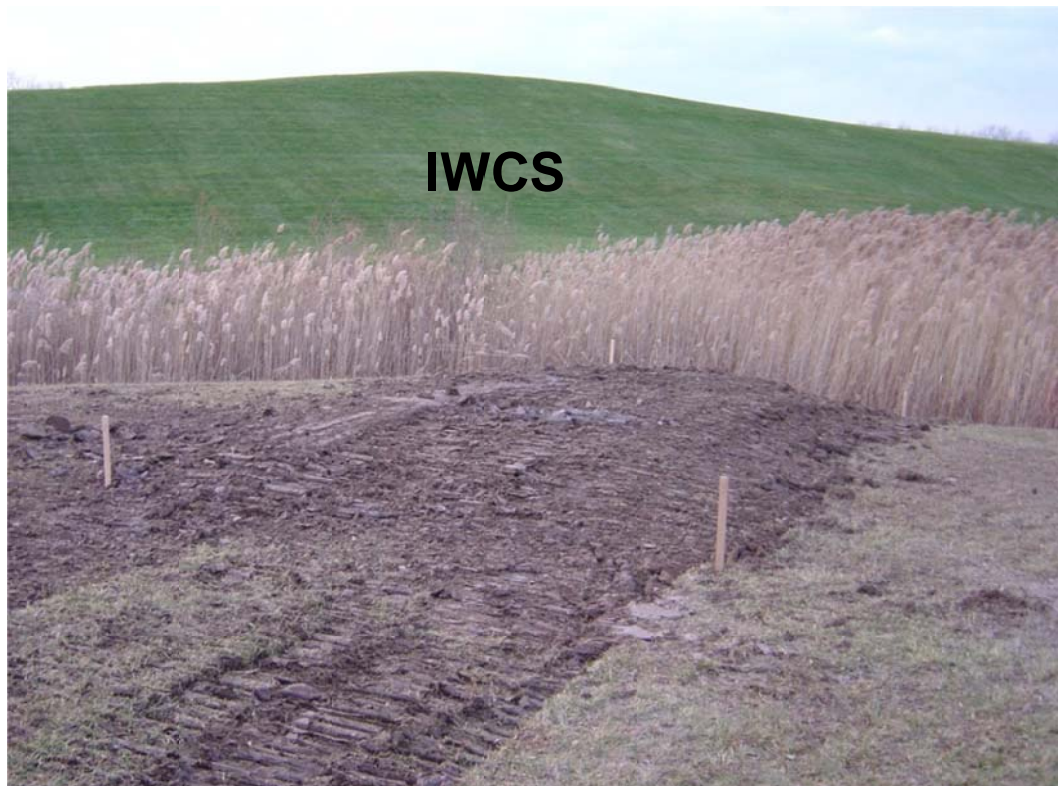
A west-northwestward view of trench PE-1 after it had been backfilled with the previously excavated soils. Soils were placed back into the excavation in 1'-2' lifts and compacted with the excavator bucket. The 4 corners of the excavation were marked with wooden stakes and later surveyed.

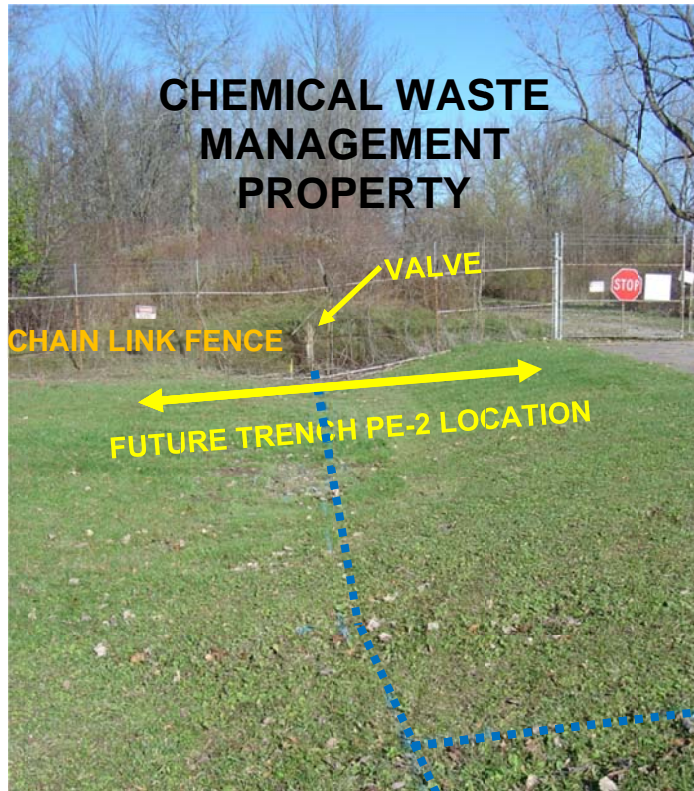
An northward view from "N" Street (northeast corner of EU 2) showing the geophysical survey markouts (blue lines) for suspected water lines near location PE-2. The chain link fence separates the NFSS (to the south) and Chemical Waste Management (to the north) properties.

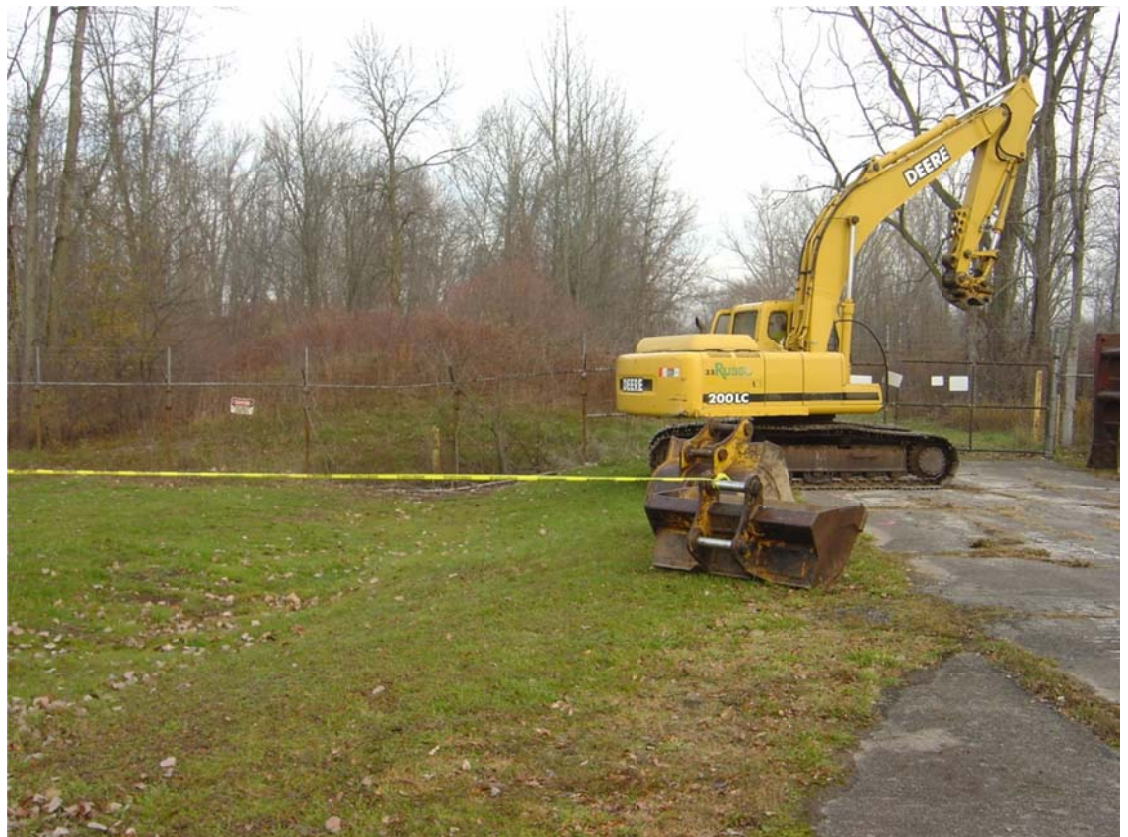
**Photo No.**  
PE2-2

A northward view from "N" Street (northeast corner of EU 2) showing location PE-2 just before excavation activities commenced.

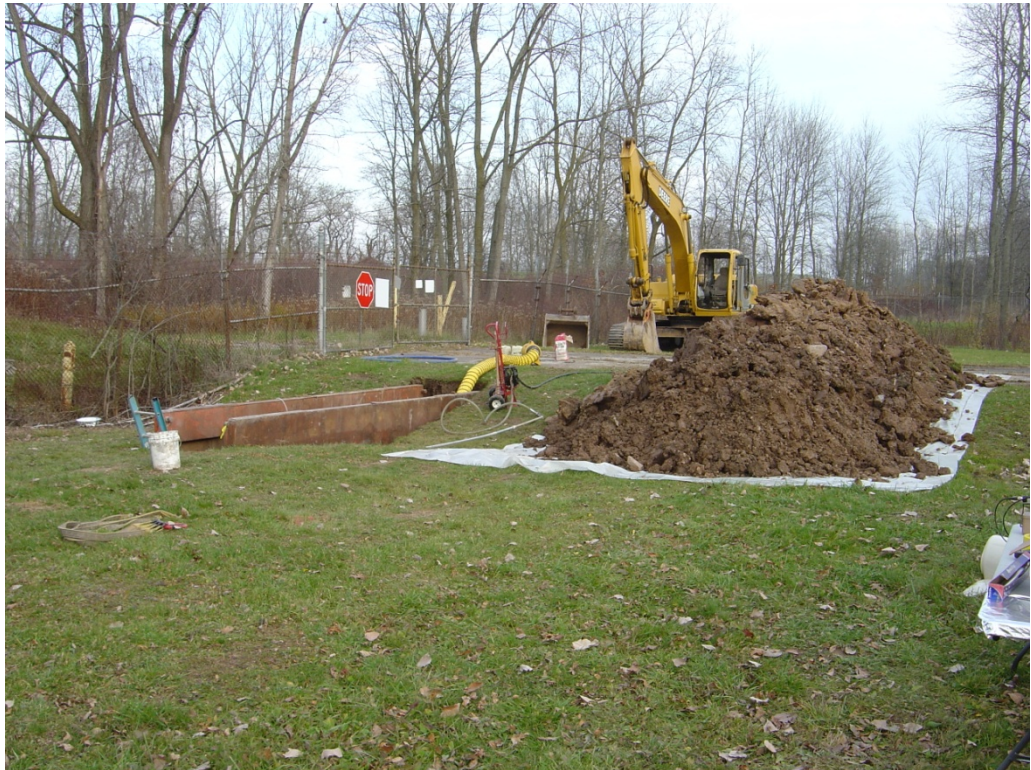
A northeastward view of the equipment set up at location PE-2 during excavation of the trench.

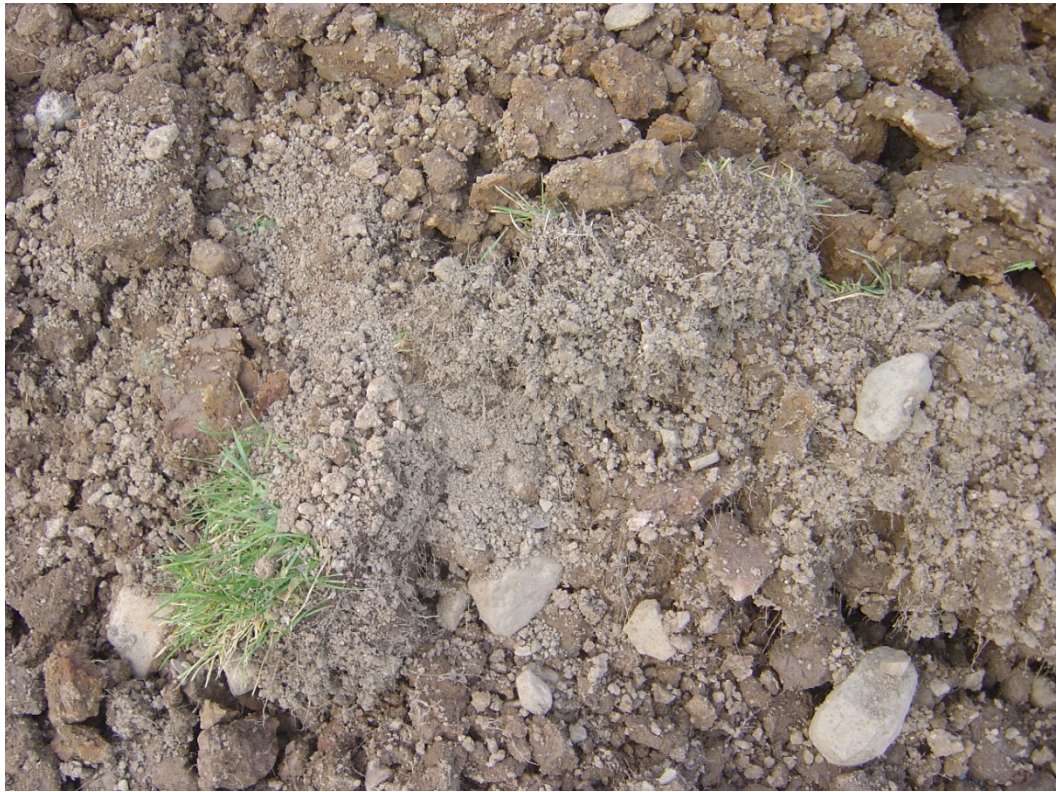
A view of the dark brown silty loam surficial soil (center of photo) and underlying brown silty clay (upper right and lower left corners of photo) encountered at location PE-2.

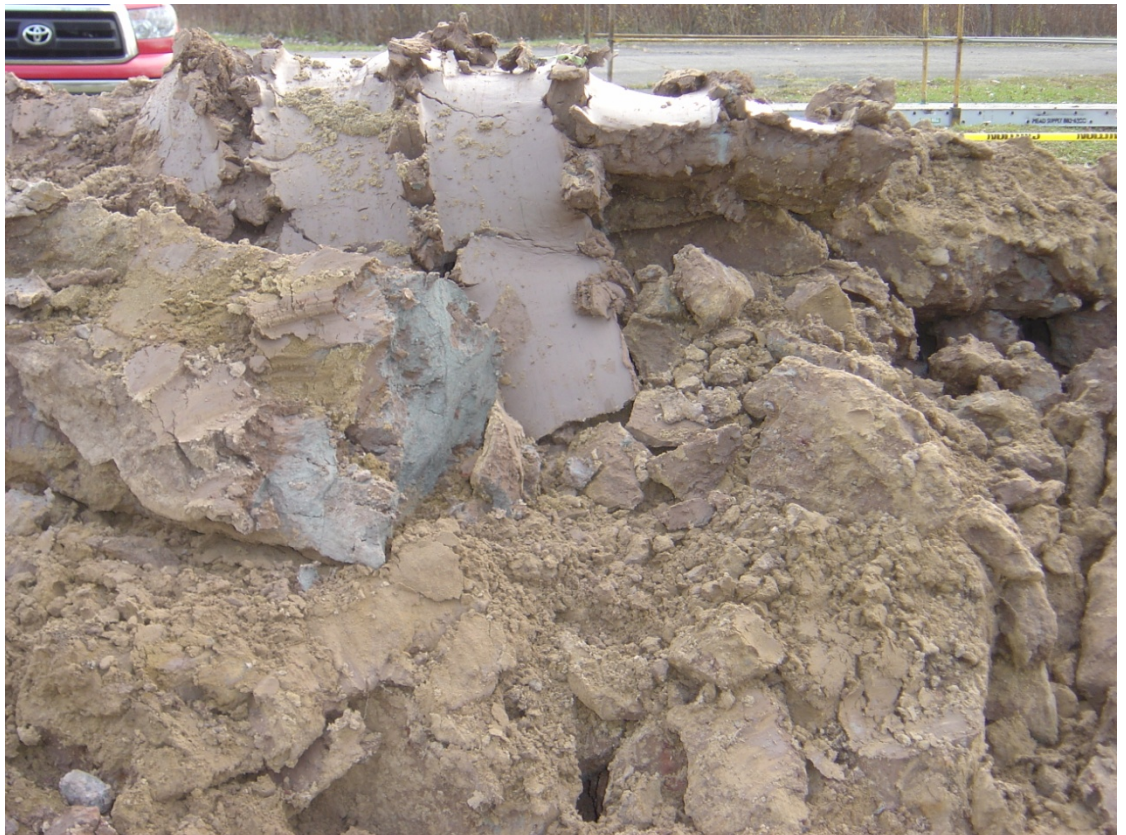
**Photo No.**  
PE2-6

A view of the reddish brown silty clay (upper portion of photo) encountered at location PE-2. Note gray silty partings (center of photo) and yellowish brown fine sandy lenses (lower half of photo) encountered in the reddish brown silty clay. The fine sandy lenses were slightly moist, but did not produce water.

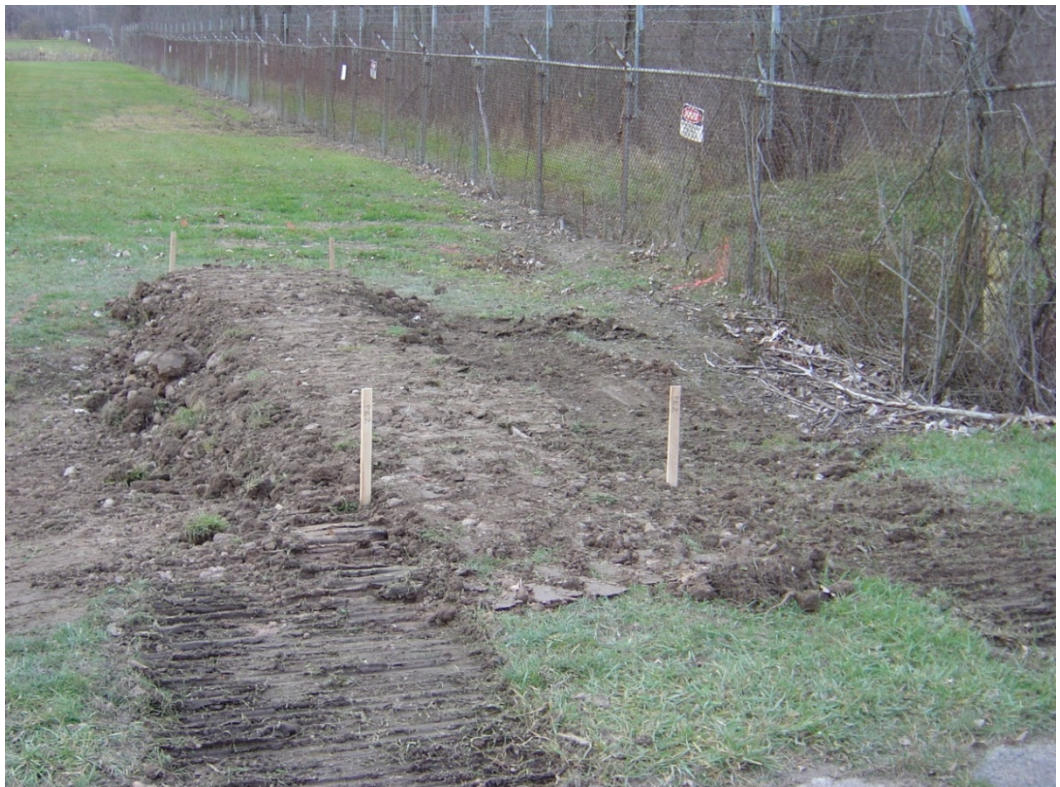
A westward view of trench PE-2 after it had been backfilled with the previously excavated soils. Soils were placed back into the excavation in 1'-2' lifts and compacted with the excavator bucket. The 4 corners of the excavation were marked with wooden stakes and later surveyed.

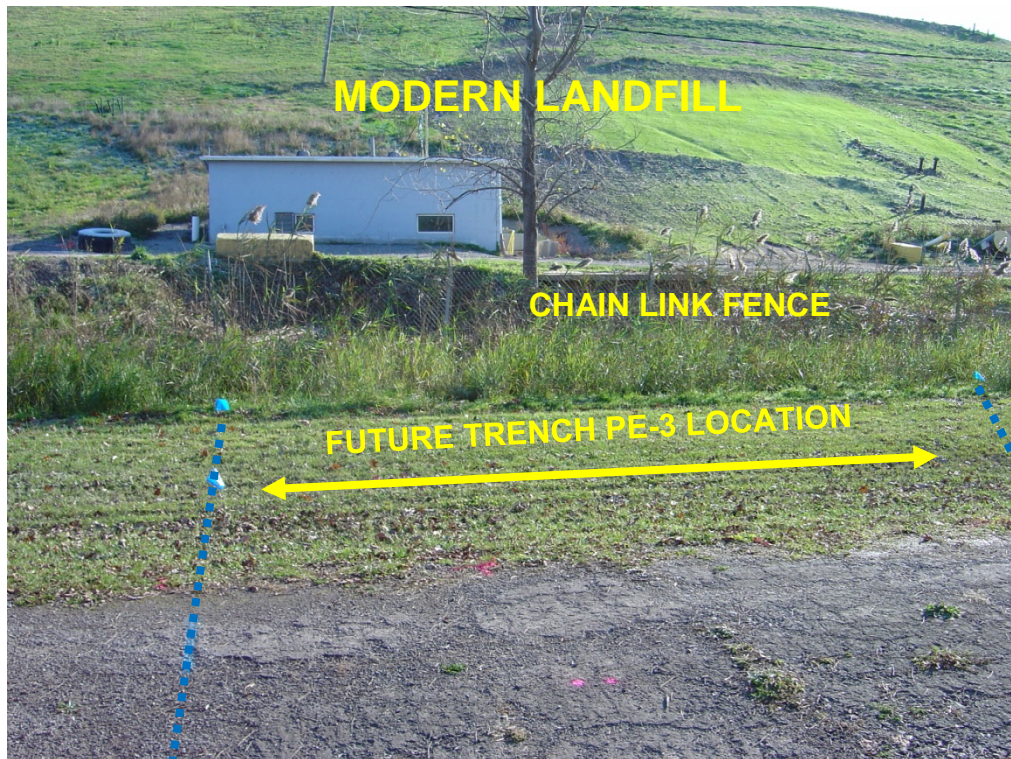
An eastward view from the asphalt access road on the east side of EU 12 showing the geophysical survey markouts (2 blue lines/blue flags) for suspected water lines at location PE-3. The chain link fence separates the NFSS and Modern Landfill properties; Modern Landfill is the mound in the background.

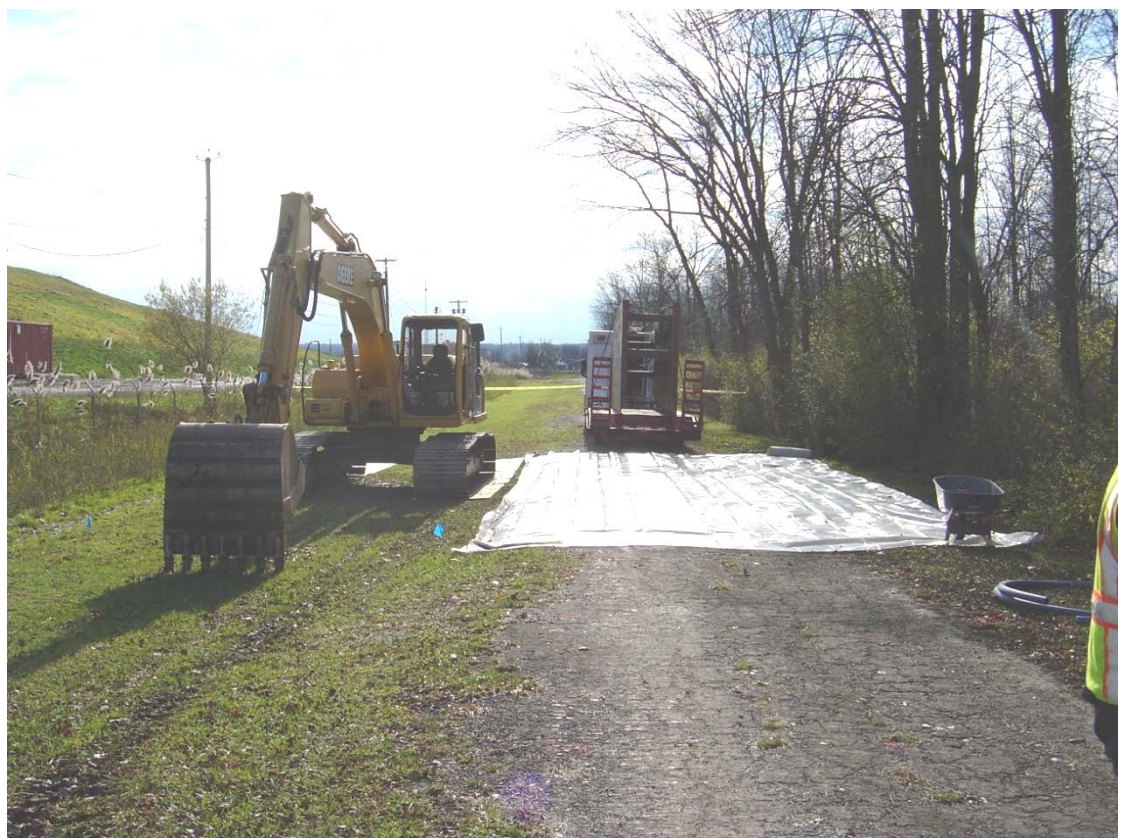
**Photo No.**  
PE3-2

A southward view from the asphalt access road on the east side of EU 12 showing location PE-3 just before excavation activities commenced. Modern Landfill is in the left center portion of the photo.

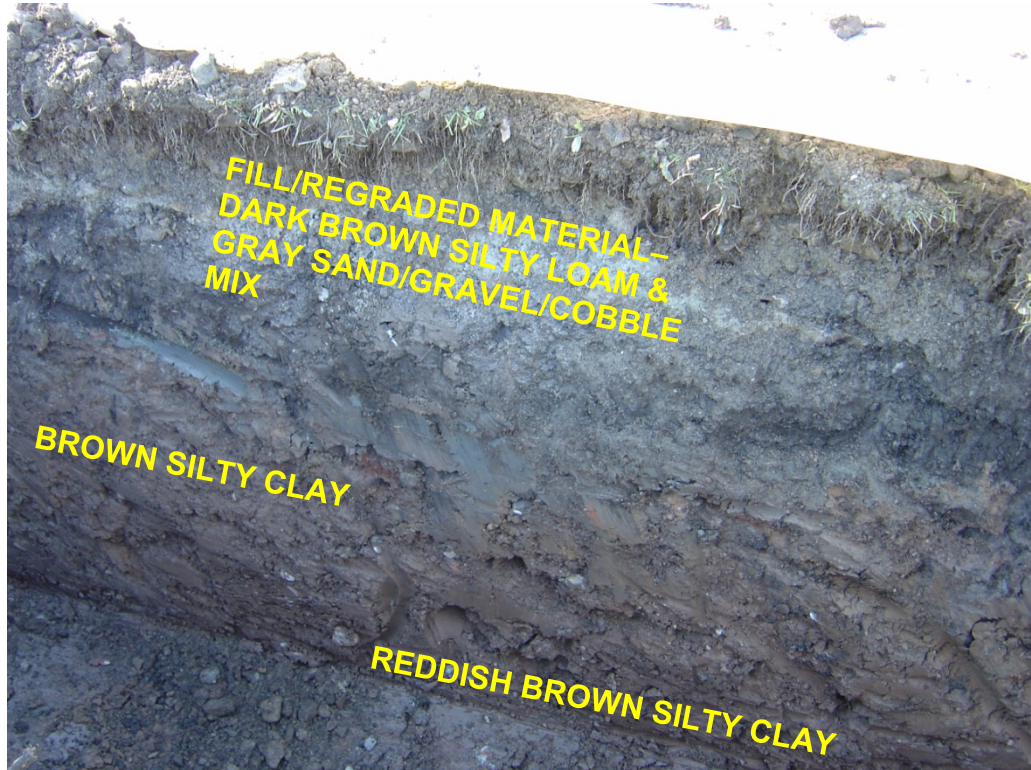
A view of the west sidewall at the north end of trench PE-3; approximately 6' total trench depth. The strata are labeled on the photo.

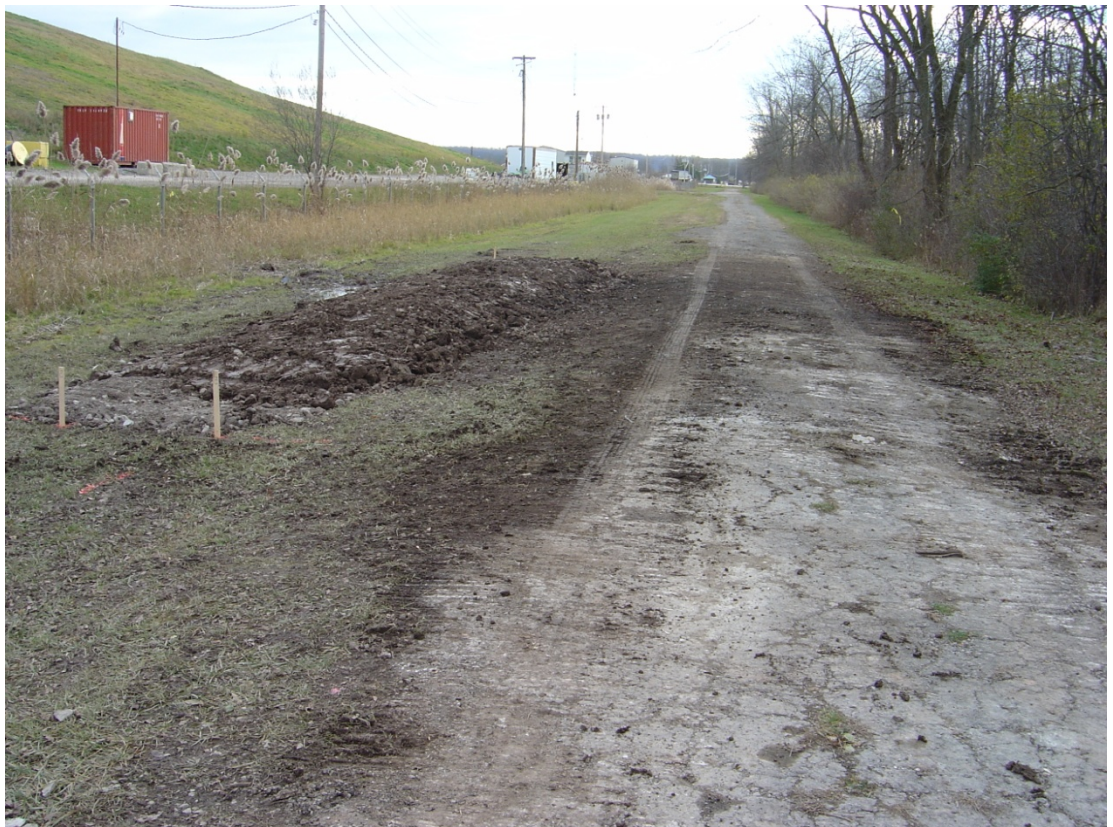
A southward view from the asphalt access road of trench PE-3 after it had been backfilled with the previously excavated soils. Soils were placed back into the excavation in 1'-2' lifts and compacted with the excavator bucket. The 4 corners of the excavation were marked with wooden stakes and later surveyed.

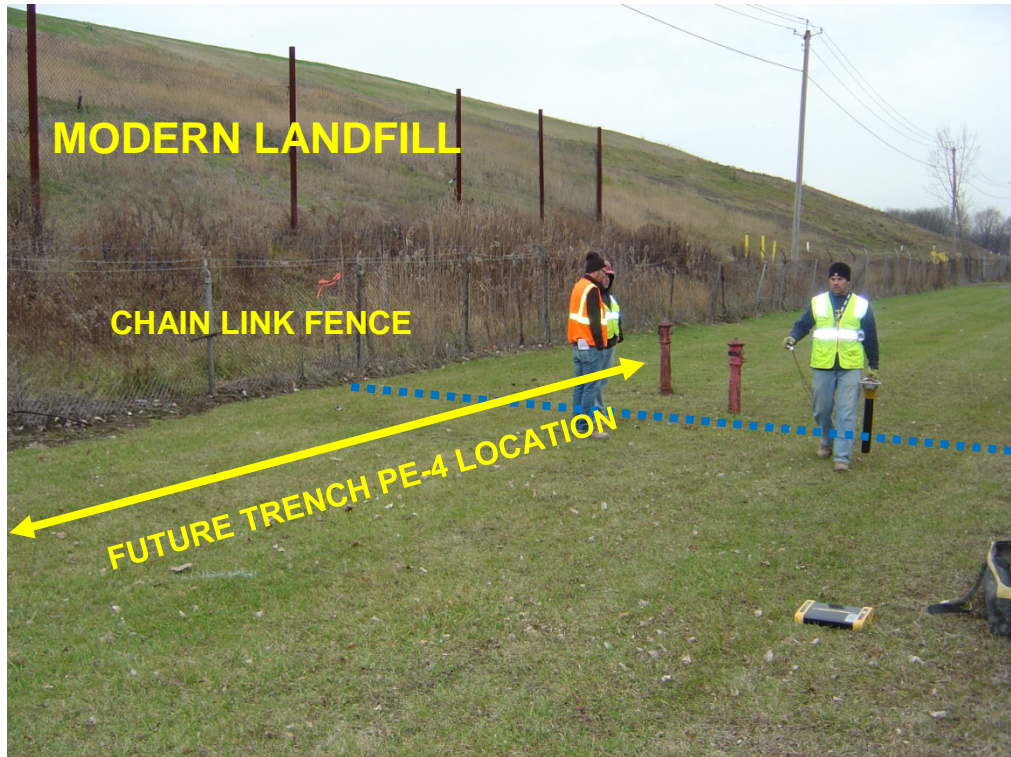
A southwestward view from the asphalt access road ("O" Street) near the southeast corner of EU 5 showing the geophysical survey being conducted to locate suspected water lines at location PE-4 (blue line shows approximate location of group of 3 pipes). The chain link fence separates the NFSS and Modern Landfill properties; Modern Landfill is the mound in the background.

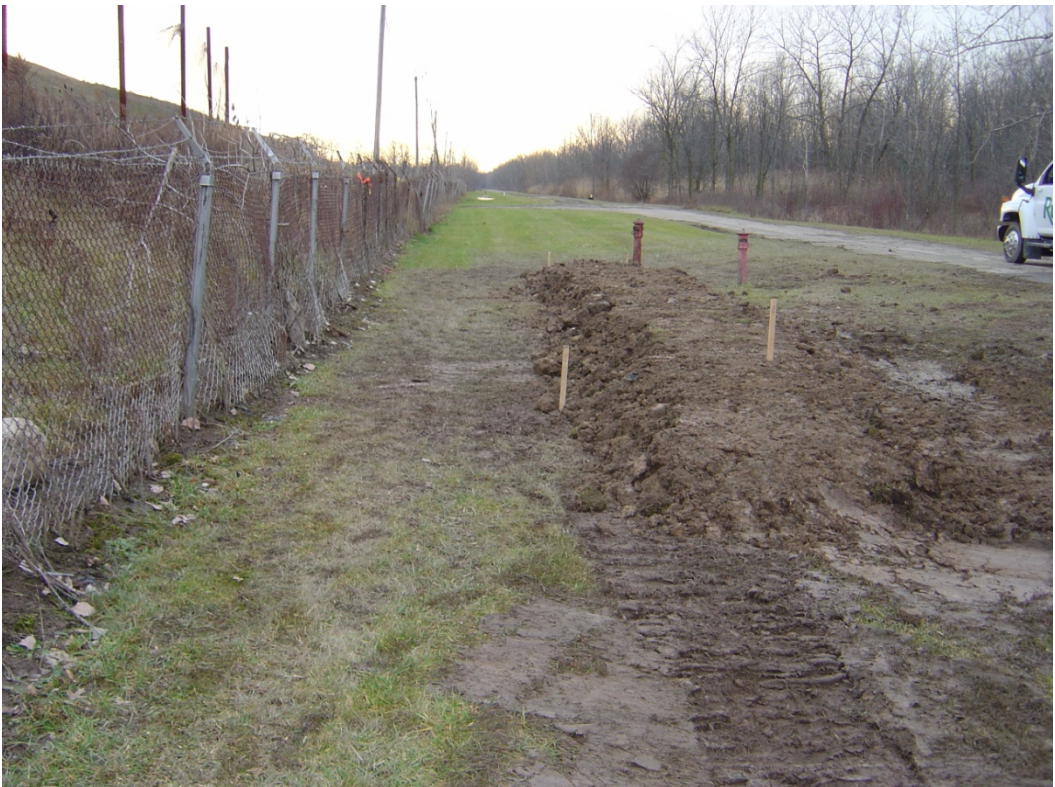
A westward view of trench PE-4 after it had been backfilled with the previously excavated soils. Soils were placed back into the excavation in 1'-2' lifts and compacted with the excavator bucket. The 4 corners of the excavation were marked with wooden stakes and later surveyed.

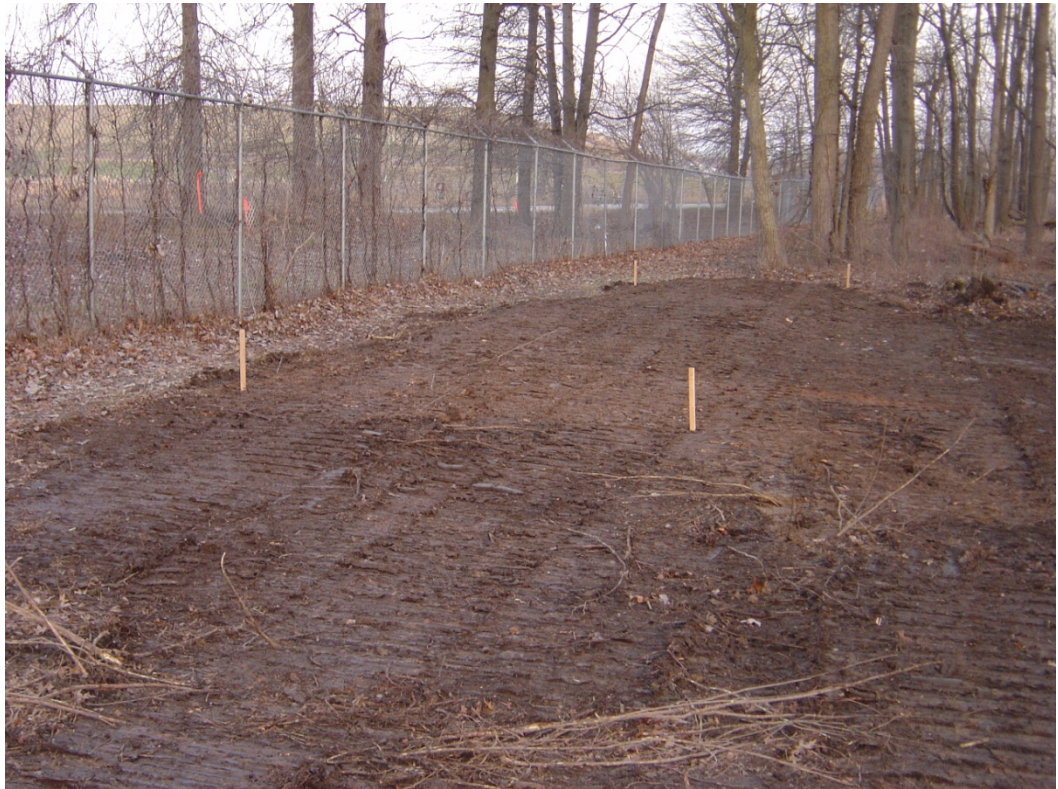
An eastward view of trench PE-5 after it had been backfilled with the previously excavated soils. Soils were placed back into the excavation in 1'-2' lifts and compacted with the excavator bucket. The 4 corners of the excavation were marked with wooden stakes and later surveyed.

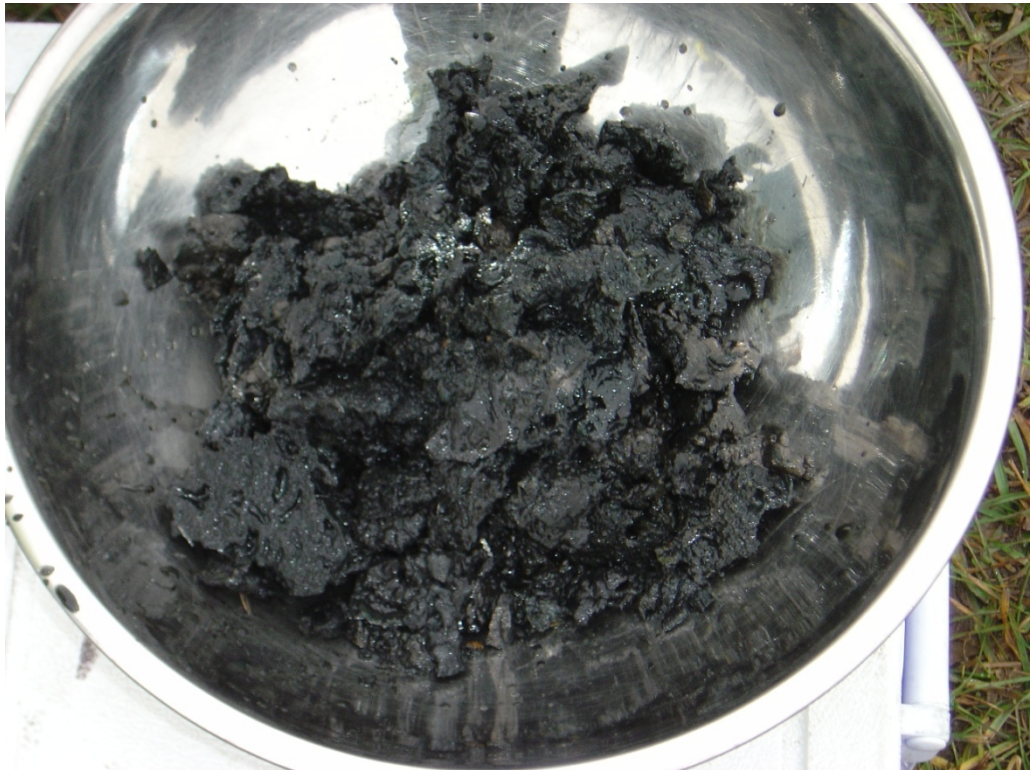
Sample PE6PIPE1SED,  
hard black scale  
collected from the inside  
of PIPE 1.

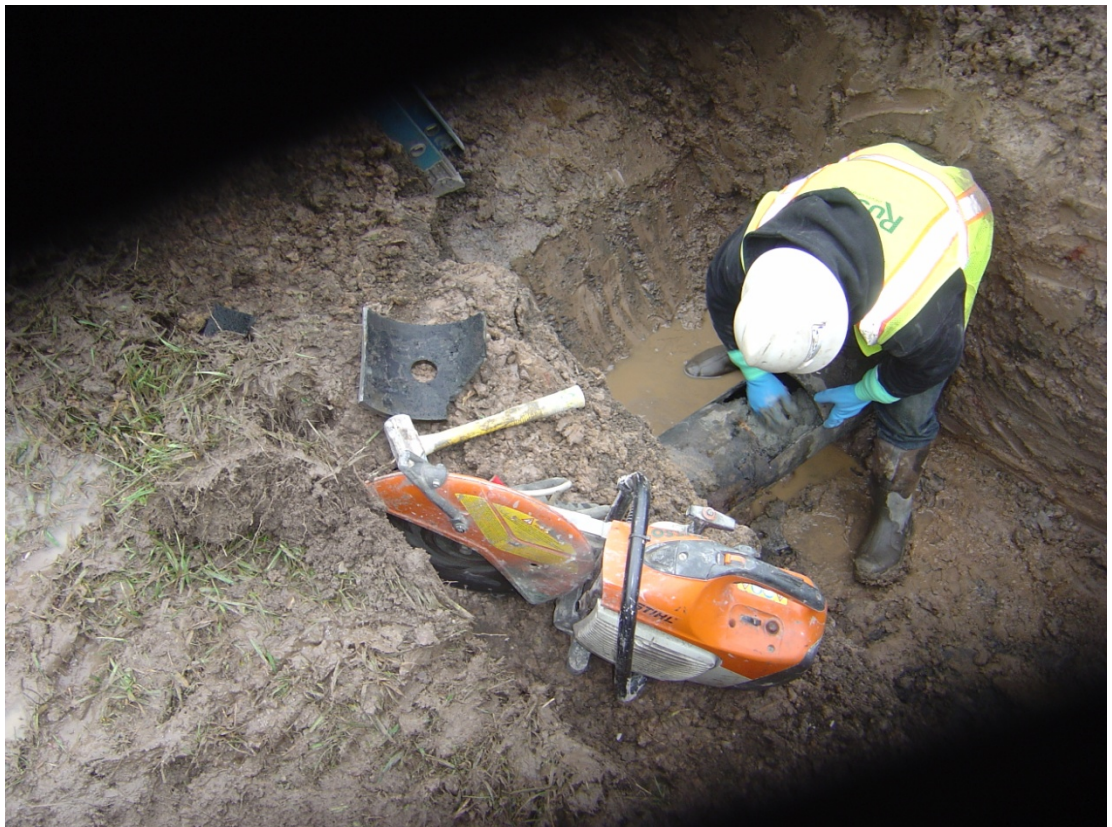
**Photo No.**  
PE6-4

A northward view of the  
bottom of trench PE-6  
showing the pipe after  
PIPE1 was cut open and  
the interior was being filled  
with Speed Crete Red Line  
concrete to prevent liquid  
migration within the pipe.  
Afterward, this pipe was  
encased in 1.5 yds<sup>3</sup> of  
concrete to prevent liquid  
migration along the outside  
of the pipes (right). Top of  
concrete over pipe was  
brought up to ~13' bgs.

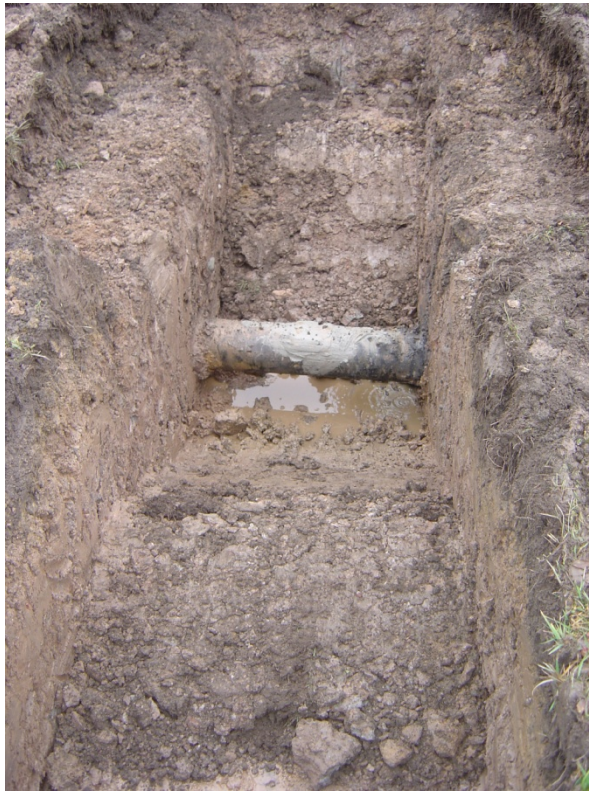
A northwestward view of PE-6 after PIPE1 was filled with Speed Crete Red Line concrete to prevent liquid migration within the pipe.

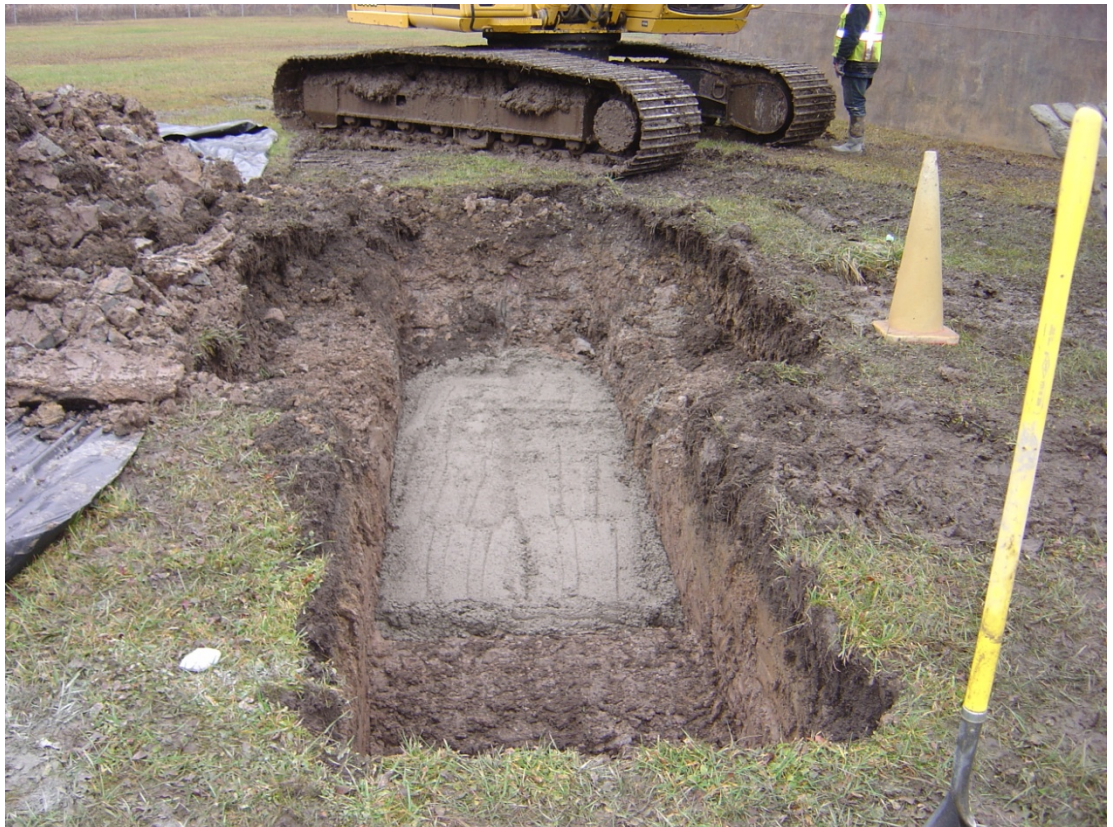
**Photo No.**  
PE6-6

A northwestward view of PE-6 after PIPE1 was encased in 3 yds<sup>3</sup> of concrete to prevent liquid migration along the outside of the pipe. Top of concrete over pipe was brought up to ~3.2' bgs.

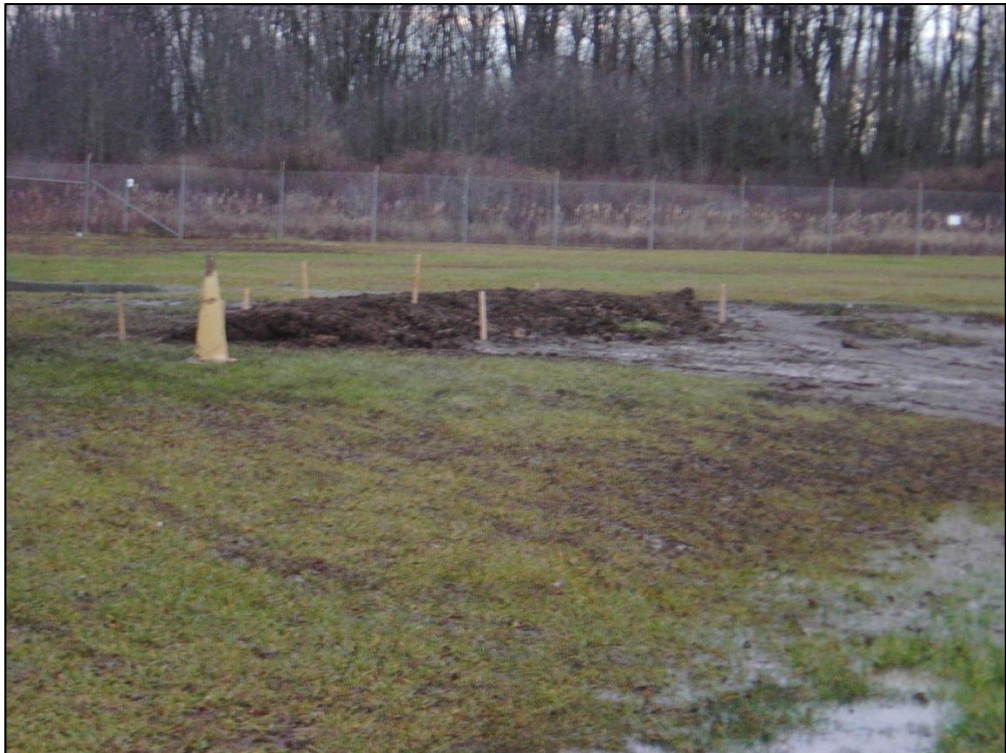
A westward view of trench PE-6 after it had been backfilled with the previously excavated soils. Soils were placed back into the excavation in 1'-2' lifts and compacted with the excavator bucket. The corners of the excavation were marked with wooden stakes and later surveyed.
