A COMPREHENSIVE CHARACTERIZATION AND HAZARD ASSESSMENT OF THE DOE-NIAGARA FALLS STORAGE SITE

U.S. DEPARTMENT OF ENERGY REMEDIAL ACTION PROGRAM

June 1981

FINAL REPORT

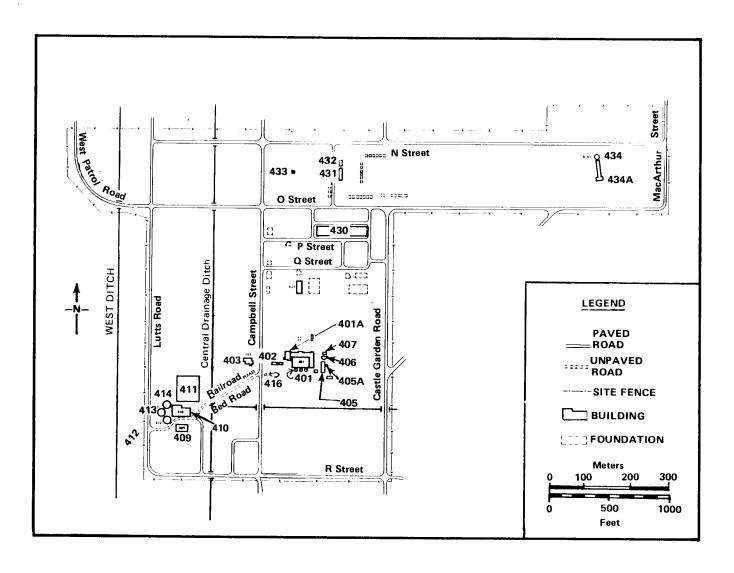
FIGURE 1-2. DIAGRAM OF THE DOE-NIAGARA FALLS STORAGE SITE SHOWING STRUCTURES AND FEATURES OF THE SITE

The northeast portion of the Site contains numerous foundations and supports. The large number of tank supports located near 0 Street and between N and 0 streets are uncontaminated (no meter or smear readings above background). The concrete pad north of the north vault (Building 431) has 1 to 2 mR/hr beta-gamma levels, none of it transferable. The north vault is uncontaminated, but the south vault floor has 0.5-0.75 mR/hr beta-gamma. This contamination is primarily on dust since beta-gamma smear measurements ranged from 200-250 dpm/100 cm². The small building near the New Naval work area which is called the radium storage vault (Building 433) is also uncontaminated (see Chapter 1, Figure 1-2).

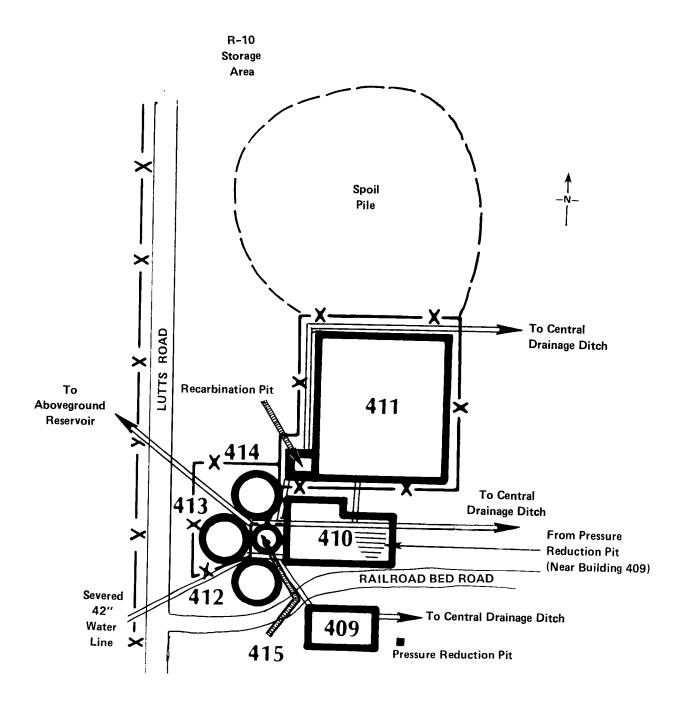
Table 4-2 summarizes gamma and X-ray exposures measured in and around residue storage buildings. Inside the buildings in the southwest complex (see Figure 4-2), exposure readings ranged from 0.03 to 8.1 mR/hr.

FIGURE 4-2. ENLARGED DIAGRAM OF RESIDUE STORAGE BUILDINGS IN THE SOUTHWEST PORTION OF THE SITE

Figure 4-2 shows connecting pipes in the southwest residue storage complex. Connecting pipes from all residue storage buildings are summarized in Table 4-4. Building 409 has connections both to the canal surrounding the surge tank, Building 415, and to the Central Drainage Ditch. However, no contamination was found in the drains of Building 409. Building 410 has an input pipe from the pressure reduction pit, the source of potable water from the Town of Lewiston. The valve was closed but water continually dripped at a slow rate from the pipe into a canal in the southeast corner of Building 410. It was resealed in the fall of 1980. A pipe connecting the west bay of Building 411 into the canal in the northeast room of Building 410 was steel plate sealed but leaked slowly into the canal until it was resealed during the fall of 1980. Contaminated sediments are apparent below the pipe in the canal (see Appendix G, Table G1-7) and a deposition pattern below the pipe is apparent. Finally, four pipes 0.8 m (30 in.) in diameter connect the Venturi vault at the extreme northeast wall of Building 410 with the Central Drainage Ditch. While these pipes are valved closed at the Central Drainage Ditch, some leakage into the ditch was occurring and pipes were sealed during the autumn of 1980.

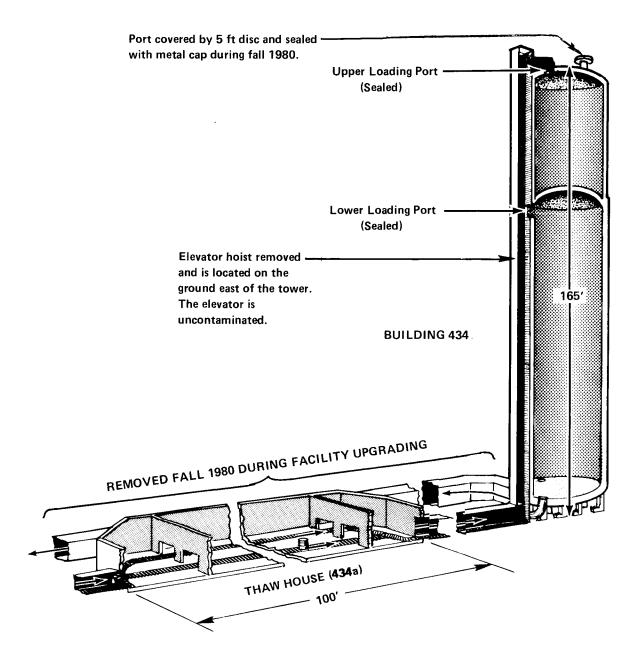
FIGURE 4-3. DIAGRAM OF BUILDING 434, THE WATER TOWER, NOW USED FOR STORAGE OF SELECTED AFRICAN METALS CORPORATION PITCH-BLENDE RESIDUES, THE K-65's, AND THE THAW HOUSE, 434A

Instrument and smear surveys of Building 434 show a maximum reading at 30-34 m above the ground at a crack in the seal of the old catwalk door and lower loading port (see Appendix G, Table G1-9). Betagamma readings at the tower surface ranged from 0.2-30 mR/hr. Dose rates at the top of the tower ranged from 20-42 mR/hr (see Appendix G, Table G1-10). Random smears taken at the top of the tower showed levels 20-5,000 dpm/100 cm² of dominantly (70 percent) short-lived (<24 hrs half-life) alpha radiation from deposition of radon daughters from radon escaping from the port in the center of the top of the tower. The tower has been capped and sealed since these measurements were made. The thaw shed south of Building 434 was empty and only minimum contamination was found. Surface beta-gamma instrument readings did not exceed 0.5 mR/hr. No transferable beta-gamma or alpha radiation was found (see Appendix G, Table G1-9). The only contaminated area of the building was at the north end and where the conveyor belt delivered K-65 residue drums to the

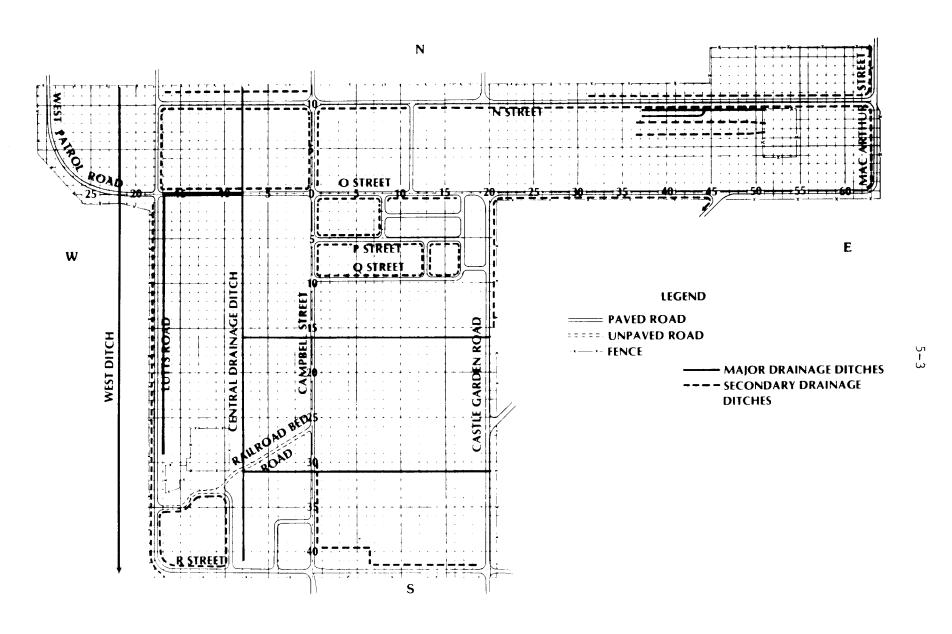
All environmental radiological surveys were based on the 15 m x 15 m (50 ft x 50 ft) grid pattern covering the 77-hectare (190-acre) DOE-Niagara Falls Storage Site. The grid was established with its origin at the intersection of Campbell and O streets with its "X" axis on O Street and its "Y" axis on Campbell Street (Figure 5-1). Each location on the grid can, therefore, be defined by its "X,Y" coordinates which are based on an alpha-numeric system of direction and distance. For example, N10E2O corresponds to a location 10 grid points north or 150 m (500 ft) and 20 grid points or 300 m (1,000 ft) east of the origin at the intersection of Campbell and O streets. With this system, any point on the Site can be located for the surveys and, through permanent markers, located at any point in the future.

FIGURE 5-1. DOE-NIAGARA FALLS STORAGE SITE MAP SHOWING
15 x 15 METER (50 x 50 FT) GRID AND MAJOR FEATURES

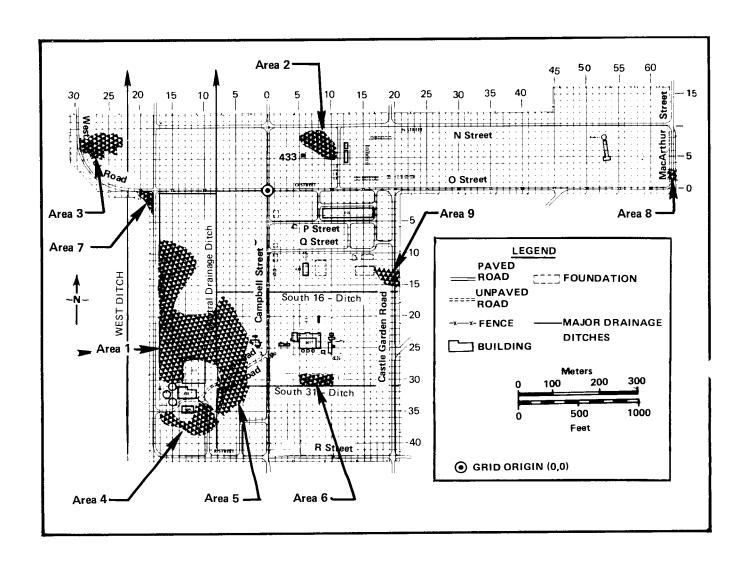
Figure 5-2 locates the nine contaminated areas identified within the Site. Smaller ($<1~m^2$) areas above background are indicated in quadrant maps reporting beta-gamma instrumental survey results (see Appendix H.3, Figs H3-1 through H3-16). Areas which were above background in instrumental readings (both beta-gamma and gamma readings) but resulted from "shine" from storage buildings are within areas indicated in these data presented in Appendix H (see Tables H3-1 through H3-4).

FIGURE 5-2. MAP OF CONTAMINATED AREAS OF THE DOE-NIAGARA FALLS STORAGE SITE

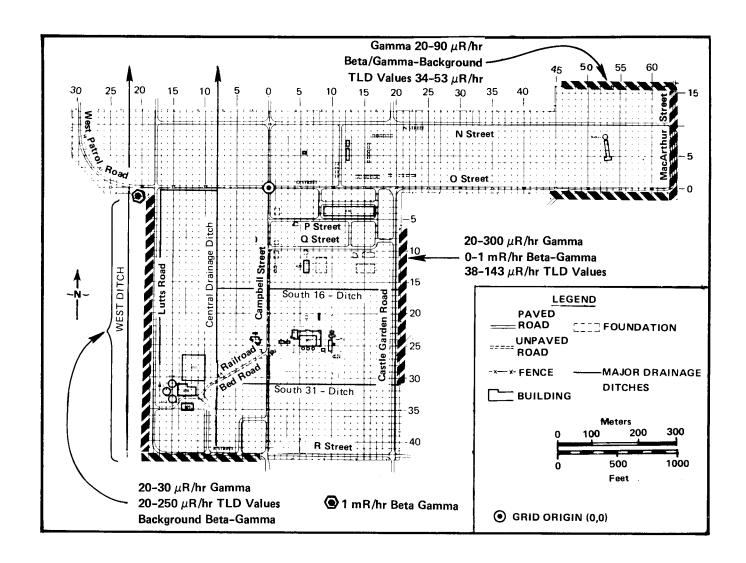
FIGURE 5-3. PERIPHERY AREAS OF THE SITE WHICH EXCEED BACKGROUND INSTRUMENTAL (1 M GAMMA, 1 CM BETA-GAMMA) READINGS

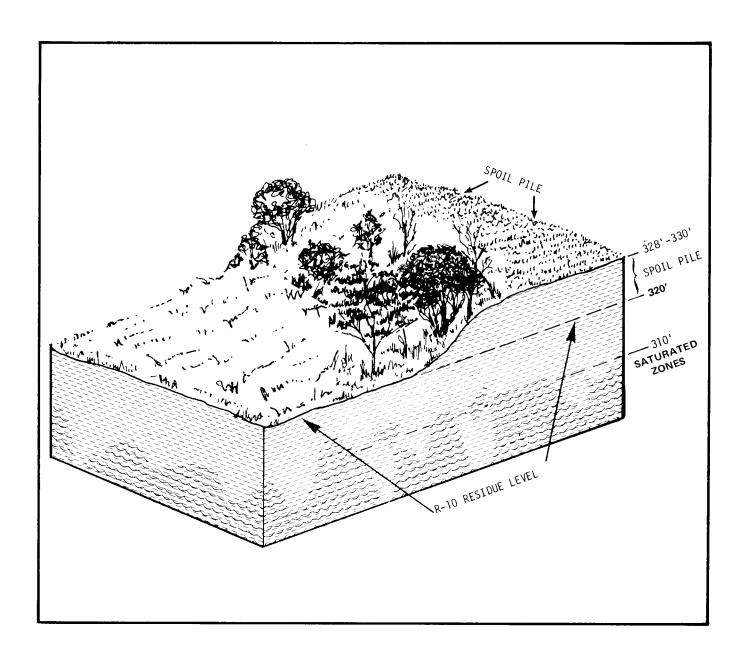
FIGURE 5-4. CUTAWAY DIAGRAM OF THE R-10 RESIDUE STORAGE AND SPOIL PILE AREA SHOWING THE LOCATION OF THE SPOILS AND THE SATURATED ZONES UNDERLYING THIS AREA

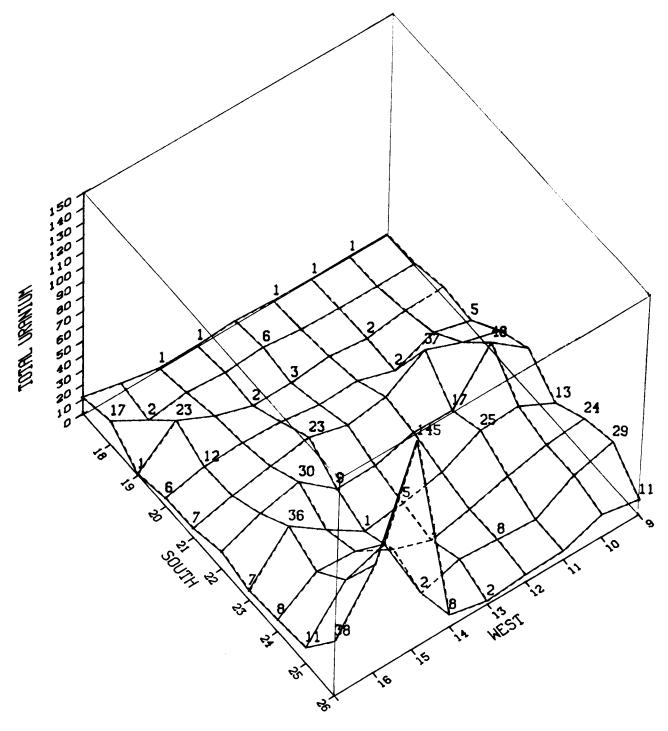
FIGURE 5-5. THREE-DIMENSIONAL REPRESENTATION OF URANIUM CONCENTRATIONS
IN THE SURFACE OF THE R-10 RESIDUE STORAGE AND SPOIL PILE AREA

found on the spoil pile immediately north of Building 411. Minimal concentrations occur in the north of the R-10 residue storage area, approximately 137 m (450 ft) north of Building 411.

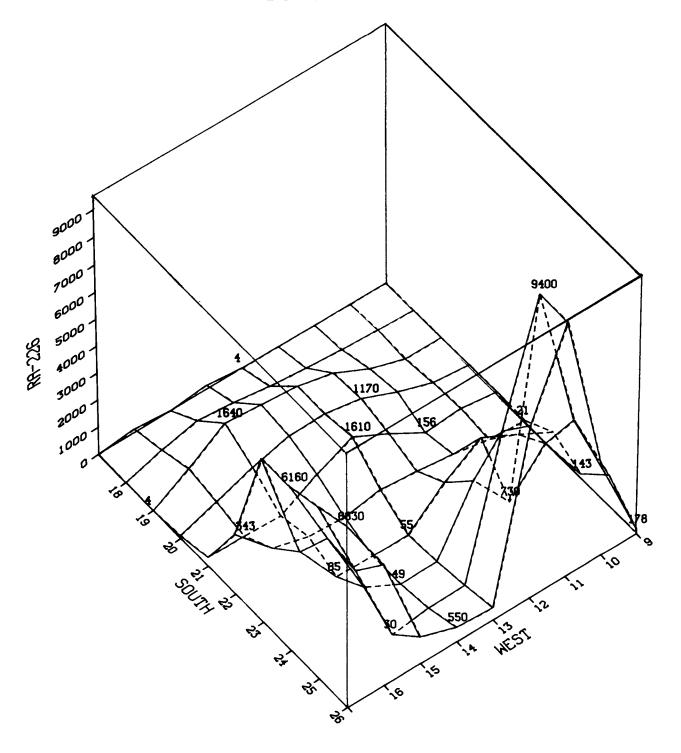
FIGURE 5-6. THREE-DIMENSIONAL REPRESENTATION OF 226 RA CONCENTRATIONS IN THE SURFACE (0-2 FT) OF THE R-1C RESIDUE STORAGE AND SPOIL PILE AREA

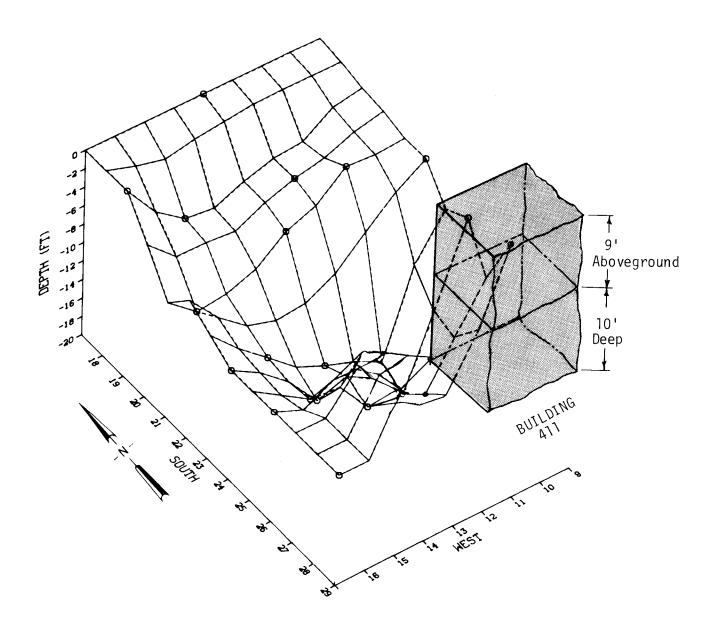
FIGURE 5-7. THREE-DIMENSIONAL REPRESENTATION OF THE DEPTH PROFILES LEFT INTACT IN THE R-10 RESIDUE AND SPOIL PILE AREA AFTER SOILS CONTAMINATED BY $$>5$\ PCI/G\ ^{226}RA$ WERE REMOVED

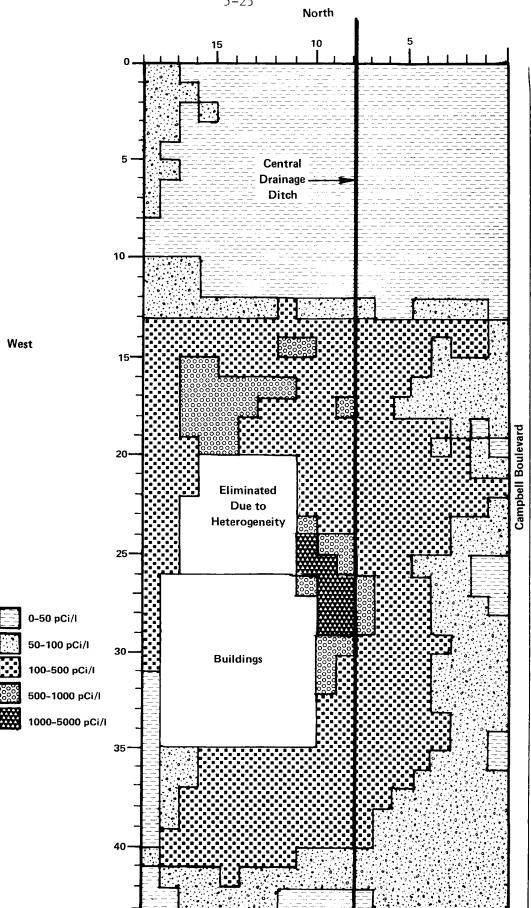
FIGURE 5-8. CONTOURS OF $^{2\,2\,2}\,\mathrm{RN}$ IN SURFACE AIR IN THE SOUTHWEST QUADRANT OF THE SITE AS ESTIMATED USING A KRIEGING AVERAGING ROUTINE ON THE DATA BASE

detected using the Terradex cups. Average 222 Rn concentrations at the soil surface in the R-10 residue storage area ranged from 400-800 pCi/l (see Appendix H, Table H-7).

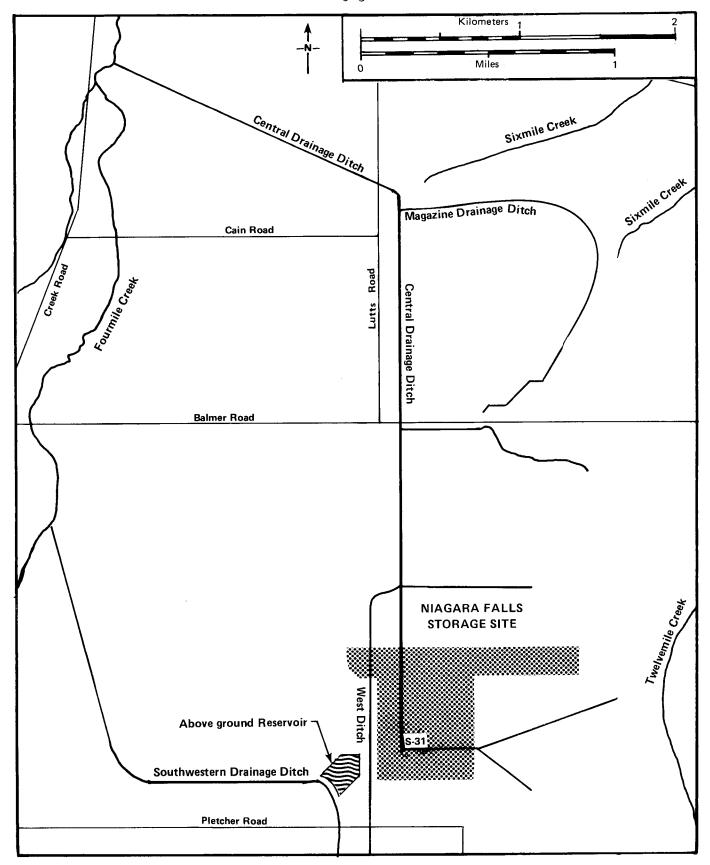
FIGURE 6-1. DRAINAGES OF THE DOE-NIAGARA FALLS STORAGE SITE

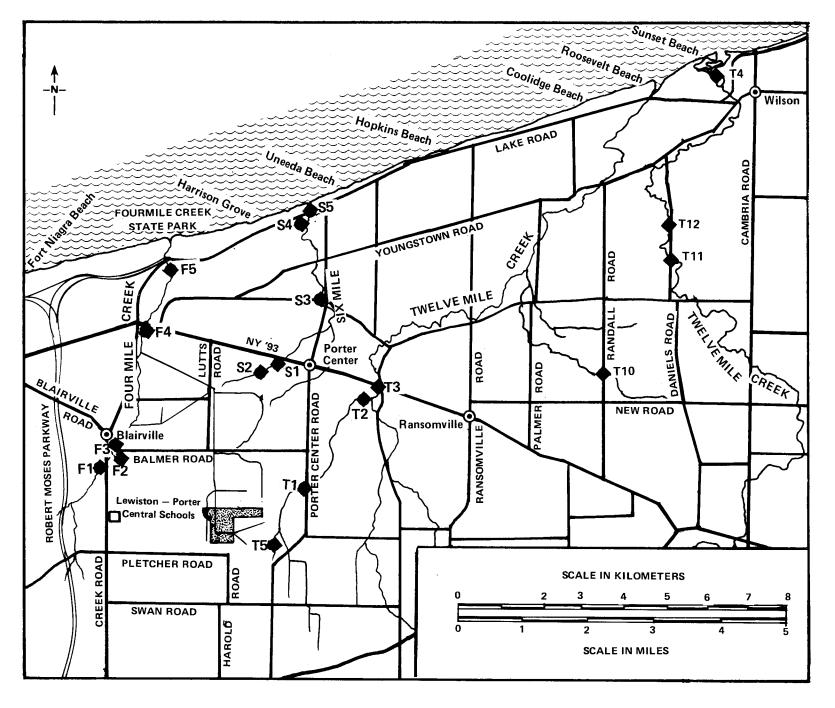
FIGURE 6-2. SEDIMENT SAMPLING LOCATIONS IN FOURMILE, SIXMILE, AND TWELVEMILE CREEKS

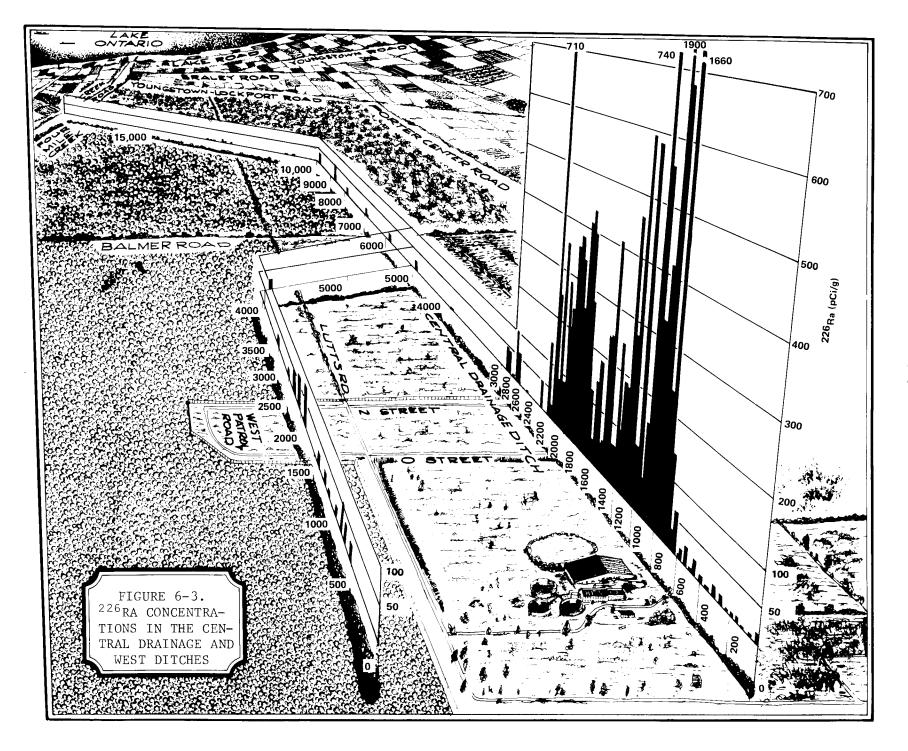
On-site contamination, shown to be well in excess of the proposed ²²⁶Ra limits (see Figure 6-3), also appears to be limited to surface sediments. Contamination in the Central Drainage Ditch in excess of the 5 pCi/g 226 Ra proposed limit was found to a maximum depth of 0.6 m (2 ft), except in a short section near the R-10 residue storage and spoil pile area (see Appendix I, Table I-6). Thus, as was the case in off-site areas, contamination within most of the on-site portion of the Central Drainage Ditch is limited to the surface sediments no deeper than 0.6 m (2 ft). The exceptions to this conclusion seem to occur over a 90-m (300 ft) length of the ditch along the R-10 residue storage and spoil pile area (from S26WB to S20W8 on the Site grid). Levels in excess of 5 pCi/g were found from the surface of sediments to 1.2 m (4 ft) in depth in two cores from this area (see Appendix I, Table I-6). It should be noted, however, that subsurface contamination was not detected in the drill core taken between these two contaminated cores. This same type of heterogeneity occurred in drill cores from on-site contaminated areas

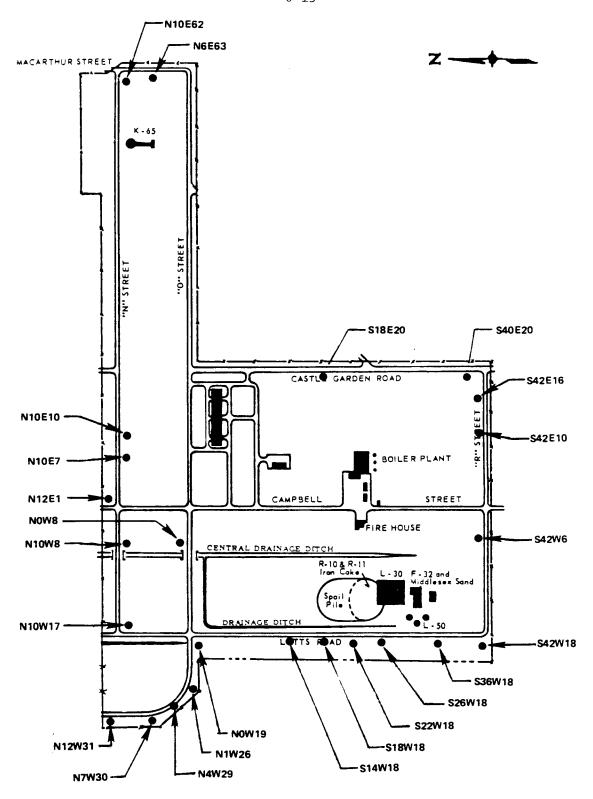
FIGURE 6-4. LOCATION OF PERIMETER WELLS

Monitoring wells used for these evaluations were established during the summer of 1979 and sampled during 1980. Locations of wells at the Site periphery and in the R-10 residue storage area used for this characterization are shown in Figures 6-4 and 6-5. Wells were encased as specified. Depths to saturated zones were established during splitspoon sampling during 1979 and by measuring depth to free water in wells during 1980 (see Appendix B, QA Documents EE-SP-11, EE-SP-26 and HL-QAP-J-5594).

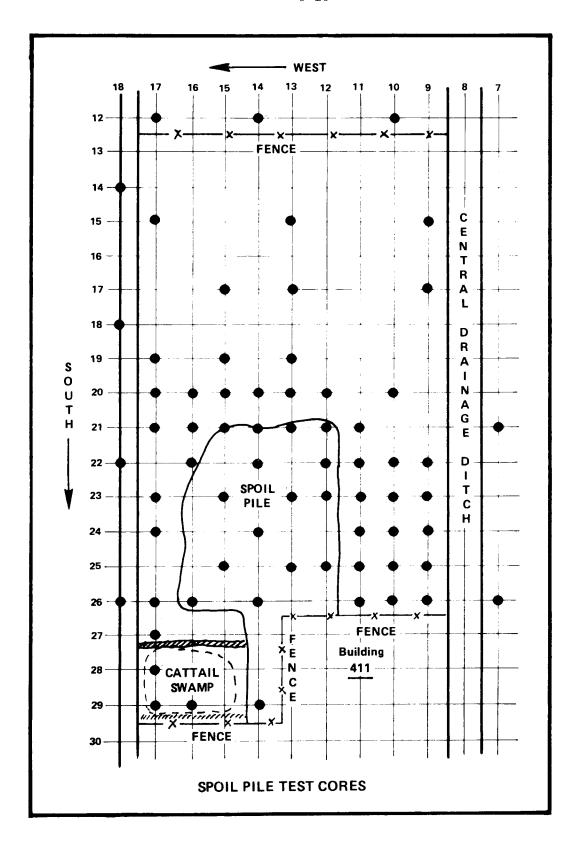
FIGURE 6-5. LOCATION OF WELLS ON THE R-10 RESIDUE STORAGE AND SPOIL PILE AREA
